AC Recondition Repair Report

FolderID: 97414
FormID: 9086774

Delta Plastics (11016)
8801 Frazier Pike
Little Rock, AR 72206

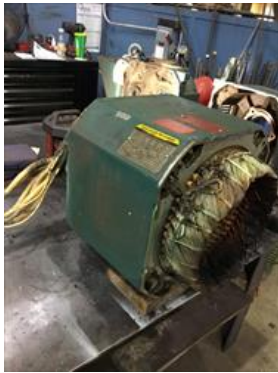
P12.1

General			
1. Job Number	97414		
2. Report Date			
3. Customer	DELTA PLASTICS LR		
Name Plate Information			
4. Manufacturer	BALDOR		
5. Model			
6. Serial Number	B9126122-020001 JQ		
7. Horsepower	150 HP		
8. KW			
9. Volts	460 Volts		
10. Amps	180		
11. RPM	1750		
12. Frame	URL2882Z		P12
13. Enclosure	DP		P13
14. Cycles	60		
15. Phase	3		
16. Service Factor	1.0		
17. Motor Mount Position			
Initial Inspection			
18. Number of Leads	6		P18
19. Lead Length	12 Inches		
20. Lead Size			
21. Lead Condition	(P) Pass		
22. Lead Markings	1,2,3		
23. Lug Size, Condition, and Type	N/a		
24. Winding RTD's			
25. Winding Rtd's Condition			
26. Shaft Run Out			
27. Does Shaft Turn Freely	no		P27
28. Does Shaft Have Visible Damage	yes		P28
29. Bearing Rtd's			
30. Bearing Rtd's Condition			
31. Contamination			P31
Yes			
32. Frame Condition	(P) Pass

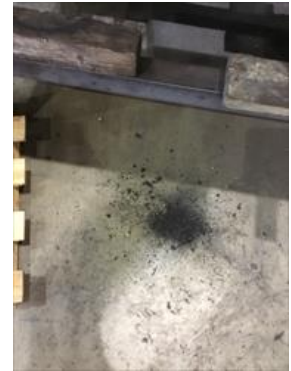
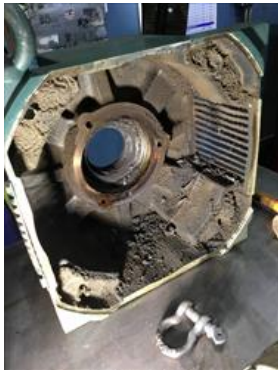
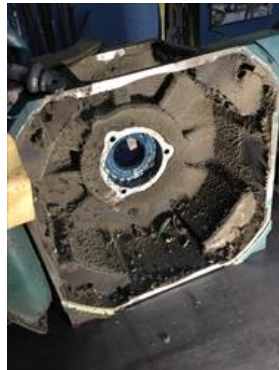
P31.8

67.	Cause of Failure	<i>Lack of lubricant in D.E bearing caused excessive failure and contaminated grease in the O.d.e bearing contributed to premature failure of the bearings and is responsible for bearing pieces embedded in the motor windings.</i>

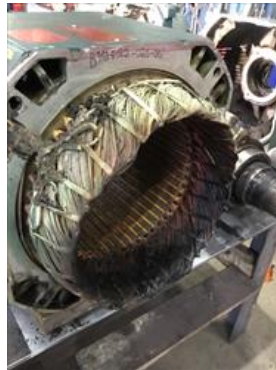
P41.11

37.	Winding Resistance 2-3		
38.	Winding Resistance 1-3		
39.	Resistive Imbalance		
40.	Hi-Pot		
 	41. Surge Test	(F) Fail	P41
42.	Stator Condition		
43.	Failure Location		P43
Initial Rotor Inspection

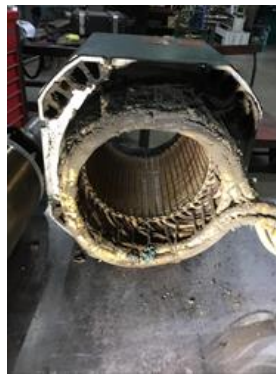
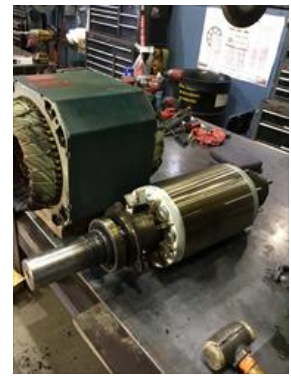
P44.15

44.	Rotor Type	squirrel cage	P44
45.	Air Gap <10% Variation		
46.	Number of Rotor Bars		
47.	Number of Broken Rotor Bars		
48.	Growler Test		
 	49. Rotor Condition	(P) Pass	P49
Mechanical Inspection

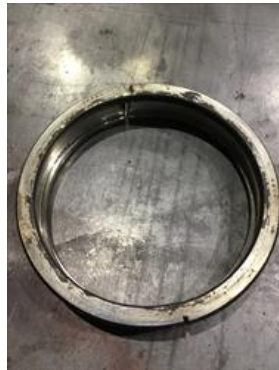
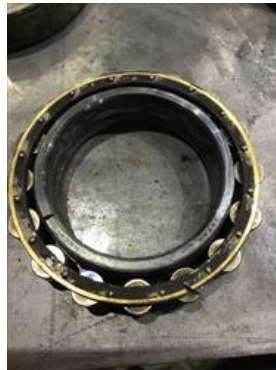
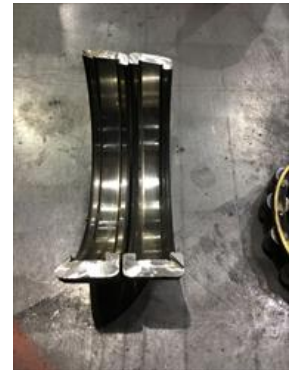
P51.18

50.	Bearing Manufacture	nachi	
51.	Bearing DE Size	nu215/C3	P51
52.	Bearing DE Type		
53.	DE Bearing Qty.		
54.	Bearing ODE Size	6211/C3	P54
55.	Bearing ODE Type	ball bearing

62.	DE Seal	(NA) Not Applicable	
63.	DE Seal Type/Size		
64.	ODE Seal	(NA) Not Applicable	
65.	ODE Seal Type/Size		
Root Cause of Failure			
66.	Component Failure	D.e. bearing

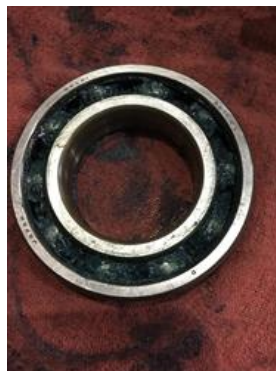
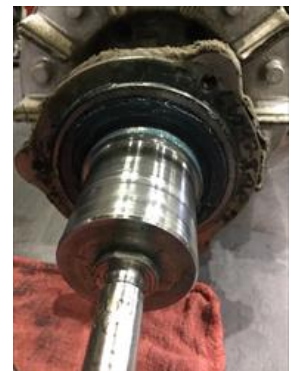
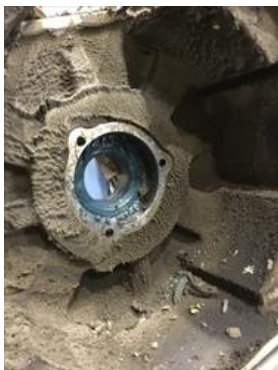
P59.23

56.	ODE Bearing Qty.	1	
57.	Insulated Bearing	no	
58.	Lubrication Type	polyrex	
 	59. Grease Condition	(F) Fail	P59
 	60. Bearing Retainers	(Y) Yes	P60
61.	Shaft Grounding Device	(NA) Not Applicable

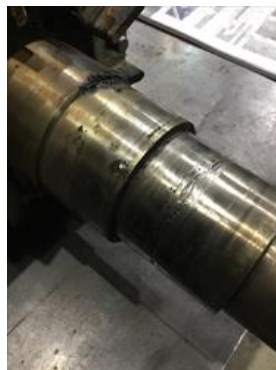
P73.27

70.	Shaft Run Out		
71.	Initial Shaft Run Out		
72.	Final Shaft Run Out		
73.	DE Bearing Shaft Fit	(F) Fail	P73
74.	DE Initial Shaft Bearing Fit Size 1	"	
75.	DE Initial Shaft Bearing Fit Size 2

76.	DE Initial Shaft Bearing Fit Size 3		
77.	DE Finial Shaft Bearing Fit Size 1	2.9537 "	P77
	<i>Belzona shaft fit</i>		
78.	DE Finial Shaft Bearing Fit Size 2	2.9537 "

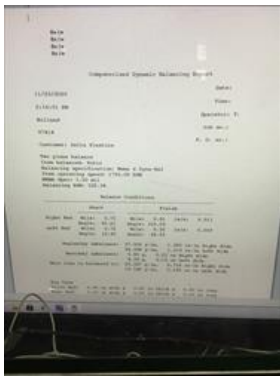
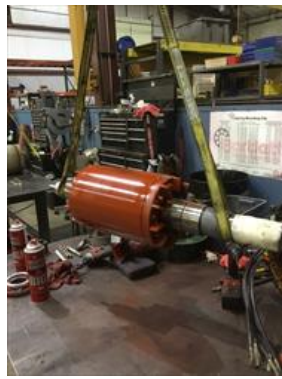
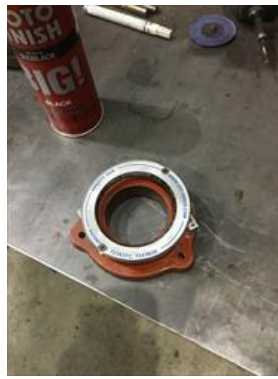
P119.29

115.	Foot Flatness		
116.	Foot Condition		
117.	Flange Condition		
118.	Service Technician		
Balancing Report		 	
119.	Balance Type		P119
120.	Balance Operating Speed

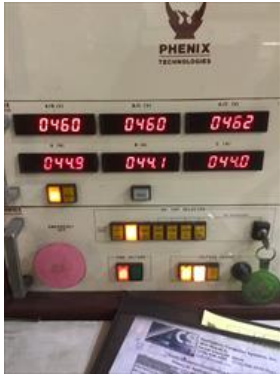
P133.32

127.	Meggar Testing Reading		
128.	Surge Test		
129.	Hi-Pot		
130.	Winding Resistance 1-2		
131.	Winding Resistance 2-3		
132.	Winding Resistance 1-3		
133.	Test Run Voltage Phase A	460 Volts	P133

134.	Test Run Amps A	44.9 Amps	
135.	Test Run Voltage Phase B	460 Volts	
136.	Test Run Amps B	44.1 Amps	
137.	Test Run Voltage Phase C	462 Volts	
138.	Test Run Amps C	44 Amps

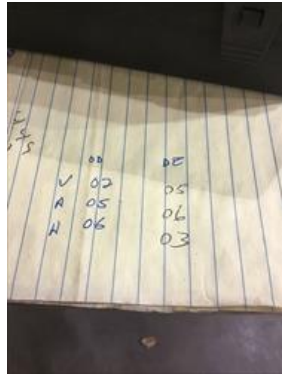
P139.34

139.	DE Horizontal Vibration Reading	0.03 In/Sec	P139
140.	DE Vertical Vibration Reading	0.05 In/Sec	
141.	DE Axial Vibration Reading	0.06 In/Sec	
142.	ODE Horizontal Vibration Reading	0.06 In/Sec

143.	ODE Vertical Vibration Reading	0.02 In/Sec	
144.	ODE Axial Vibration Reading	0.05 In/Sec	
145.	Ambient Temp at start of Test Run		
146.	Temp at 5 minutes

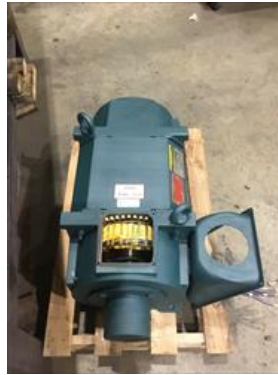
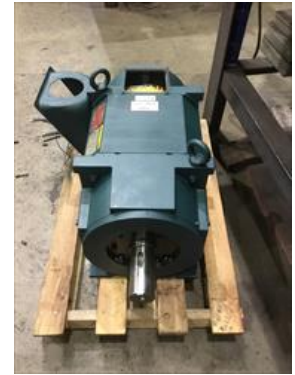
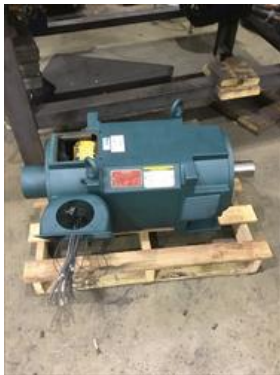
P158.35

● 158. Motor Paint

(P) Pass
