## AC Recondition Repair Report

### Peco Foods

625 S. Allen Street  
Batesville, AR 72501

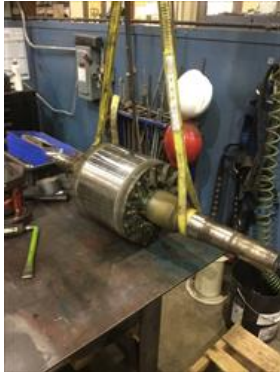
**P4.1**

43.	Failure Location		
<b>Initial Rotor Inspection</b>			 
44.	Rotor Type		P4
45.	Air Gap <10% Variation		
46.	Number of Rotor Bars	39	
47.	Number of Broken Rotor Bars	0

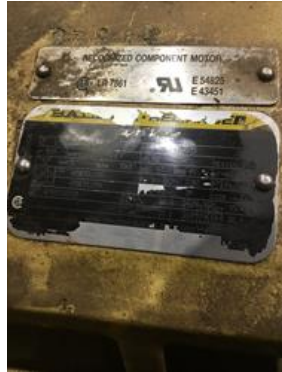
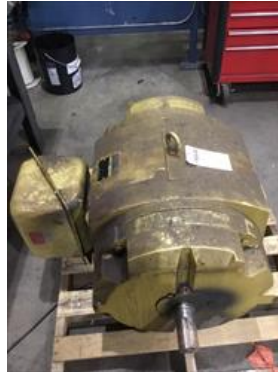
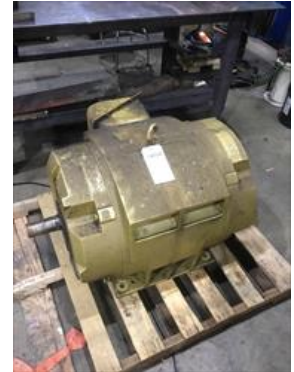
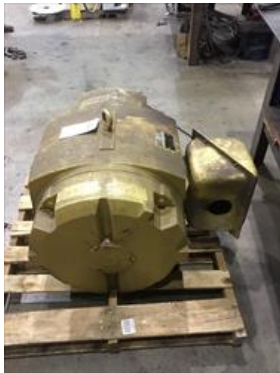
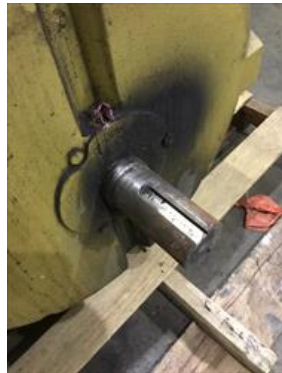
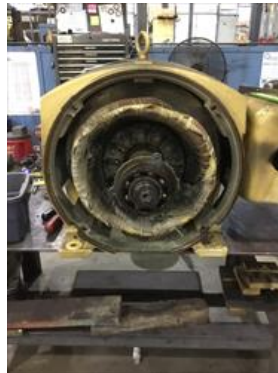
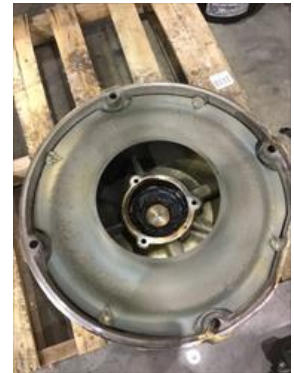
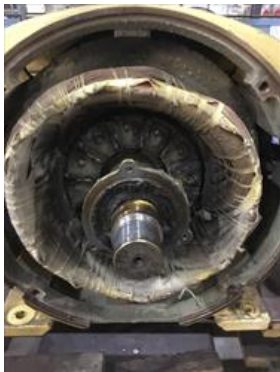
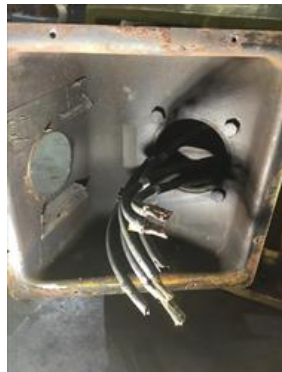
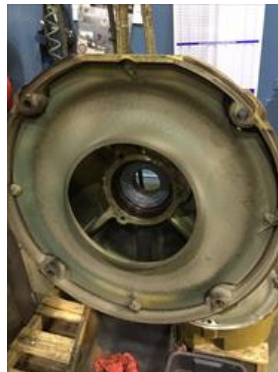
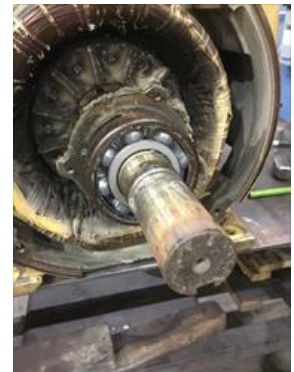
General		
1. Job Number	97565	
2. Report Date		
3. Customer	PECO FOODS	
Name Plate Information		
4. Manufacturer	BALDOR	P5
5. Model		
6. Serial Number	A1907302031	
7. Horsepower	200	
8. KW		
9. Volts	460	
10. Amps	221	
11. RPM	3565	
12. Frame	444TS	
13. Enclosure	DP	
14. Cycles	60	
15. Phase	3	
16. Service Factor		
17. Motor Mount Position		
Initial Inspection		
18. Number of Leads	6	
19. Lead Length	Inches	
20. Lead Size		
21. Lead Condition	(F) Fail	
22. Lead Markings	1-6	P51
23. Lug Size, Condition, and Type		
24. Winding RTD's		
25. Winding Rtd's Condition		
26. Shaft Run Out		
27. Does Shaft Turn Freely		
28. Does Shaft Have Visible Damage	no	
29. Bearing Rtd's		
30. Bearing Rtd's Condition		
31. Contamination		P104
<i>Contaminated grease</i>		
32. Frame Condition	(P) Pass	P106
33. Fan Condition	(NA) Not Applicable

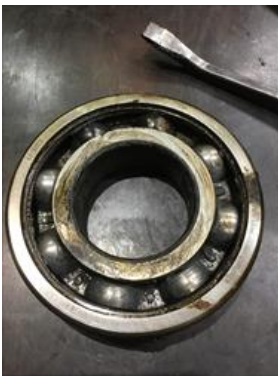
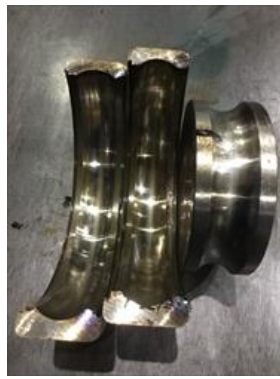
**P15.13**

48. Growler Test	(P) Pass	
 	49. Rotor Condition	(P) Pass	
<b>Mechanical Inspection</b>			 
50.	Bearing Manufacture	SKF	
51.	Bearing DE Size	6312 2Z/C3	P15

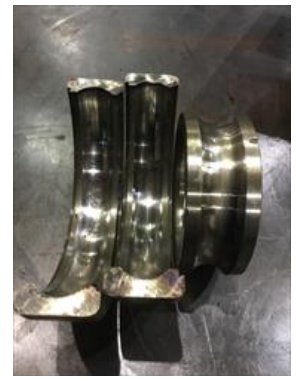
**P53.16**

52.	Bearing DE Type	regular ball bearing	
53.	DE Bearing Qty.	1	
54.	Bearing ODE Size	6312 2Z/C3	
55.	Bearing ODE Type	regular ball bearing	P53
56.	ODE Bearing Qty.	1

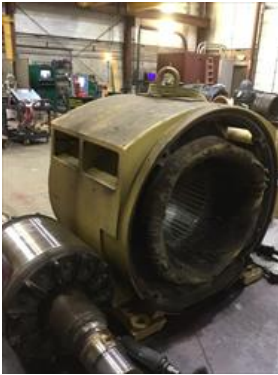
**P65.17**

36.	Winding Resistance 1-2		
37.	Winding Resistance 2-3		
38.	Winding Resistance 1-3		
39.	Resistive Imbalance		
40.	Hi-Pot		
41.	Surge Test		
42.	Stator Condition		P65

62.	DE Seal		
63.	DE Seal Type/Size		
64.	ODE Seal		
65.	ODE Seal Type/Size		
<b>Root Cause of Failure</b>			
66.	Component Failure	leads	
67.	Cause of Failure		
	<i>Loose connection inside terminal box.</i>

68.	Comments		
	<i>Found lead ends melted inside connection box and winding strings burnt through. Rewind required.</i>

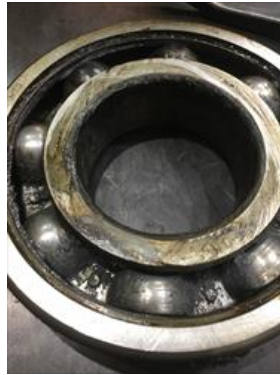
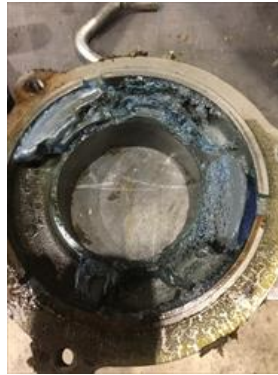
**P74.18**

57.	Insulated Bearing	no	
58.	Lubrication Type	grease	
 	59. Grease Condition	(F) Fail	P74
 	<i>Dirty/gritty</i>		
 	60. Bearing Retainers	(Y) Yes	P80
61.	Shaft Grounding Device
