Hi-Speed Industrial Service  
7030 Ryburn Dr  
Millington, Tn 38053  
901-873-5300

## AC Recondition Repair Report

1. Job Number	97621
2. Report Date	
3. Customer	SAGE LR

4. Manufacturer	TSURUMI	P5
-----------------	---------	----

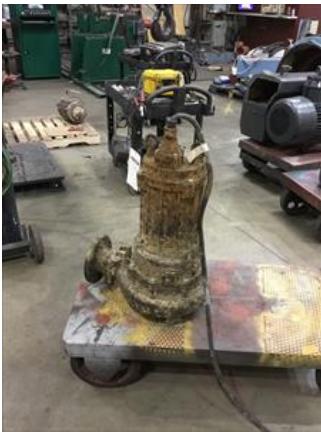
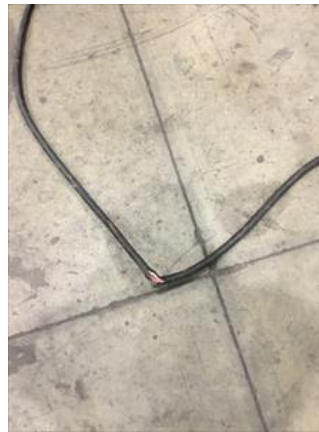
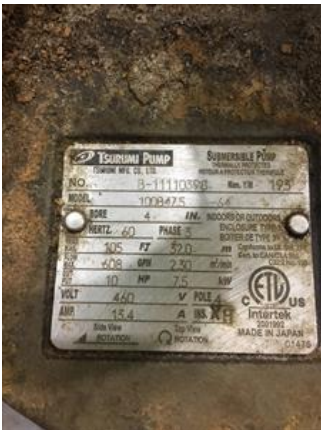
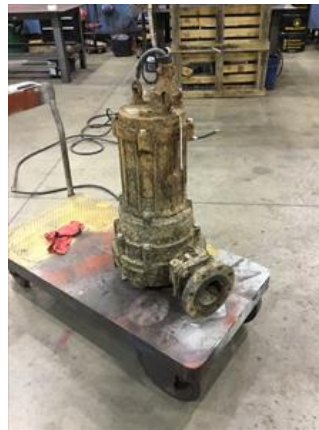
<i>Insulation cut in multiple places. Cord is 4c. 35' long.</i>	
20.	Lead Size

21. Lead Condition	<b>(F) Fail</b>
22.	Lead Markings	
23.	Lug Size, Condition, and Type	
24.	Winding RTD's	
25.	Winding Rtd's Condition	
26.	Shaft Run Out	<b>0.001</b>
27.	Does Shaft Turn Freely	<b>yes</b>

66.	Component Failure	seals	
67.	Cause of Failure	Seal failure.	
68.	Comments	Replace power cord.	
69.	Service Technician	Terrence Holland

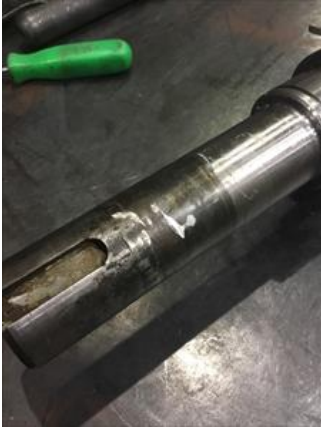
P94

28. Does Shaft Have Visible Damage

yes Minor

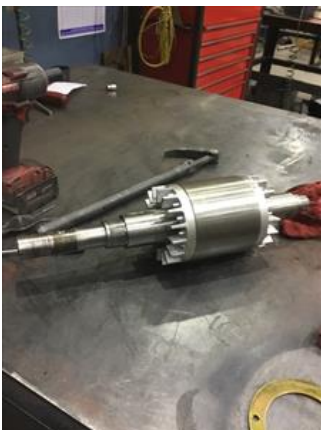
P4

44. Rotor Type squirrel cage

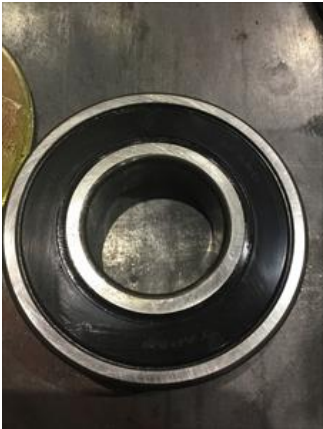
50.	Bearing Manufacture	koyo	
51.	Bearing DE Size	6309 2rs	P15

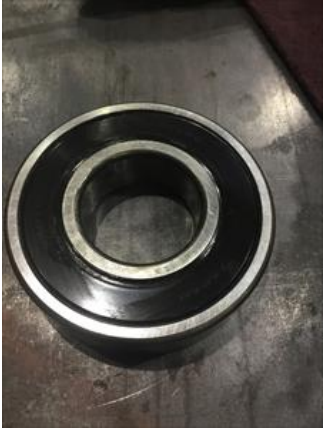
52.	Bearing DE Type	regular ball bearing	P23

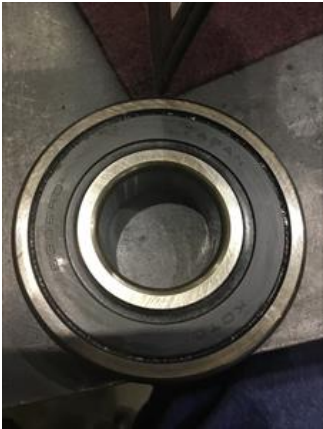
53.	DE Bearing Qty.	1	
54.	Bearing ODE Size	6306 2rs	P43

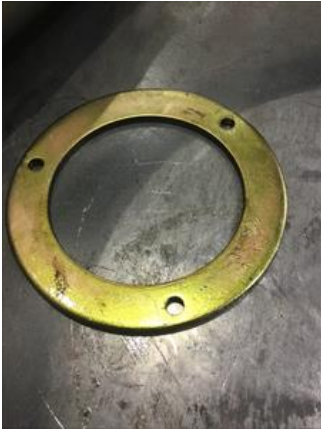
56.	ODE Bearing Qty.	1	
57.	Insulated Bearing	no	
58.	Lubrication Type	oil	
59.	Grease Condition	(NA) Not Applicable	
60.	Bearing Retainers	(Y) Yes	P80
