Hi-Speed Industrial Service
7030 Ryburn Dr
Millington, Tn 38053
901-873-5300

AC Recondition Repair Report

Reynolds Metals company
1333 highway 270
Malvern, AR 72104

Performed By: Motor Shop LR 1
Date Completed: 1/6/2021

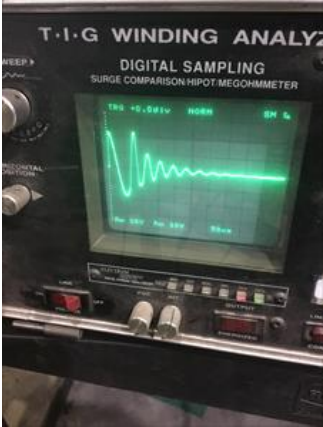
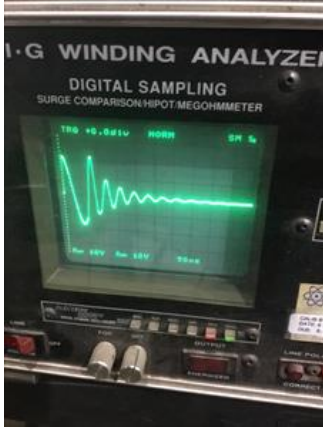
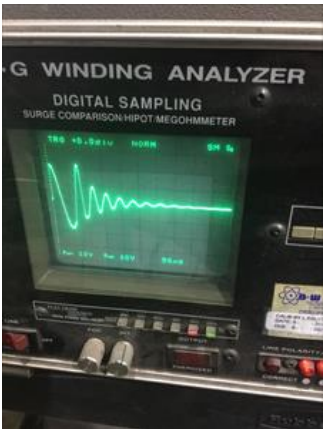
35.	Resistance to Ground	Mohm	
36.	Winding Resistance 1-2		
37.	Winding Resistance 2-3		
38.	Winding Resistance 1-3		
39.	Resistive Imbalance		
40.	Hi-Pot		
41.	Surge Test	(P) Pass	P58
<div>

</div>			
42.	Stator Condition	good	
43.	Failure Location		
Initial Rotor Inspection			
44.	Rotor Type	squirrel cage

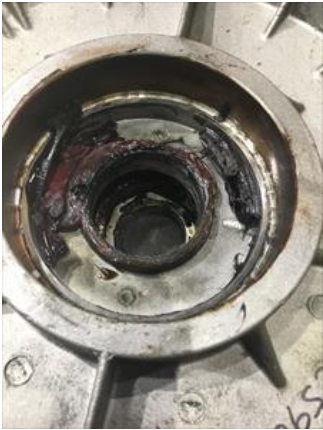
55.	Bearing ODE Type	regular ball bearing	
56.	ODE Bearing Qty.	1	
57.	Insulated Bearing	no	
58.	Lubrication Type	grease

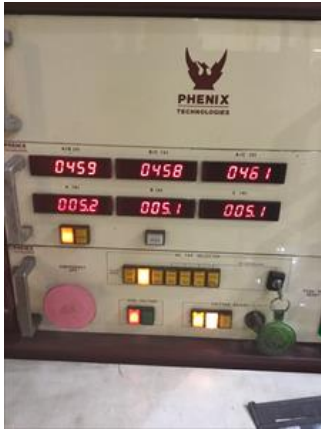
127. Meggar Testing Reading	Mohm
128. Surge Test	(P) Pass
129. Hi-Pot	
130. Winding Resistance 1-2	
131. Winding Resistance 2-3	
132. Winding Resistance 1-3
