AC Recondition Repair Report

1. Job Number	97701
2. Report Date	
3. Customer	HI SPEED MIL.

4. Manufacturer	US ELECTRIC	P5
-----------------	-------------	----

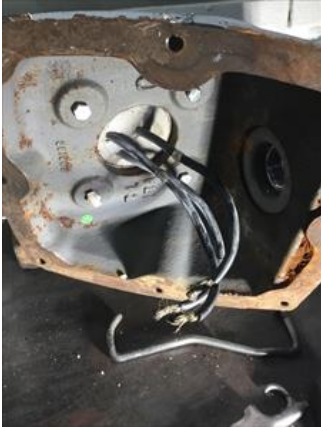
P13

18. Number of Leads

3

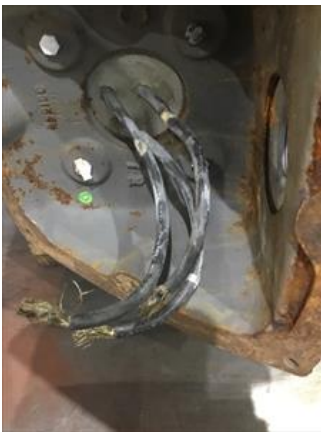
P37

19. Lead Length

9 Inches

20. Lead Size

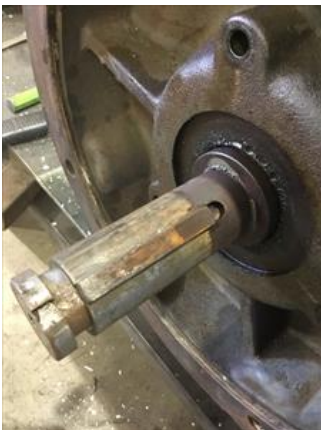
28. Does Shaft Have Visible Damage no P94

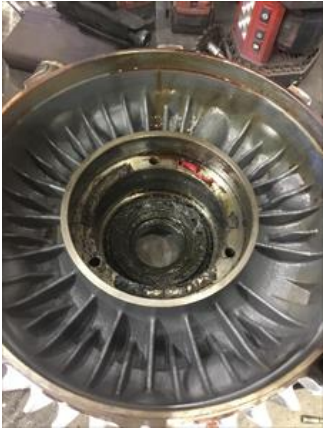
29.	Bearing Rtd's	
30.	Bearing Rtd's Condition	
31.	Contamination <i>Grease dirty/contaminated</i>	P104

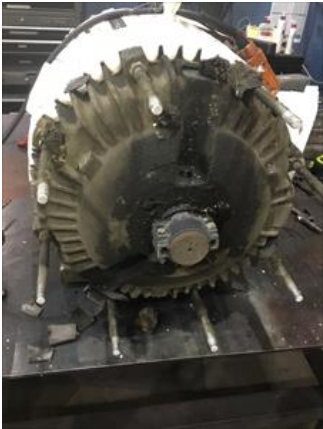
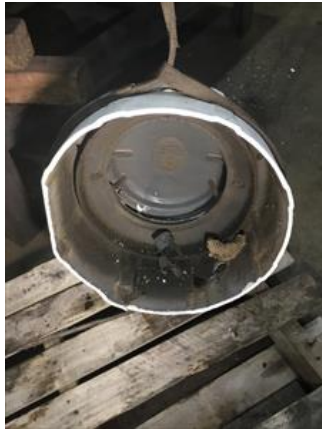
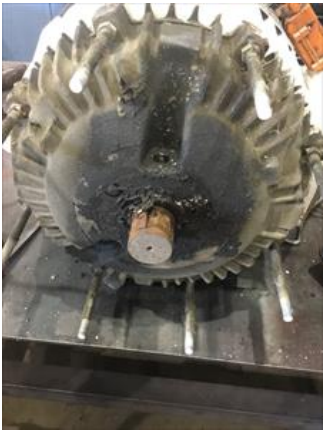
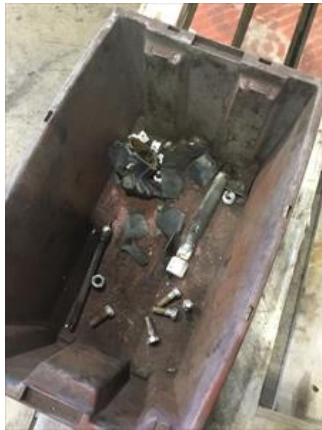
●	32.	Frame Condition	(P) Pass	
●	33.	Fan Condition	(F) Fail	P109

34. Broken or missing components

Fan assembly

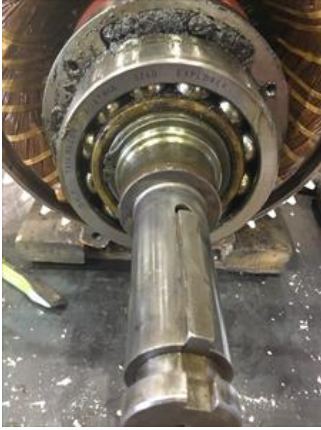
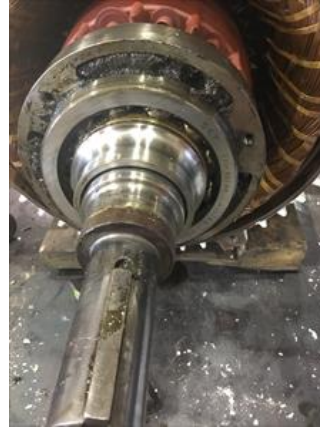
P15

51. Bearing DE Size

SKF 7314 BECBM

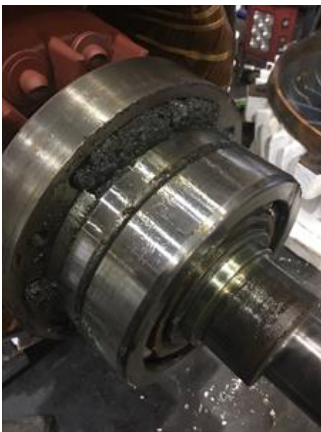
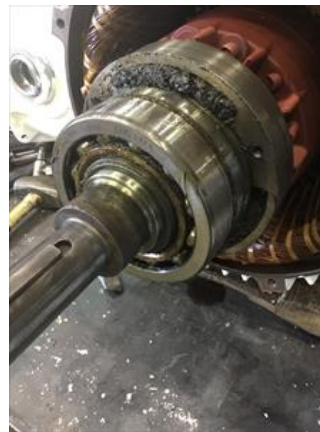
P30

52. Bearing DE Type

thrust

53. DE Bearing Qty.

2

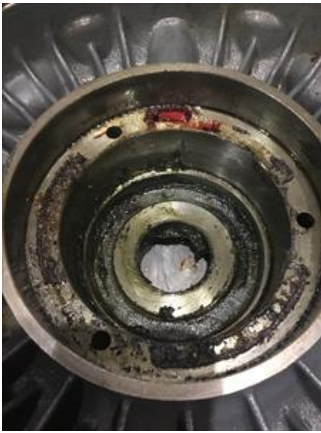
P74

☒ 59. Grease Condition

(F) Fail
