AC Recondition Repair Report

Green Bay Packaging, Pinecrest
(11362)
P.O. Box 37
Plummerville, AR 72127

Performed By: Motor Shop LR 1
Date Completed: 11/12/2020

General			
1. Job Number	97456		
2. Report Date			
3. Customer	GREENBAY/ PINECREST		
Name Plate Information			
4. Manufacturer	TOSHIBA		P5
5. Model	B2504FLF4BM

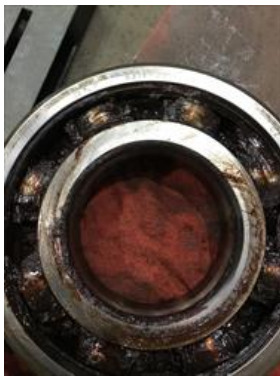
P1.1

50.	Bearing Manufacture	SKF	P1
51.	Bearing DE Size	6322C3	P15
52.	Bearing DE Type	Ball	P23

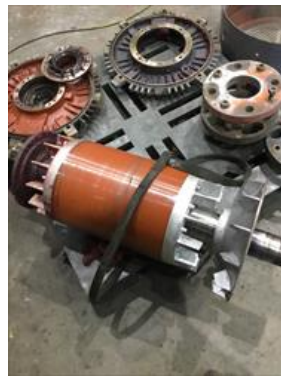
P4.2

44.	Rotor Type		P4
45.	Air Gap <10% Variation		
46.	Number of Rotor Bars		
47.	Number of Broken Rotor Bars	0

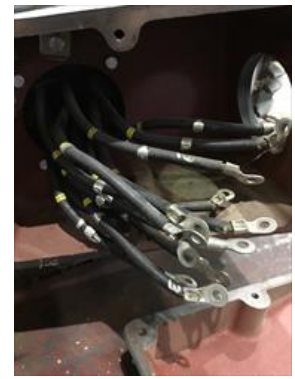
P13.4: 12

16. Service Factor	1.15		P85
17. Motor Mount Position	F1		
Initial Inspection			
18. Number of Leads	12		P13
19. Lead Length	10 Inches		
20. Lead Size	2		
21. Lead Condition	(P) Pass

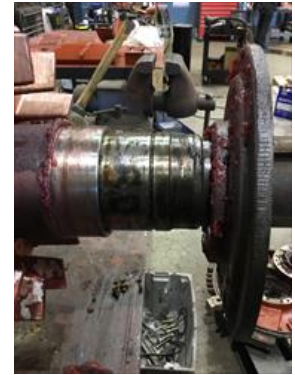
P39.8

70.	Shaft Run Out	(P) Pass	
71.	Initial Shaft Run Out	0.0005 "	
72.	Final Shaft Run Out	0.0005 "	
73.	DE Bearing Shaft Fit	(P) Pass	P39
74.	DE Initial Shaft Bearing Fit Size 1	4.3313 "

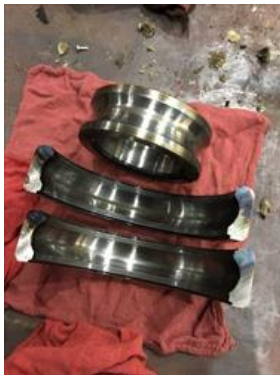
P43.9

53.	DE Bearing Qty.	Bad	
54.	Bearing ODE Size	6318-2Z	P43
55.	Bearing ODE Type	Ball	P53
56.	ODE Bearing Qty.	Bad	P59
57.	Insulated Bearing	no	
58.	Lubrication Type	grease	P69

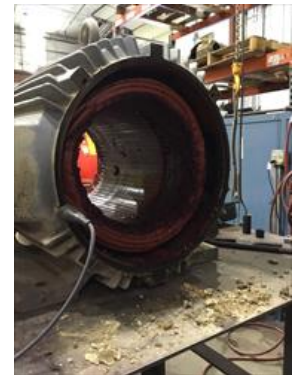
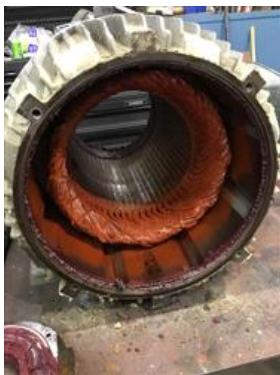
P65.12

37.	Winding Resistance 2-3	0.0127 Ohm's	
38.	Winding Resistance 1-3	0.0127 Ohm's	
39.	Resistive Imbalance		
40.	Hi-Pot	Ua	
41.	Surge Test	(P) Pass	
42.	Stator Condition	good	P65

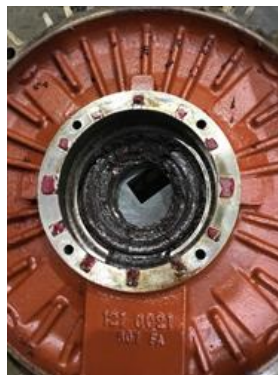
P74.15

59.	Grease Condition	(F) Fail	P74
60.	Bearing Retainers	(NA) Not Applicable	
61.	Shaft Grounding Device	(N) No	
62.	DE Seal	(NA) Not Applicable	
63.	DE Seal Type/Size

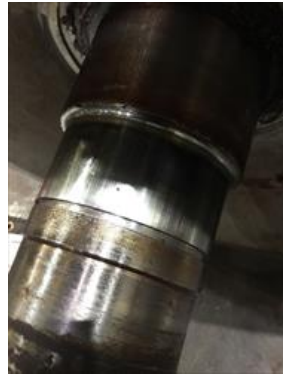
P93.22

79.	DE Finial Shaft Bearing Fit Size 3		
80.	ODE Bearing Shaft Fit	(P) Pass	P93
81.	ODE Initial Shaft Bearing Fit Size 1	3.5434 "	
82.	ODE Initial Shaft Bearing Fit Size 2	3.5433 "

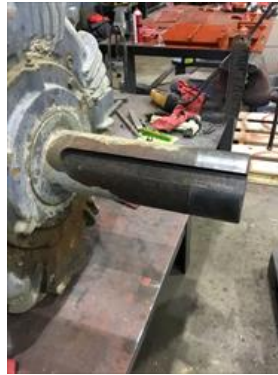
P94.23

27. Does Shaft Turn Freely	yes		
28. Does Shaft Have Visible Damage	no		P94
29. Bearing Rtd's	(N) No		
30. Bearing Rtd's Condition	(NA) Not Applicable		
31. Contamination			P104
	Yes , mixing grease

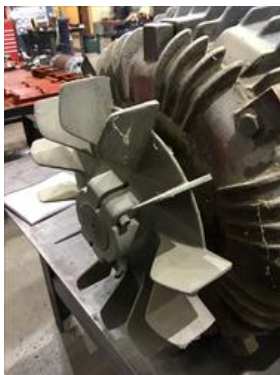
P109.25

33.	Fan Condition	(P) Pass	P109
34.	Broken or missing components		
	None		
Initial Electric Test

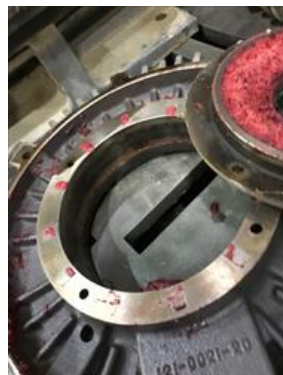
P129.26

92.	ODE Final Air Seal Shaft Size		
93.	DE Endbell Fit	(P) Pass	P129
94.	DE Initial Endbell Fit Size 1	9.449999999999999 "	
95.	DE Initial Endbell Fit Size 2	9.449999999999999 "

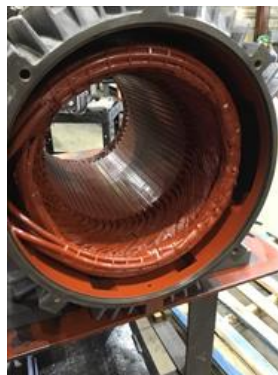
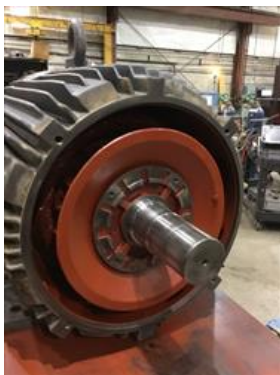
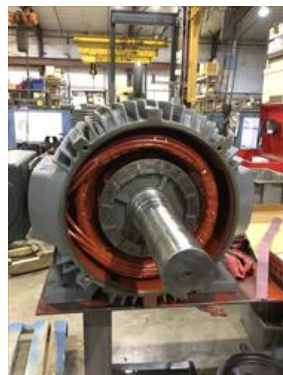
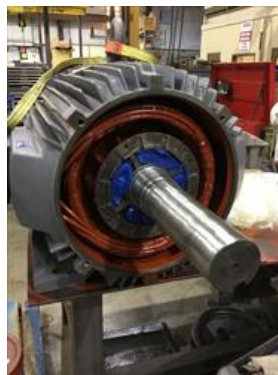
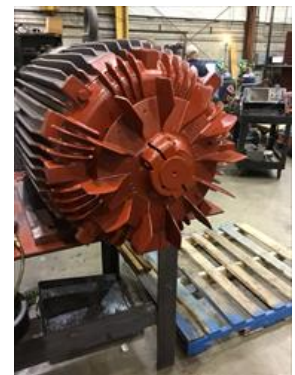
P136.27

158. Motor Paint	(P) Pass P136
	159. Service Technician	David Maclin

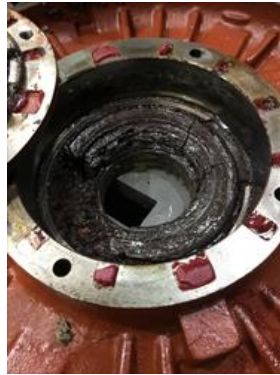
P145.38

101.	DE Endbell Air Seal Fit		
102.	Initial Endbell Air Seal Fit Size		
103.	Finial Endbell Air Seal Fit Size		
104.	ODE Endbell Fit	(F) Fail	P145
105.	ODE Initial Endbell Fit Size 1	7.4824 "

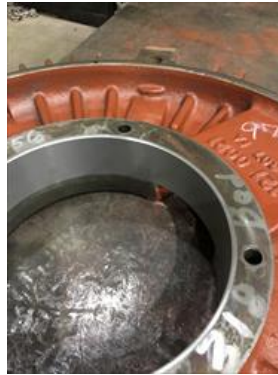
P149.39

106.	ODE Initial Endbell Fit Size 2	7.4828 "	
107.	ODE Initial Endbell Fit Size 3	7.4813 "	
108.	ODE Final Endbell Fit Size 1	7.4811 "	P149
109.	ODE Final Endbell Fit Size 2	7.481 "
