7030 Ryburn Dr Millington, Tn 38053 901-873-5300

P5

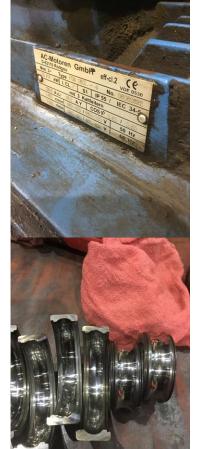
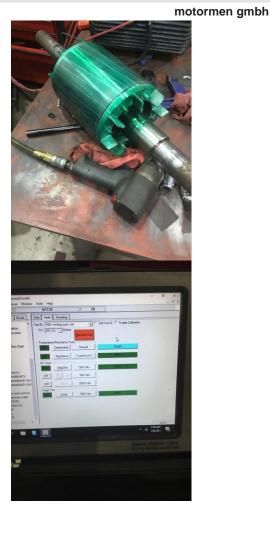
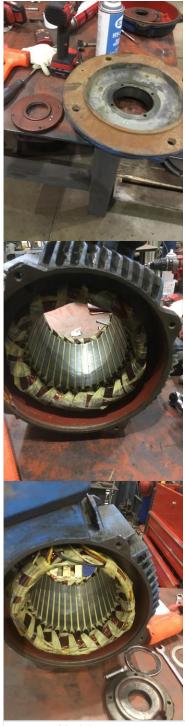
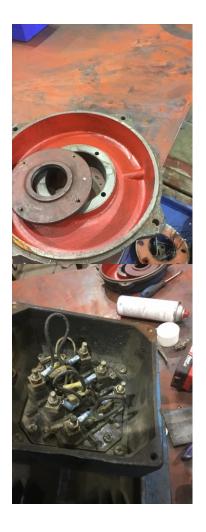
Name Plate Information

5.	Model	FOM160L
6.	Serial Number	06062692
7.	Horsepower	
8.	KW	15 KW
9.	Volts	48 Volts
10.	Amps	28.6 Amps
11.	RPM	RPM
12.	Frame	
13.	Enclosure	
14.	Cycles	
15.	Phase

28.	Does Shaft Have Visible Damage	_
29.	Bearing Rtd's	(NA) Not Applicable
30.	Bearing Rtd's Condition	
31.	Contamination	
32.	Frame Condition	
33.	Fan Condition	(F) Fail

-	Fan and cover missing	
34.	Broken or missing components	
	Fan and cover	
nitial l	Electric Test	
35.	Resistance to Ground	Mohm
36.	Winding Resistance 1-2	Ohm

58.	Lubrication Type		
59.	Grease Condition		
60.	Bearing Retainers		
61.	Shaft Grounding Device		
62.	DE Seal	(Y) Yes	
63.	DE Seal Type/Size	45 62 12	
64.	ODE Seal	(Y) Yes	
65.	ODE Seal Type/Size	45 62 12	
Root Cause of Failure			
66.	Component Failure	contaminated bearings	
67.	Cause of Failure		
	Environmental		
68.	Comments		
	2 - 45x56x12 seals 2 - 6309 2Z bearings		
	Service Technician	David Maclin
