AC Recondition Repair Report

Kimberly Clark (10176-KCM)
500 Murphy Dr.
Maumelle, AR 72113

1. Job Number	97751
2. Report Date	
3. Customer	KIMBERLY CLARK MAUMELLE

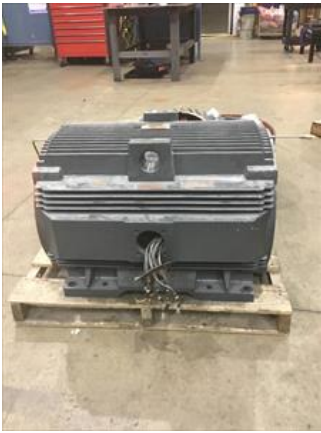
33. Fan Condition

(P) Pass

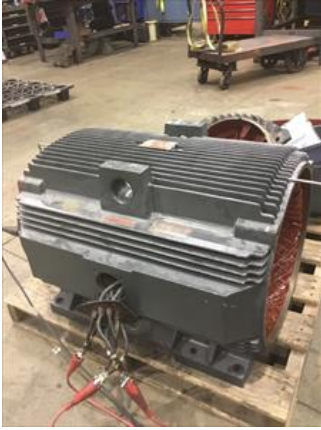
43. Failure Location

Initial Rotor Inspection

44. Rotor Type

squirrel cage

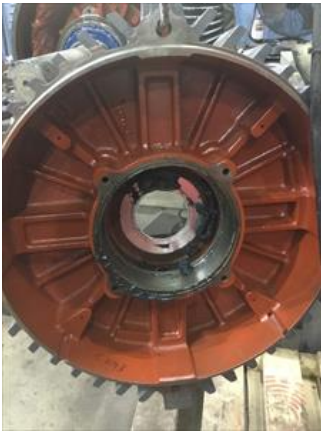
59. Grease Condition

(P) Pass
