AC Recondition Repair Report

Community Water System (12207)

LR MOTORSHOP

1. Job Number	97931
2. Report Date	02/02/2021
3. Customer	COMMUNITY WATER

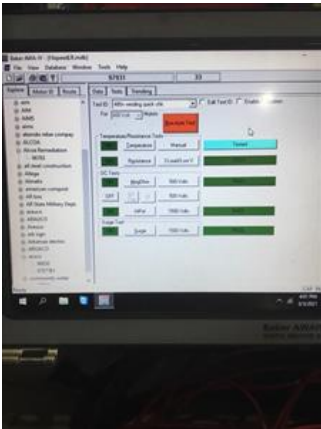
P58

35. Resistance to Ground

41. Surge Test

(P) Pass

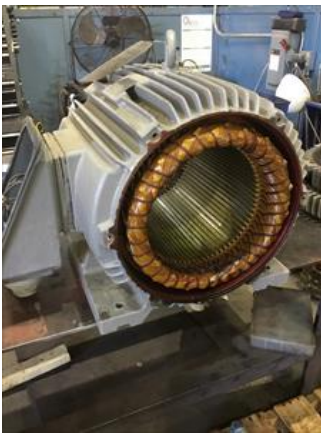
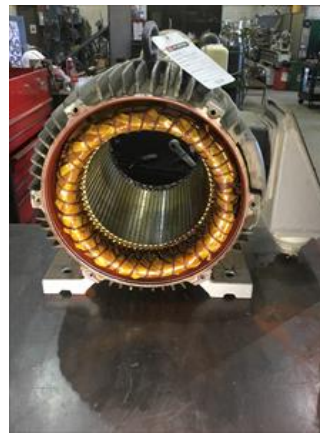
P65

42. Stator Condition

good

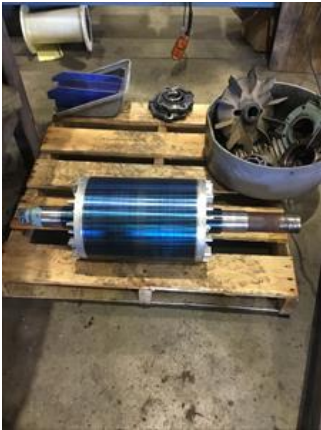
P4

44. Rotor Type

squirrel cage

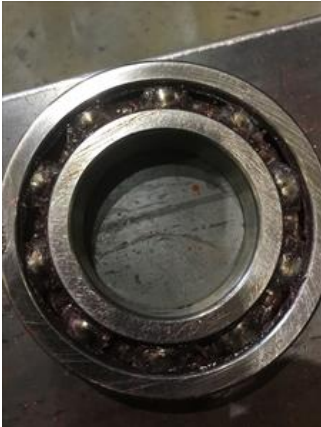
P43

54. Bearing ODE Size

6213

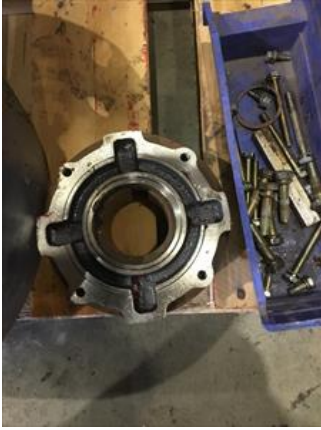
59. Grease Condition

(F) Fail

Grease contaminated

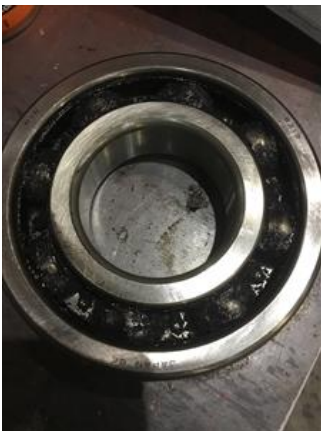
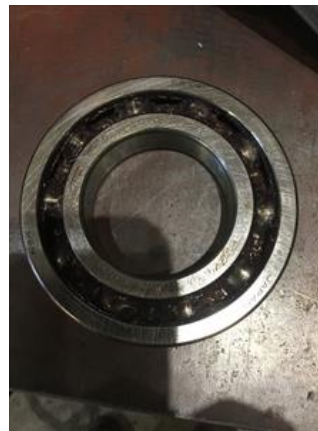
P2

66. Component Failure

bearings

67. Cause of Failure

Bearing grease contaminated
