AC Recondition Repair Report

ARKANSAS INDUSTRIAL
MACHINERY
3804 N. NONA ST
NORTH LITTLE ROCK, AR 72118

1. Job Number	97804
2. Report Date	
3. Customer	AIM

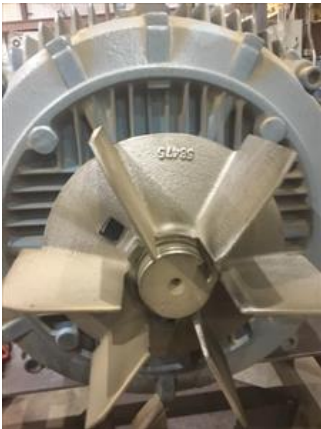
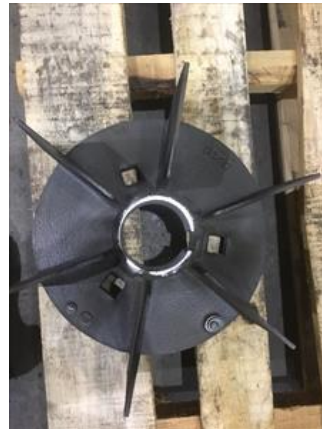
Shaft 1/8 th inch recessed

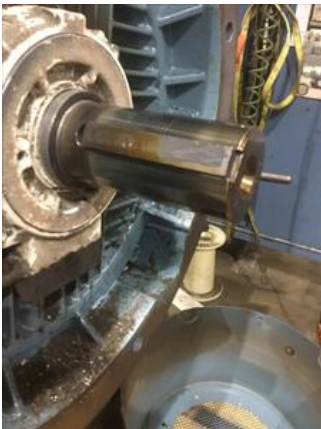
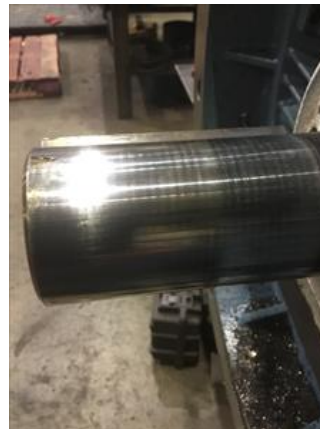
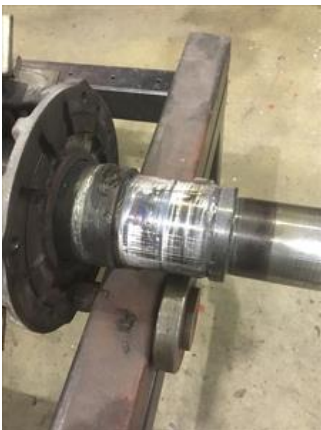
P94

28. Does Shaft Have Visible Damage

yes

Drive end bearing suffered catastrophic failure. This resulted in both the shaft fit and the housing fit being worn out of tolerance. Also the shaft was possibly crystalized from the heat generated from friction. The d.e. Bearing cap is stuck on the shaft and requires machining to be removed. The windings tested good.

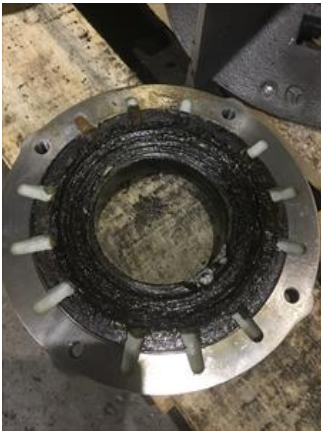
P104

31. Contamination

Grease dirty

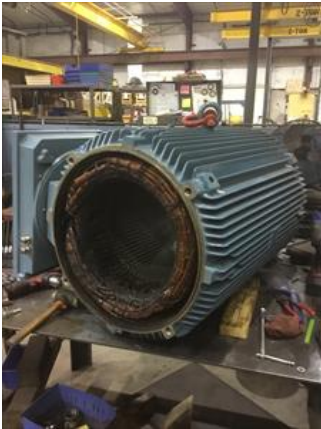
P106

32. Frame Condition

(P) Pass

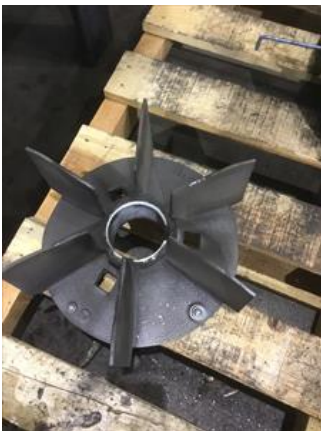
P109

33. Fan Condition

(P) Pass

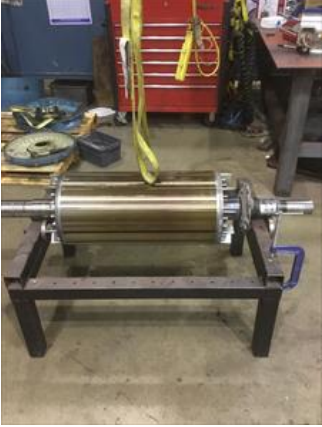
49. Rotor Condition	(P) Pass	P50

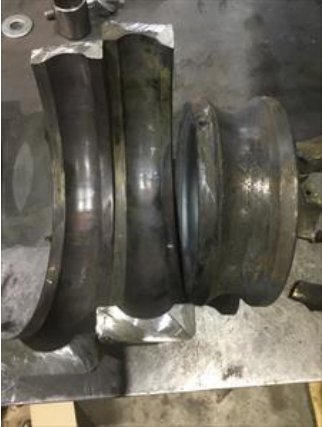
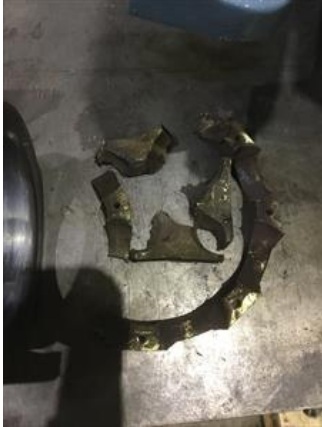
50.	Bearing Manufacture	skf	
51.	Bearing DE Size	6316M/C4VL 0241	
52.	Bearing DE Type	ceramic ball bearing	P23

66. Component Failure	drive end bearing
67. Cause of Failure	<i>Drive end bearing suffered catastrophic cage failure.</i>
68. Comments	<i>D.e. Shaft is possibly crystalized from bearing failure. Machine work required to remove bearing cap. Windings tested good.</i>
69. Service Technician	Terrence Holland

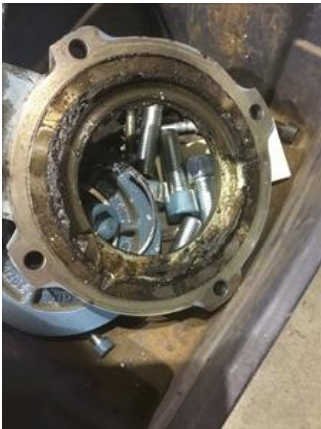
P74

59. Grease Condition

(F) Fail
