AC Recondition Repair Report

UAMS (10286)

1. Job Number	97849
2. Report Date	
3. Customer	UAMS

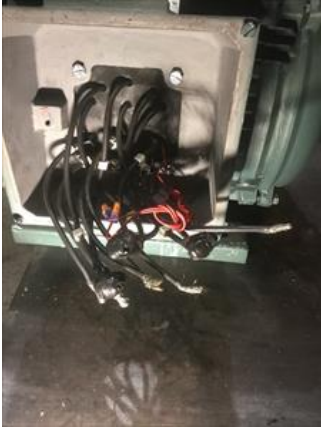
● 21. Lead Condition

(P) Pass

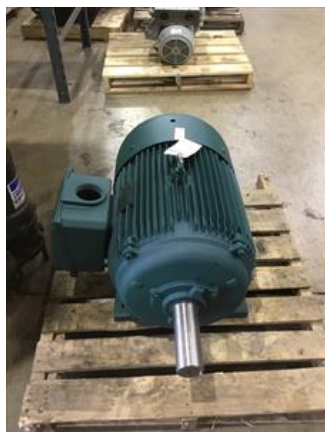
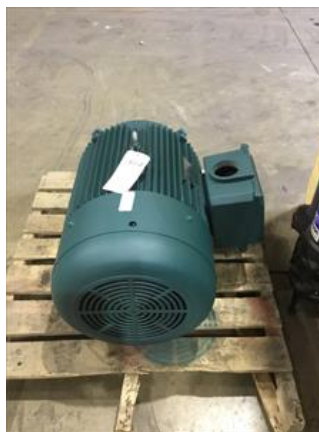
P136

158. Motor Paint	(P) Pass
