## Infrared Thermography Report

AMMONIA COMPRESSOR DRIVE MMC

DECEMBER 2021

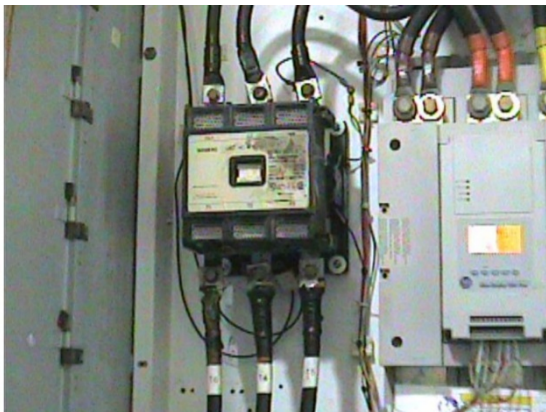
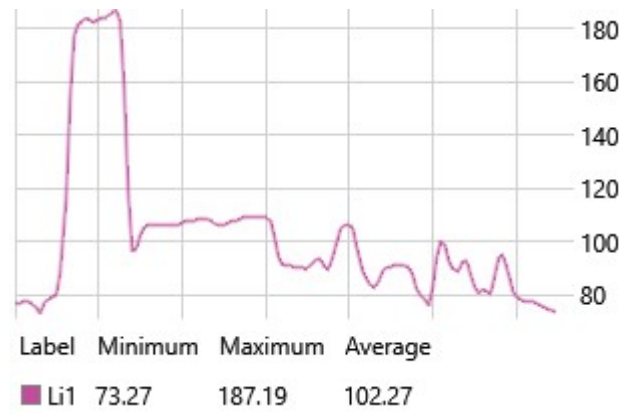
Component	Motor Starter A Phase Load Side
Equipment/Bucket ID	Ammonia Compressor 3 MCC

Fault	Loose Connection
Defect Rating	<b>CLASS II</b>

Recommendations	IR image shows over 80 degrees F delta on A phase to B and C phases This indicates connection issue. This is either at the lug connection or internal of the starter. Inspect and repair soon.
-----------------	--
