Asset #1127

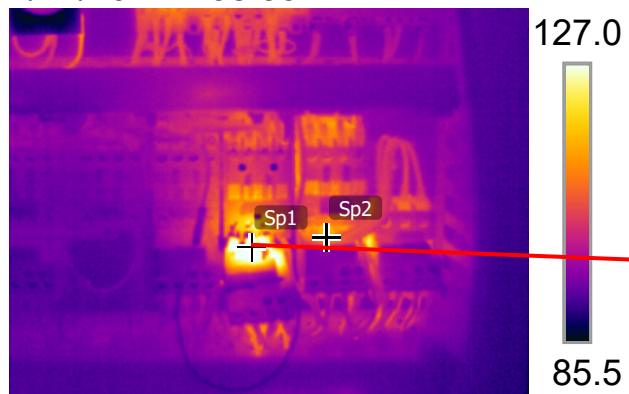
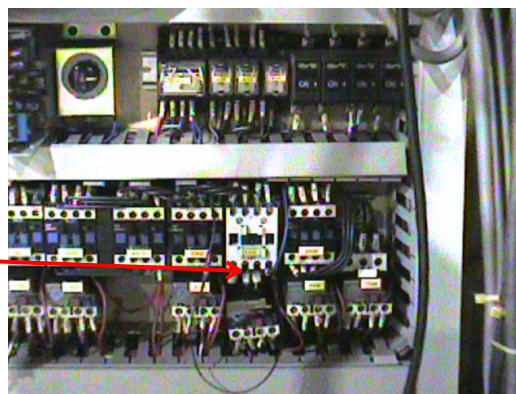
IR_1789.jpg S60 NTSC 21801575

Sp1	150.9 °F
Sp2	109.9 °F

Infrared data indicates high resistance connections between the starter and the overloads. inspect overloads and the connections between the starter and overloads. Make sure the overloads match same brand and model as the starter.
