Asset # 1226

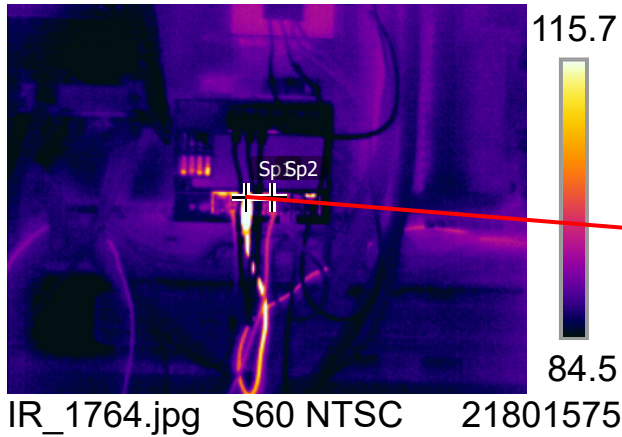
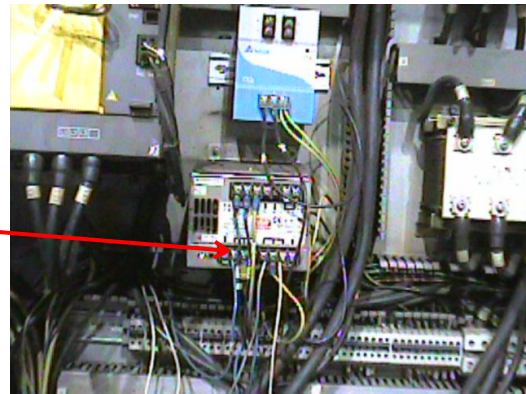
The infrared data indicates a high resistance connection that is 50\* higher than the other connections . Clean and tighten connection.

| Sp1 | 148.8 °F |
| Sp2 | 98.7 °F |
