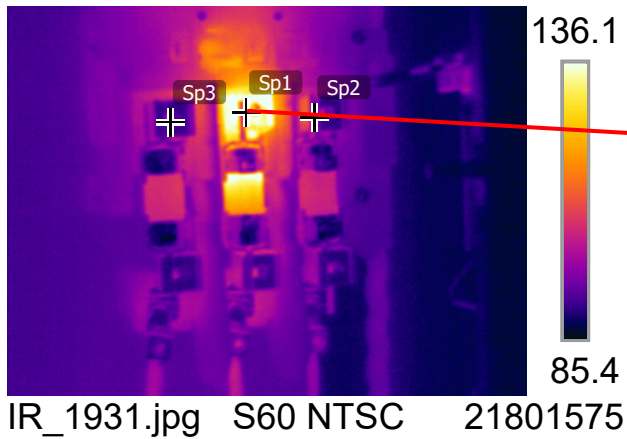
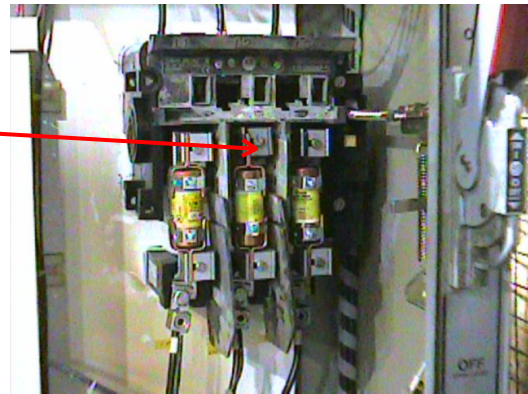
| Sp1 | 141.0 °F |
| Sp2 | 97.3 °F |
| Sp3 | 98.9 °F |

Infrared data indicates a high resistance connection on the line side of Phase B . Check the fuse clip for damage and tightness. Clean fuse holder and fuse blade. Replace if needed.
