Asset #2609

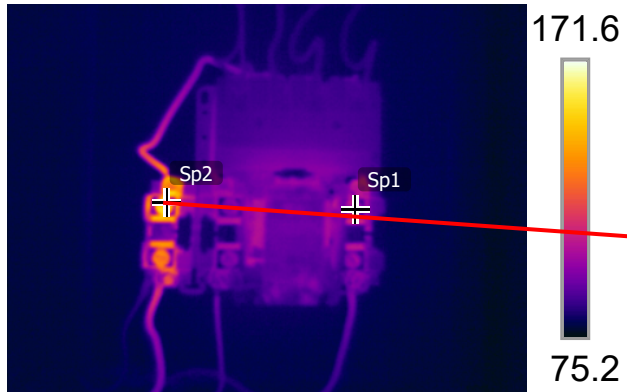
IR\_1781.jpg S60 NTSC 21801575

Infrared data indicates a high resistance connection on phase A. Clean terminal and wire. inspect for damage and replace as necessary.

| Sp1 | 106.9 °F |
| Sp2 | 161.0 °F |
