Asset #2611.

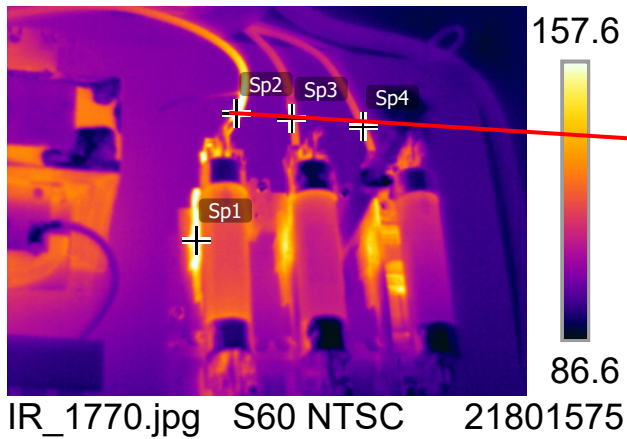
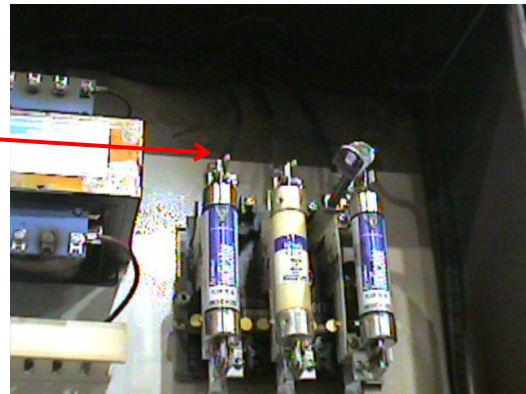
| Sp1 | 170.5 °F |
| Sp2 | 167.7 °F |
| Sp3 | 125.9 °F |
| Sp4 | 125.8 °F |

Infrared indicates a high resistance connection on the line side of phase A fuse. The fuse holder is also overheating. Clean wire and terminal. Inspect for heat damage on fuse holder replace if needed. Torque wire to manufacturer recommended torque spec.
