#### Asset # 2612

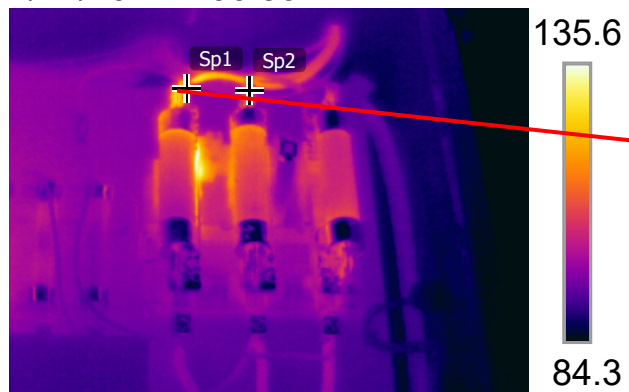
IR\_1775.jpg S60 NTSC 21801575

| Sp1 | 130.9 °F |
| Sp2 | 108.2 °F |

Infrared data indicates a high resistance connection on the load side of phase A. there is a 22.7\* delta T between phase A and phase B. Clean wire and terminal .Tighten to manufacture recommend tourqe specs. Clean the fuse holder and the fuse with sand paper.
