Asset #2652

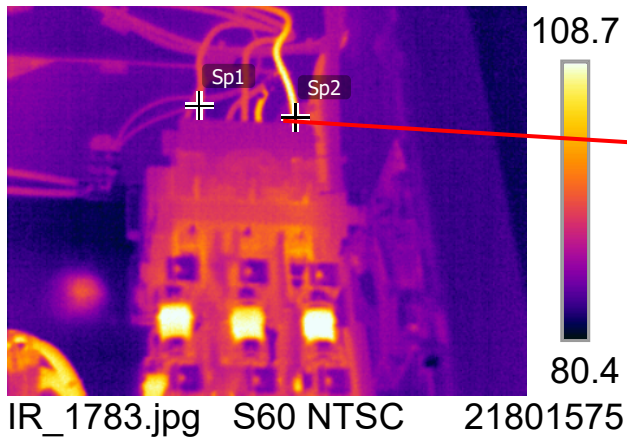
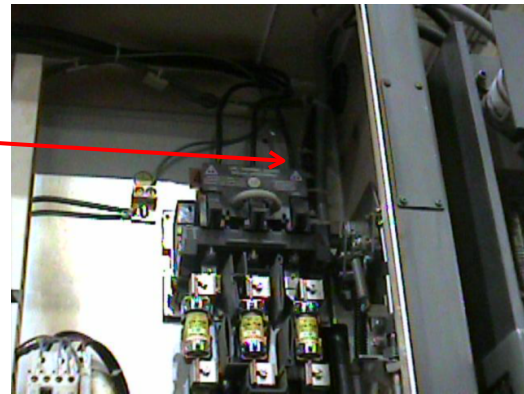
Infrared data indicates a high resistance connection on the load side of phase C. Clean terminal and wire, inspect for damage. Replace as needed.

| Sp1 | 94.9 °F |
| Sp2 | 108.0 °F |
