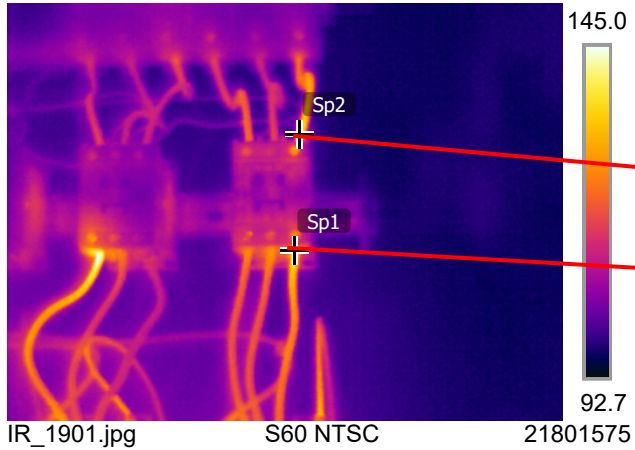
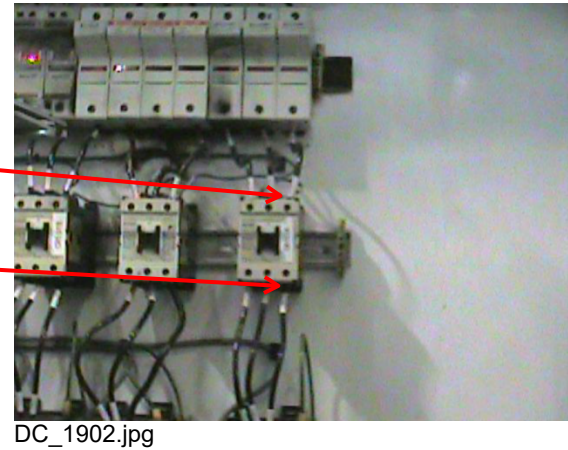
### Measurements

| Sp1 | 140.4 °F |
| Sp2 | 138.4 °F |

Infrared data indicate a high resistance connection on the line and load side of phase C . Check the contacts for damage. Replace if necessary and inspect the wire for damage, and repair as necessary tighten to proper torque.
