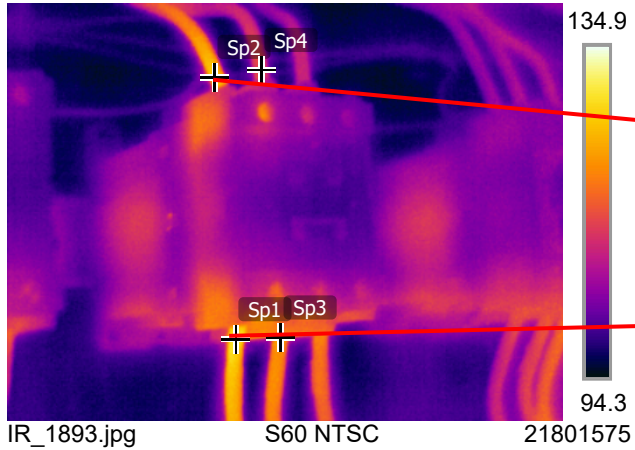
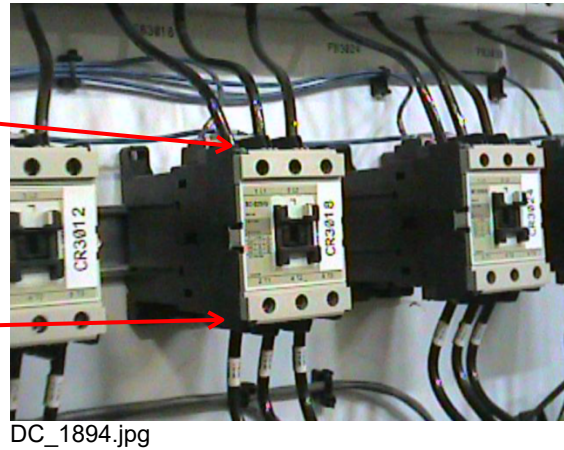
| Sp1 | 130.0 °F |
| Sp2 | 126.8 °F |
| Sp3 | 121.7 °F |
| Sp4 | 113.5 °F |

Infrared data indicates that phase a high resistance connection on line and load side of CR 3018 indicating a possible loose wire connection or contacts going bad. Check contacts for damage, replace them as necessary tighten the wire to proper torque.
