## D.C. Motor Maintenance Inspection Form

Machine: Strainer

Manufacturer: Reliance

Serial #: 01KS500717G-7T

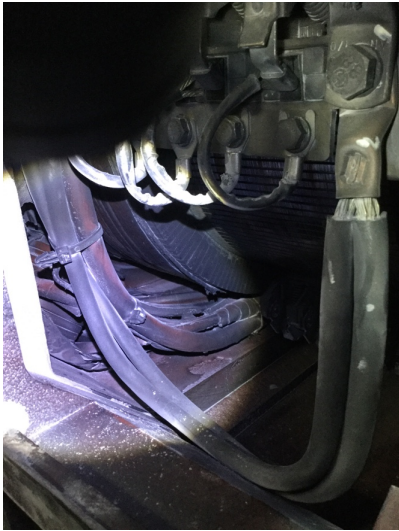
Internal photo

Internal visual appearance :

Mildly dirty

Motor has some dust and carbon building up inside. The commutator is going to need a turn and undercut before to much longer also.

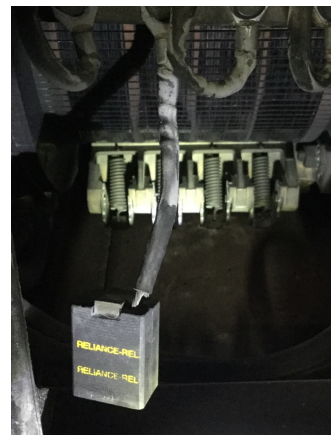
Brush photo

Brushes :

50%

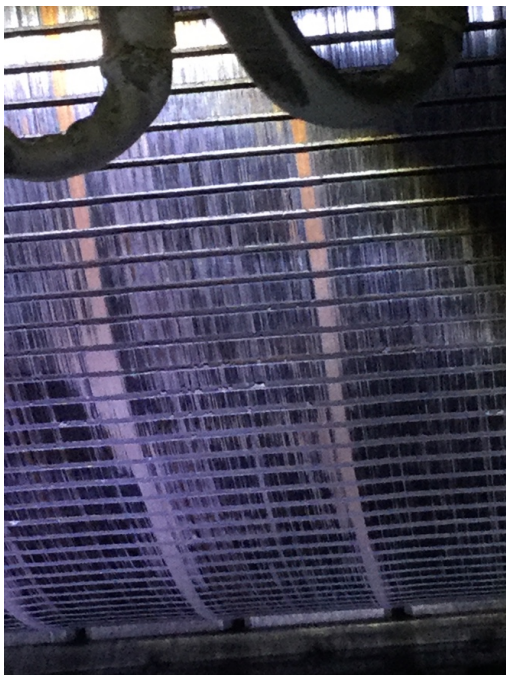
Commutator : Fair show unevenness

Comments : Commutator has irregular wear and some "threading" it needs a turn and undercut
