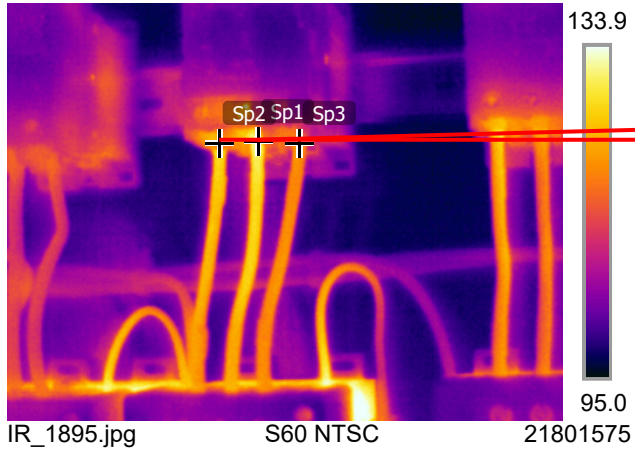
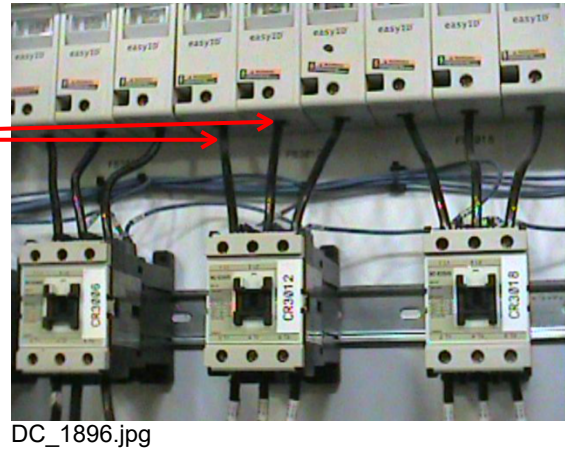
### Measurements

| Sp1 | 132.3 °F |
| Sp2 | 121.7 °F |
| Sp3 | 121.3 °F |

Infrared data indicates that the Fuse holder for phase B has a high resistance connection on the load side indicating a possible loose wire connection. Check for damage, replace as necessary tighten the wire to proper torque.
