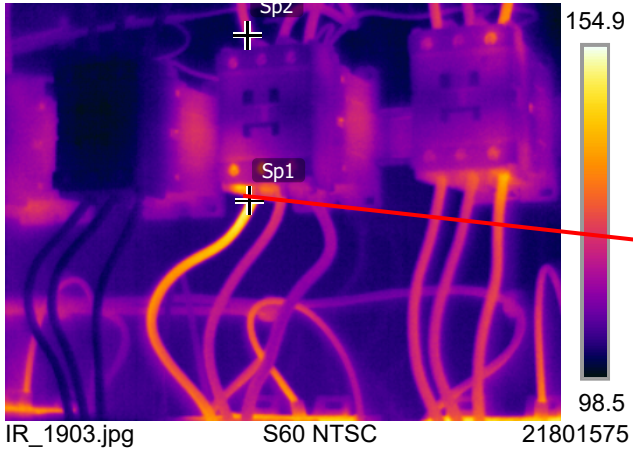
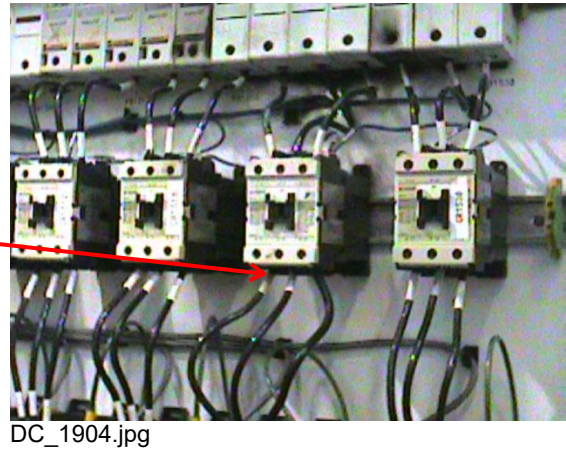
### Measurements

| Sp1 | 155.2 °F |
| Sp2 | 121.3 °F |

Infrared data indicate a high resistance connection on the load side of phase A. Check the wire for damage. Replace if necessary, and repair as necessary tighten to proper torque.
