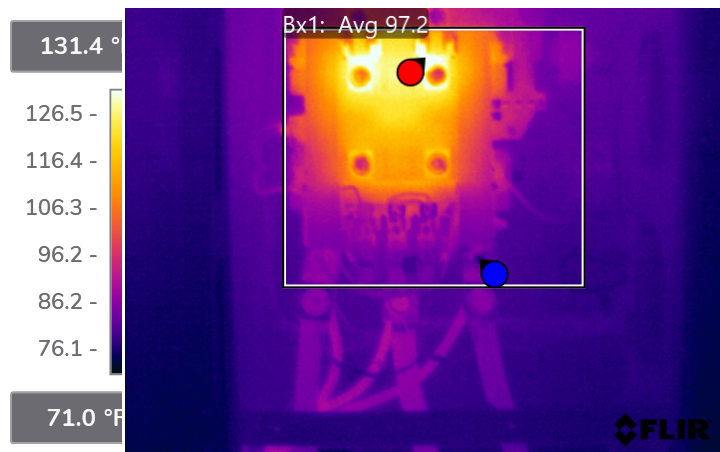
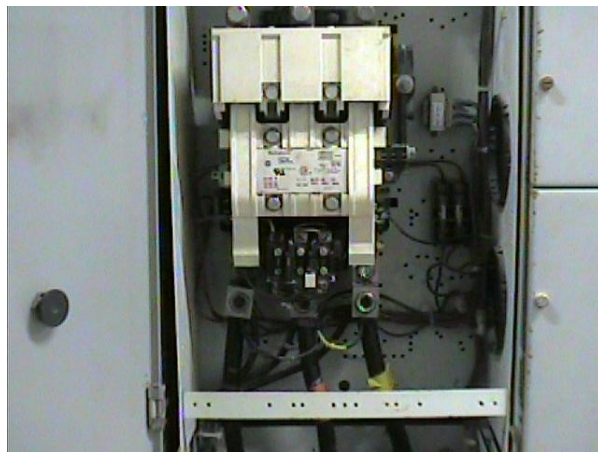
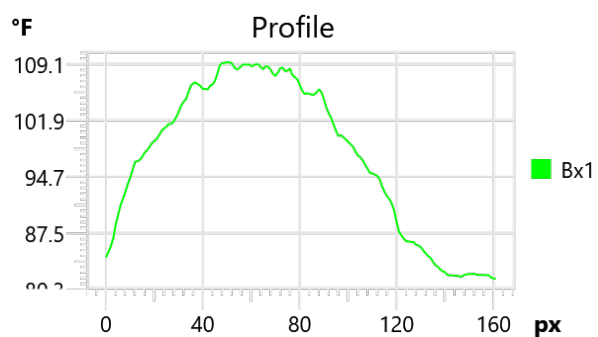
Work order # 096130 and 06207

| Minimum temp. | 71.7 °F |
| Maximum temp. | 135.3 °F |

| Max | 135.3 °F |
| Avg | 97.2 °F |
| Min | 77.0 °F |

Infrared data indicates that the thermal anomalies have been repaired..

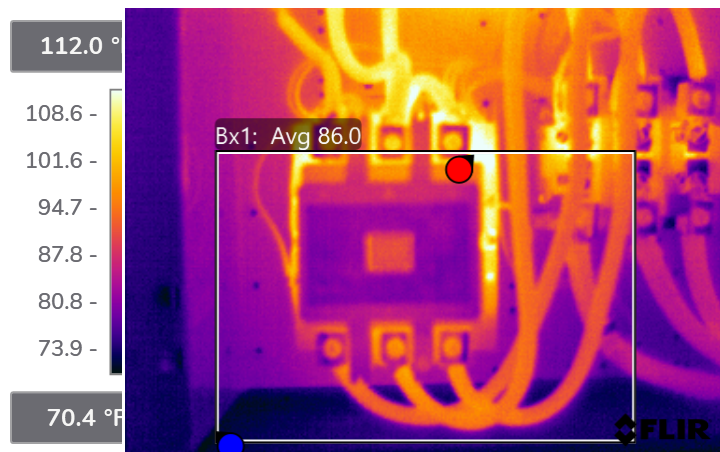
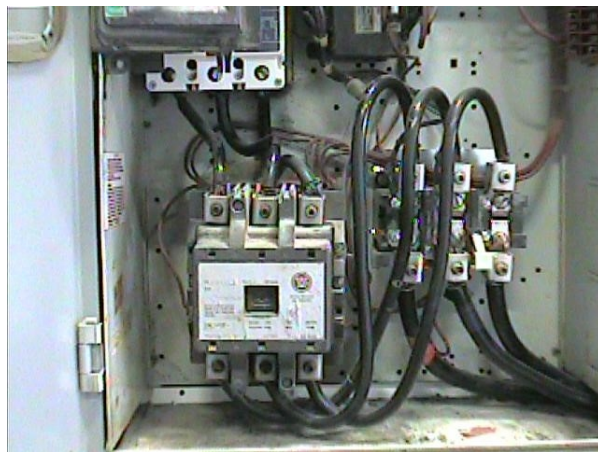
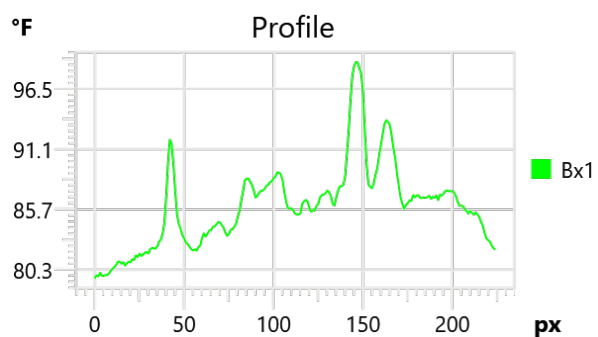
Work order # 09614 and 06208

| Minimum temp. | 68.8 °F |
| Maximum temp. | 117.2 °F |

| Max | 117.2 °F |
| Avg | 86.0 °F |
| Min | 70.1 °F |

Infrared data indicates the thermal anomalies has been resolved

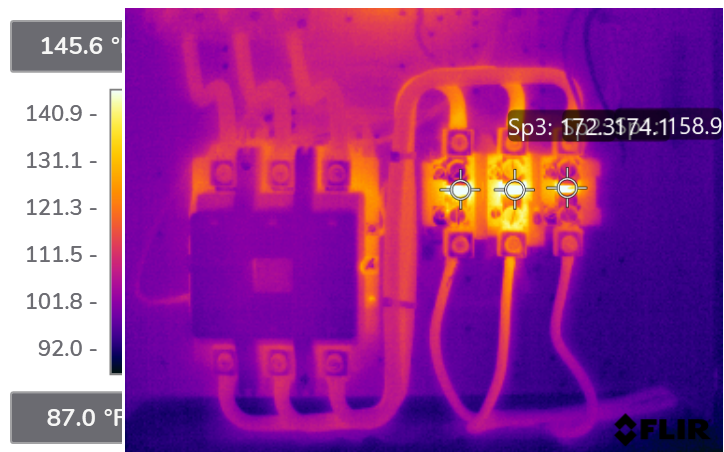
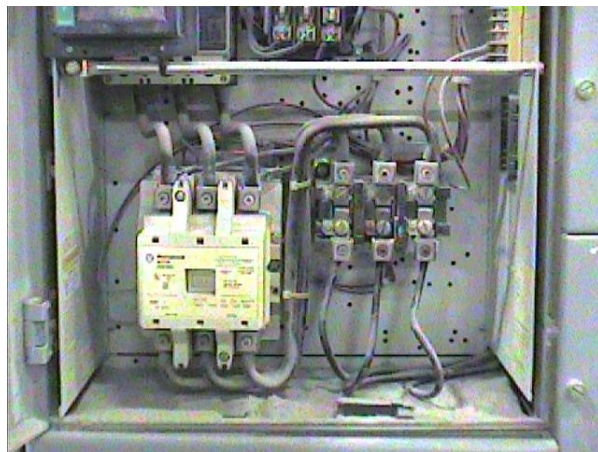
Work order # 06055

| <b>Sp3</b> | 172.3 °F |
| <b>Sp1</b> | 158.9 °F |
| <b>Sp2</b> | 174.1 °F |

Infrared data indicates that phase A and Phase B is still operating 20\* higher than phase C . Check A and B phases current draw and compare to phase C this could be due to a current imbalance causing the heating,also check the contact surface for cleanliness, clean if necessary and tighten to proper torque..
