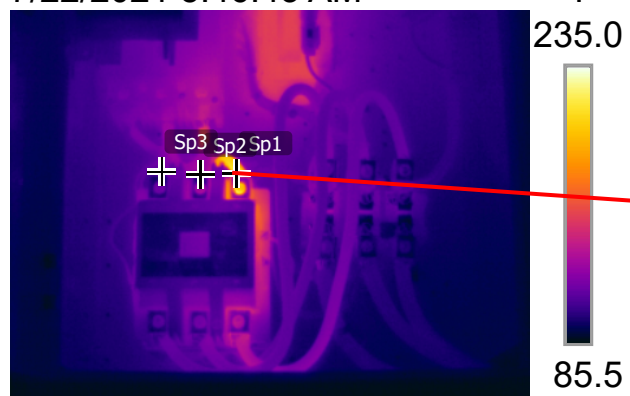
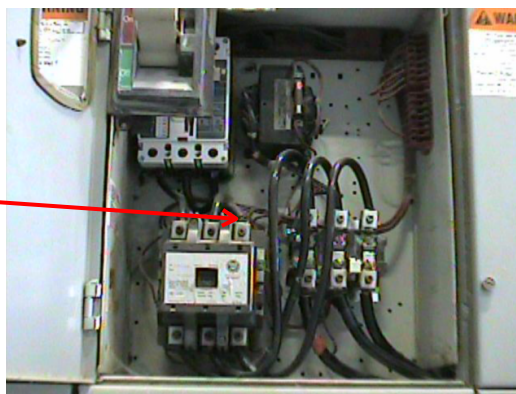
IR\_1867.jpg S60 NTSC 21801575

| Sp1 | 229.3 °F |
| Sp2 | 130.5 °F |
| Sp3 | 123.3 °F |

Infrared data indicates that Phase C is operating at over 100\* hotter than phases A and B ,This is due to a high resistance connection. Clean and inspect wire and starter for damage replace if necessary.
