Hi-Speed Industrial Service
7030 Ryburn Dr
Millington, Tn 38053
901-873-5300

AC Recondition As Found

City of Batesville (012100)
500 Riverbank
Batesville, AR 72501

Location:	Shop
Serial Number:	A2102222057
Description:	250HP BALDOR 3600RPM 449TS

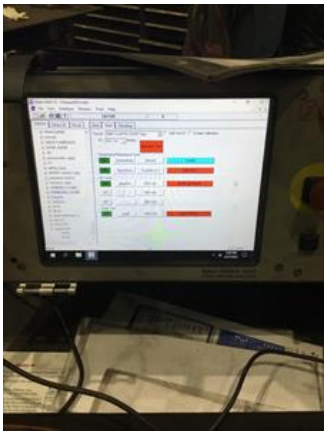
21.	Perform Surge Test	**(F) Fail**	P58

85.	Failure locations		
	Windings shorted		
86.	Root cause of failure
