Hi-Speed Industrial Service
7030 Ryburn Dr
Millington, Tn 38053
901-873-5300

AC Inspection as Found

Custom Craft Poultry
3064 E Main St
Batesville, AR 72501

Location:	Shop
Serial Number:	870183882.06.06.001
Description:	SEW GEARMOTOR 1800RPM 160M

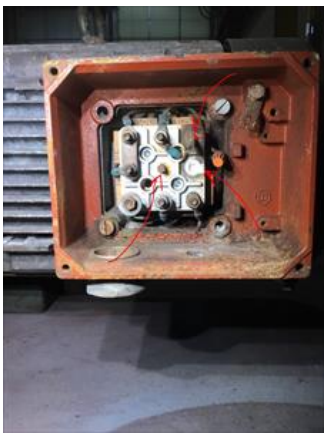
🔴	6.	Does Shaft Turn Freely?	**(No) No**	
	7.	Does Shaft Have Visible Damage?	**(No) No**	
🟢	8.	Assembled Shaft Runout	**0.002 Inches**	
	9.	Assembled Shaft End Play		
	10.	Air Gap Variation <10%		
🔴	11.	Lead Condition	**(F) Fail**	P55
		Multiple lead connection terminal posts broken.
