Hi-Speed Industrial Service
7030 Ryburn Dr
Millington, Tn 38053
901-873-5300

AC Inspection as Found

Almatis Inc/RCP Bauxite (10014)
4701 Alcoa Road
Bauxite, AR 72011

Location:	LR Motor Shop
Serial Number:	874014

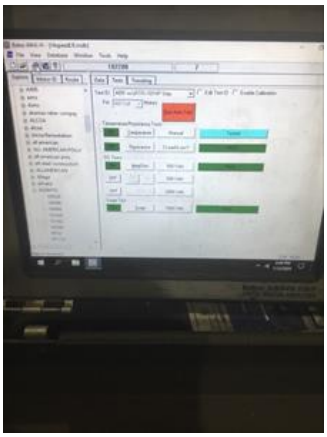
22. Perform Surge Test **(P) Pass** P58
