AC Inspection as Found

AC Inspection - Rev. 2

Location:	MOTOR SHOP LR
Serial Number:	02-J15T0339NPI
Description:	125HP SIEMENS

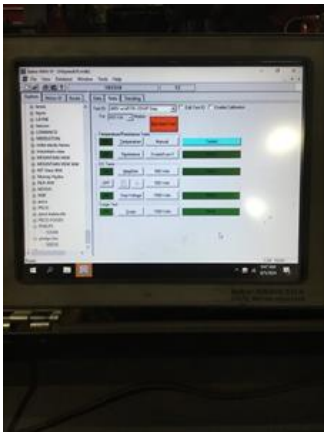
21.	Perform Surge Test	**(P) Pass**	P57

22.	Number of Stator Slots	**48**
23.	Stator Condition	**excessive grease but tests good**
24.	Stator Thermistors/Ohms	
25.	Stator Overloads/Ohms
