Hi-Speed Industrial Service
7030 Ryburn Dr
Millington, Tn 38053
901-873-5300

AC Inspection as Found

AC Inspection - Rev. 2

Location:	MOTOR SHOP LR
Serial Number:	0913023
Description:	1.5KW

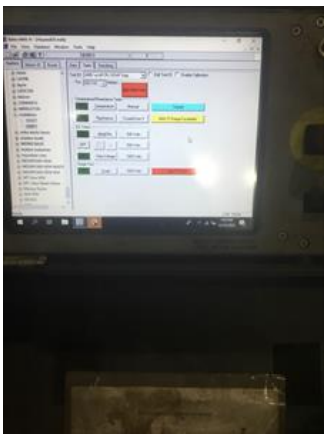
21.	Perform Surge Test	**(F) Fail**	P57

22.	Number of Stator Slots	**24**
23.	Stator Condition	**rewind**
24.	Stator Thermistors/Ohms

45.	Growler Test	**(Pass) Pass**
46.	Number of Rotor Bars	**20**
47.	Rotor Condition	**pass**
48.	List the Parts needed for the Repair Below	
	6205 & 6305 2Z bearings. ***Rewind stator.***	
49.	Signature of Technician that Disassembled Motor	**Terrence Holland**
