Hi-Speed Industrial Service
7030 Ryburn Dr
Millington, Tn 38053
901-873-5300

AC Recondition Repair Report

FolderID: 98055
FormID: 10367475

Kordsmeier (10022)
118 Harkrider
Conway, AR 72032

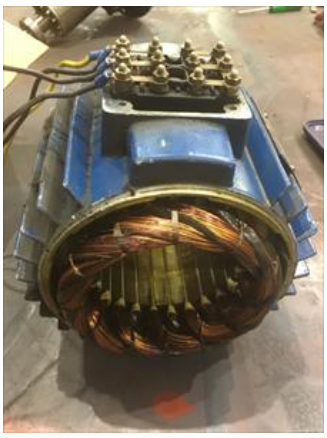
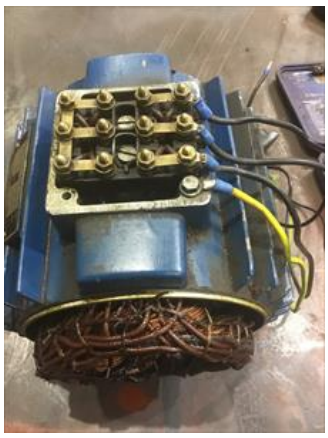
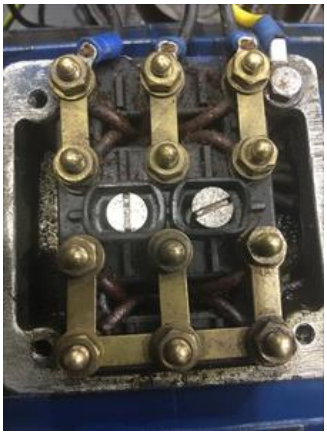
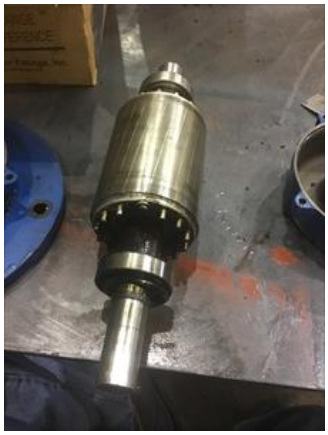
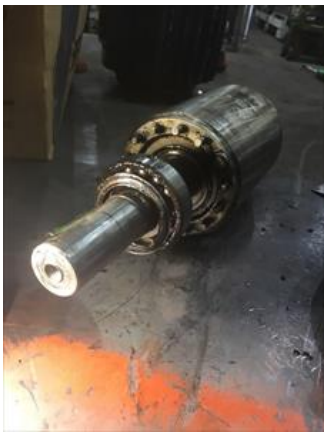
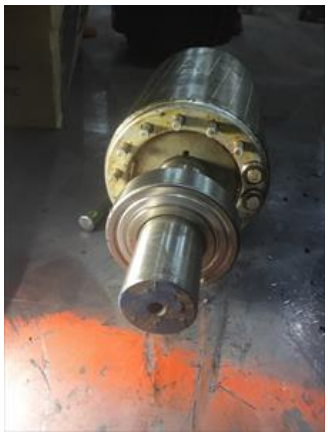
4.	Manufacturer	**SILVESTRI**

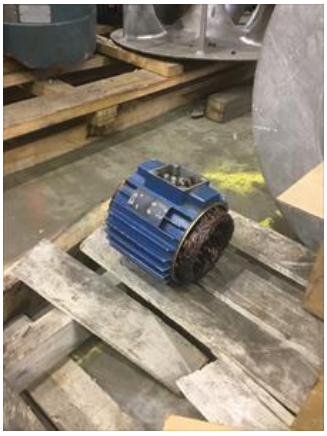
18.	Number of Leads		
19.	Lead Length		
20.	Lead Size		
21.	Lead Condition		
22.	Lead Markings		
23.	Lug Size, Condition, and Type		
24.	Winding RTD's		
25.	Winding Rtd's Condition		
26.	Shaft Run Out		
27.	Does Shaft Turn Freely	**no**	
28.	Does Shaft Have Visible Damage		
29.	Bearing Rtd's		
30.	Bearing Rtd's Condition		
31.	Contamination		
32.	Frame Condition	**(P) Pass**	P106

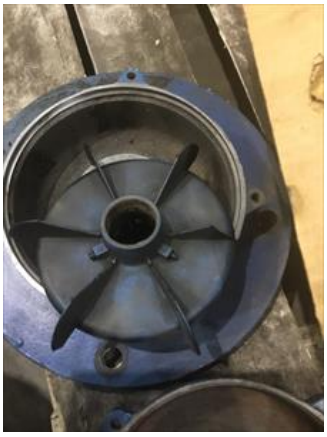
33.	Fan Condition		P109

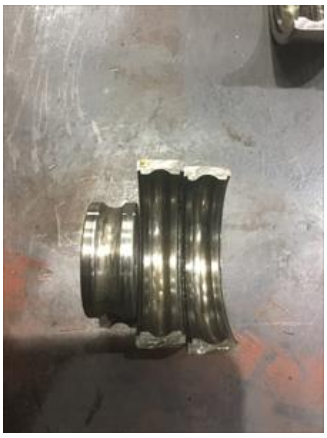
36.	Winding Resistance 1-2		
	37.	Winding Resistance 2-3		
	38.	Winding Resistance 1-3		
	39.	Resistive Imbalance		
	40.	Hi-Pot		
🔴	41.	Surge Test	**(F) Fail**	
	42.	Stator Condition	**good**	
	43.	Failure Location		
Initial Rotor Inspection				
	44.	Rotor Type	**laminate squirrel cage**	
	45.	Air Gap <10% Variation		
	46.	Number of Rotor Bars		
	47.	Number of Broken Rotor Bars		
🟢	48.	Growler Test	**(P) Pass**	
🟢	49.	Rotor Condition	**(P) Pass**	
Mechanical Inspection				
	50.	Bearing Manufacture	**skf**	P1

66.	Component Failure	**D.E. bearing.**
	67.	Cause of Failure	
		Bearing cage failure caused by contaminated grease. Windings check bad and require a rewind.	
	68.	Comments	
	69.	Service Technician	**Terrence Holland**

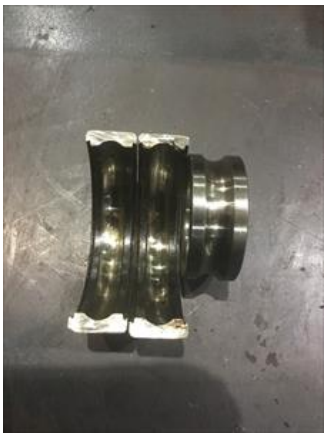
51.	Bearing DE Size	**6206**	
	52.	Bearing DE Type	**regular ball bearing**	
	53.	DE Bearing Qty.	**1**	
	54.	Bearing ODE Size	**6206**	
	55.	Bearing ODE Type	**regular ball bearing**	P53

57.	Insulated Bearing	**no**
	58.	Lubrication Type	**grease**
🔴	59.	Grease Condition	**(F) Fail**
	60.	Bearing Retainers	**(NA) Not Applicable**
	61.	Shaft Grounding Device	**(NA) Not Applicable**
	62.	DE Seal	
	63.	DE Seal Type/Size	
	64.	ODE Seal	
	65.	ODE Seal Type/Size
