## AC Recondition As Found

**Twin Rivers (12049)**  
3501 Jefferson Parkway  
Pine Bluff, AR 71602

### AC Recondition - Rev. 2

**Location:** Shop  
**Serial Number:** YZH714B713001  
**Description:** 75HP TECO 1800RPM 365T

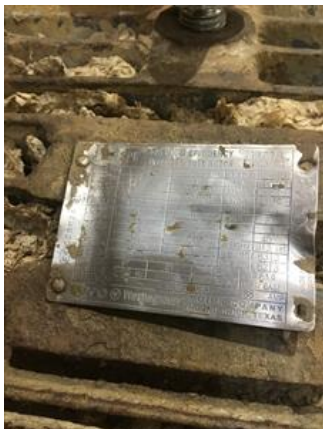
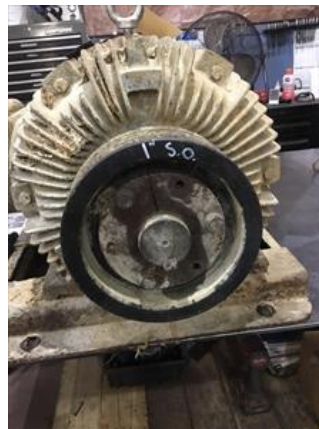
P37

1. Report Date
2. Nameplate Picture

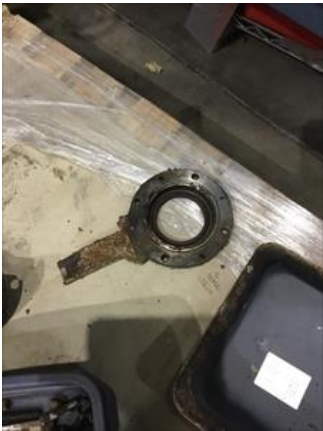
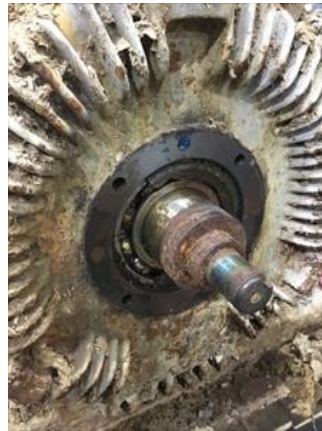
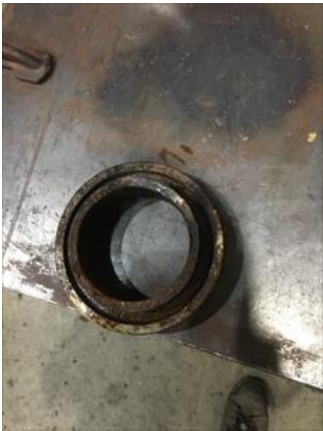
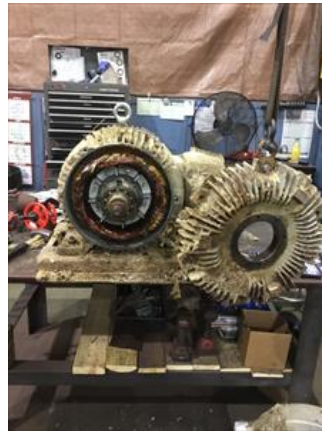
*Mount bolts corroded and need replacing.*

*Replace sheave hub 2 3/8" and repair broken motor mount base brackets. Replace worn and corroded hardware mount bolts.*

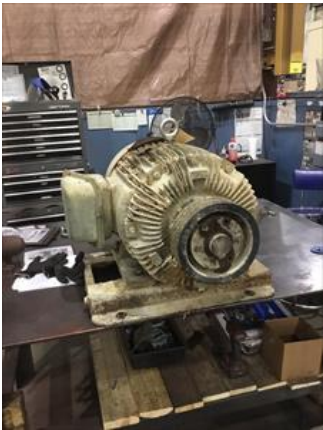
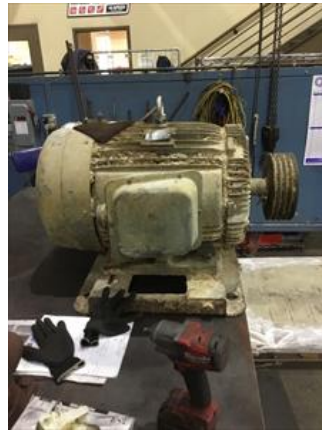
P48

3. Photos of all six sides of the machine.

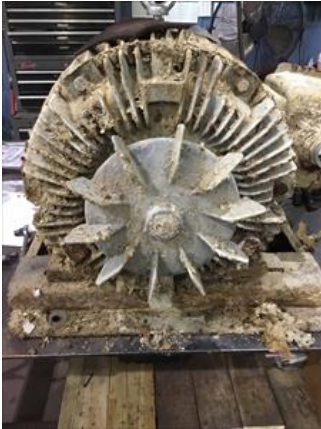
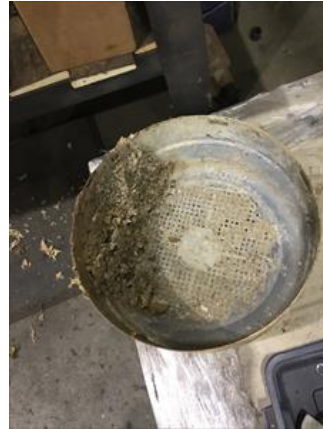
17. Heater Quantity, Ratings			
Quantity		Volts/Watts	Pass/Fail
18. Broken or Missing Components			sheave hub & motor mount base brackets

*Both housing fits bad. Motor mount base brackets need replacement.*

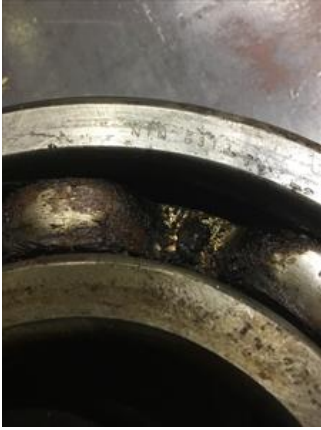
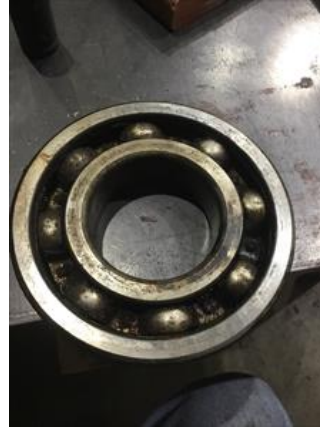
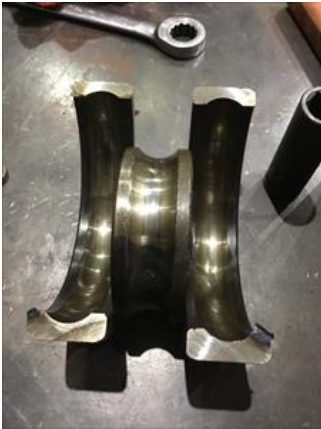
Mechanical Inspection

24. Drive End Bearing Qty.	1
25. Drive End Bearing Type	(Ball) Ball Bearing
26. Drive End Lubrication Type	(Grease) Grease Lubricated
27. Drive End Bearing Insulation or Grounding Device?	none
28. Drive End Wavy Washer/Snap-Ring Other Retention Device?	none
29. Drive End Bearing Condition	grease dirty and contaminated

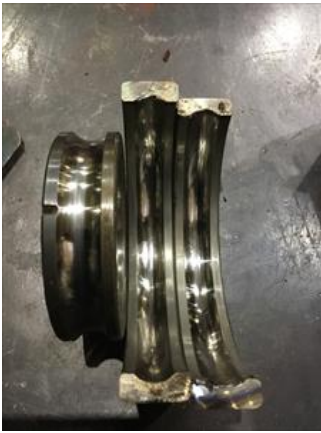
34.	Opposite Drive End Bearing Insulation or Grounding Device?	none	
35.	Opposite Drive End Wavy Washer/Snap-Ring Other Retention Device?	none	
36.	Opposite Drive End Bearing Condition	grease dirty and contaminated

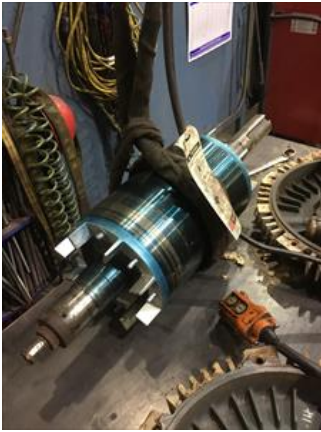
## Rotor Inspection

50. Rotor Condition pass
