## AC Recondition As Found

### 3M-Main Plant (10001)

#### AC Recondition - Rev. 2

Description: 125HP TOSHIBA 1800RPM 444T

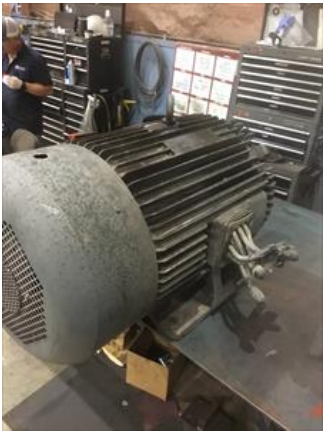
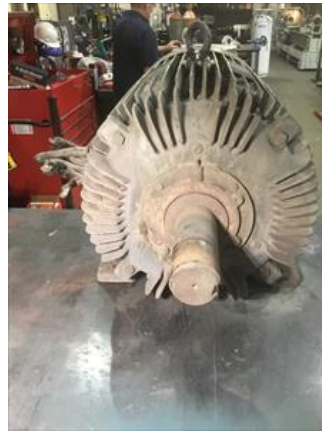
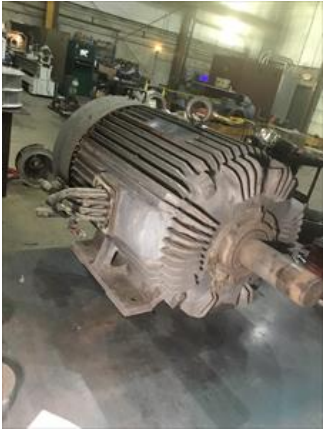
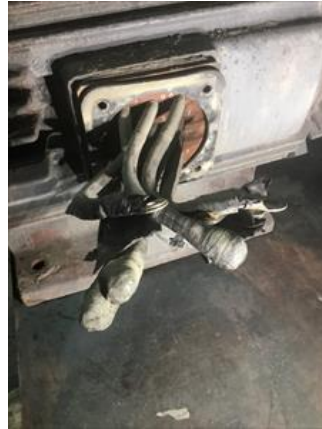
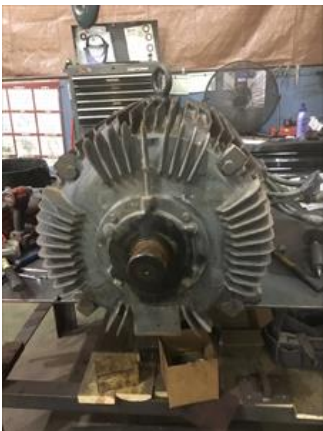
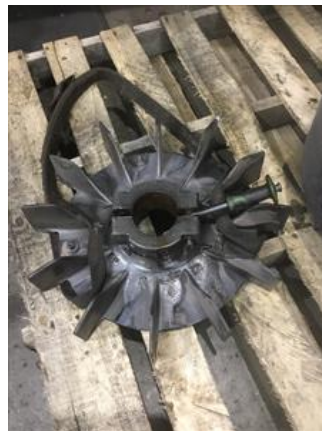
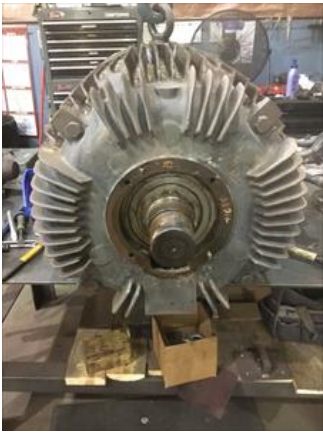
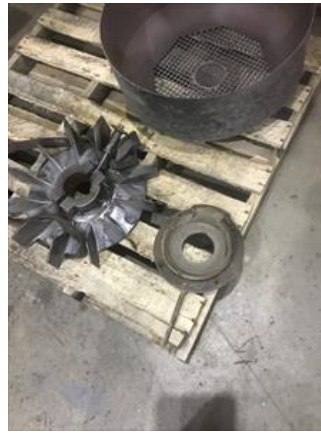
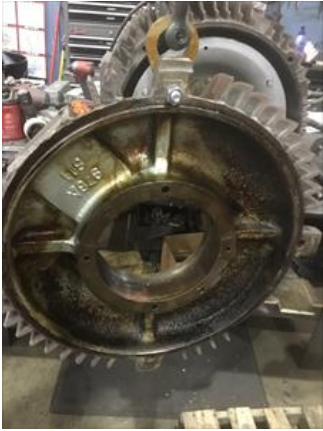
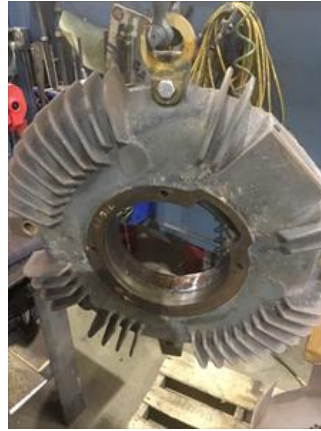
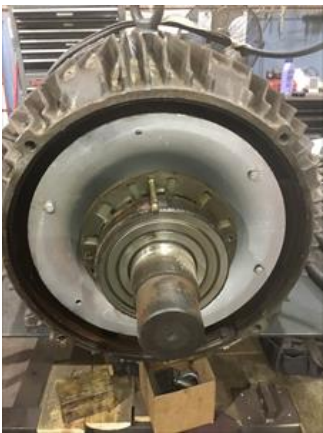
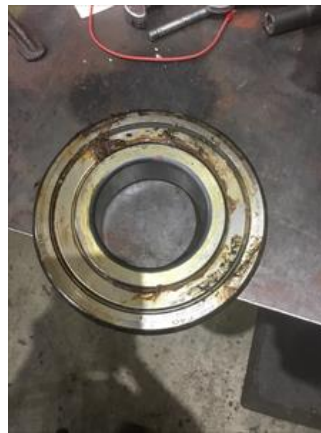
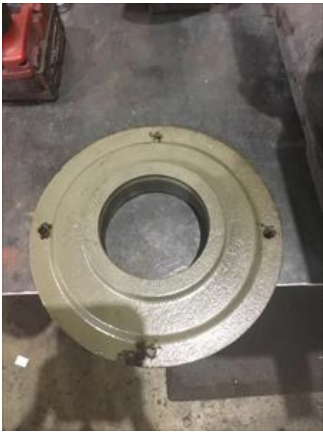
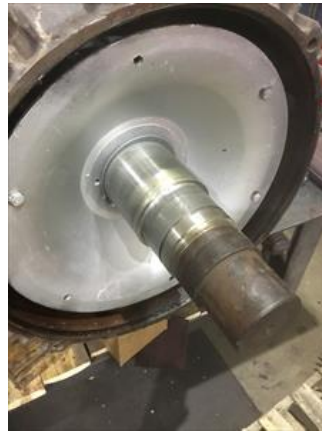
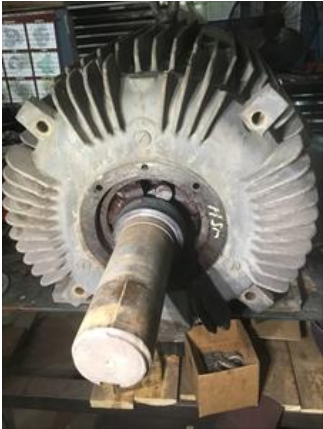
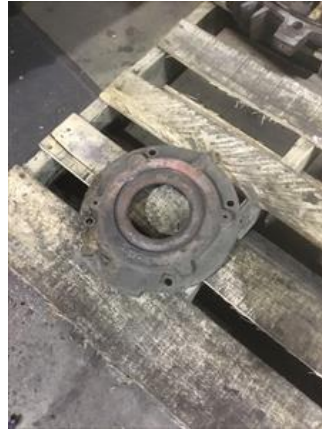
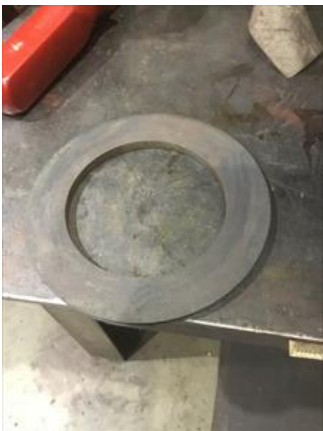
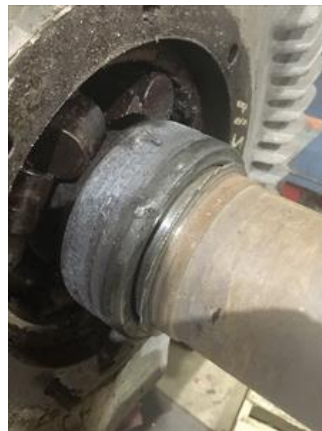
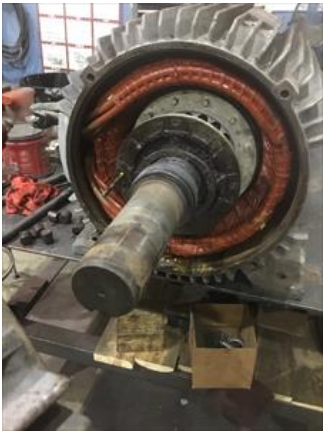
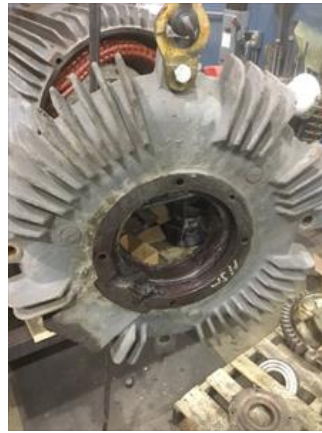
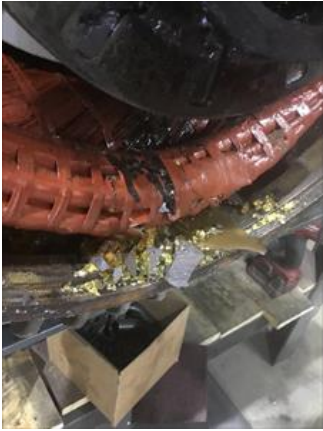
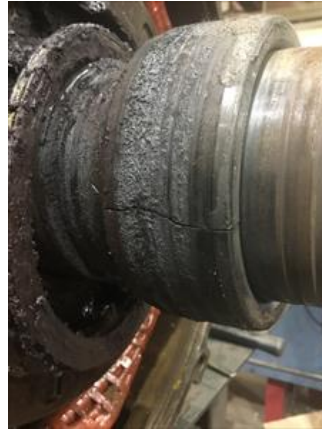
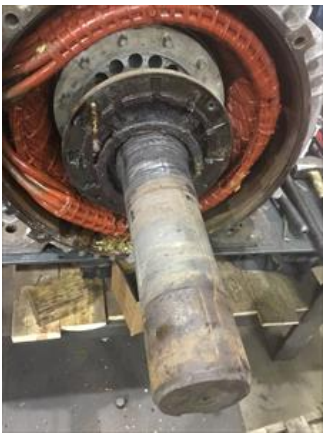
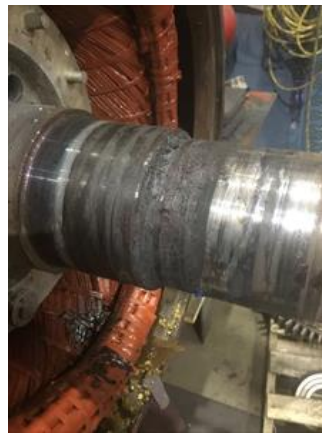
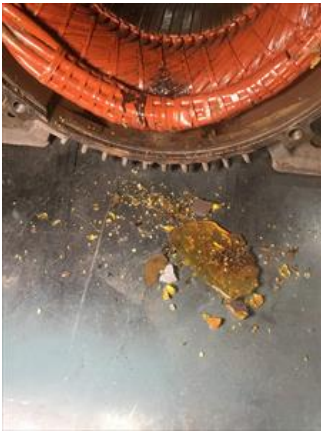
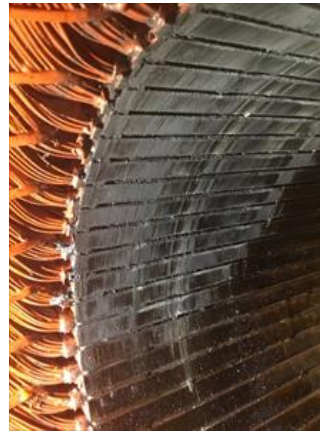
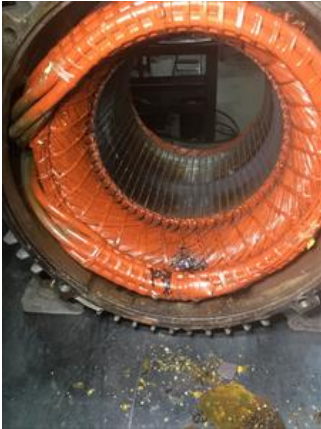
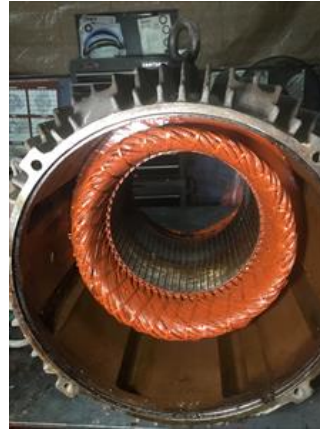
P21

3. Photos of all six sides of the machine.
4. Describe the Overall Condition of the Equipment as Received  
*Serviceable*

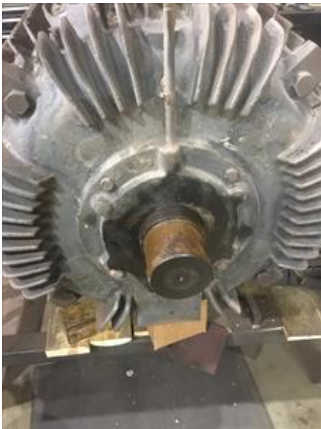
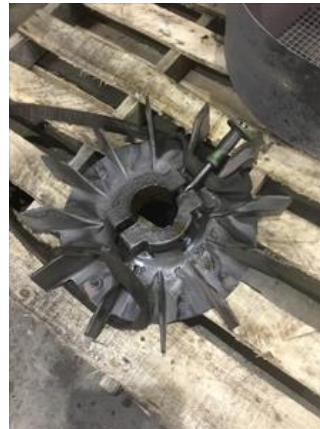
P31

5. Distance from the end of the shaft to the Coupling/Sheave
