## AC Recondition As Found

**Twin Rivers (12049)**  
3501 Jefferson Parkway  
Pine Bluff, AR 71602

### AC Recondition - Rev. 2

Description: 25HP US MOTORS AERATOR  
1200RPM 324LPHZ

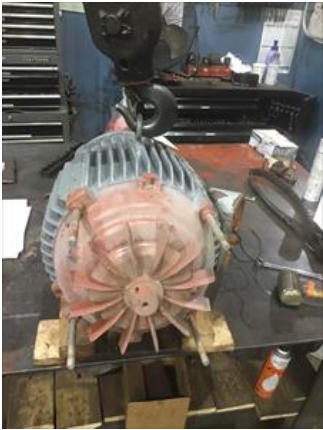
11.	Lead Length	8 Inches
12.	Frame Condition	pass

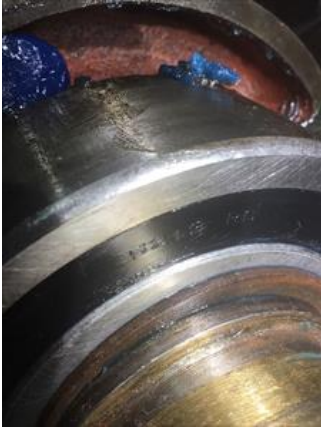
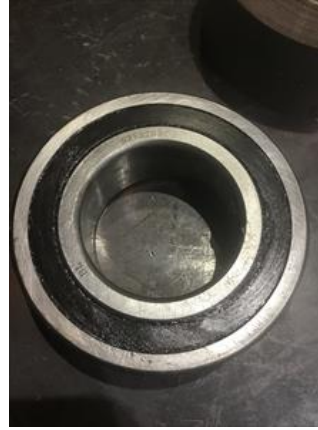
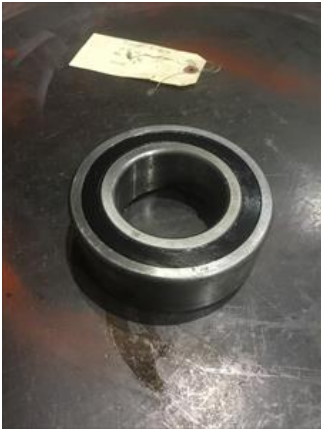
20. Drive End Bearing Qty.	1
21. Drive End Bearing Type	<b>(Ball) Ball Bearing</b>
22. Drive End Lubrication Type	<b>(Grease) Grease Lubricated</b>
23. Drive End Bearing Insulation or Grounding Device?	<b>none</b>
24. Drive End Wavy Washer/Snap-Ring Other Retention Device?	<b>none</b>
25. Drive End Bearing Condition	<b>replace</b>
26. Opposite Drive End Bearing Number-	<b>6210</b>
