AC Recondition As Found
ARKANSAS INDUSTRIAL MACHINERY
3804 N. NONA ST
NORTH LITTLE ROCK, AR 72118

AC Recondition - Rev. 2

Description: 75KW ABB

Repair Stage: Teardown Inspection

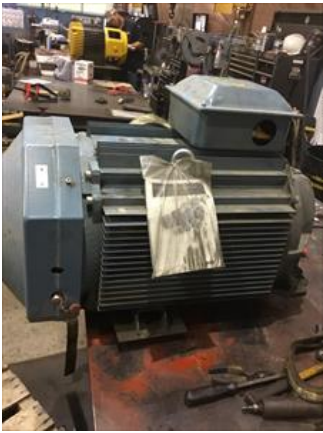
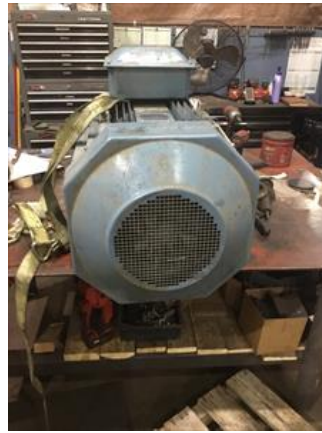
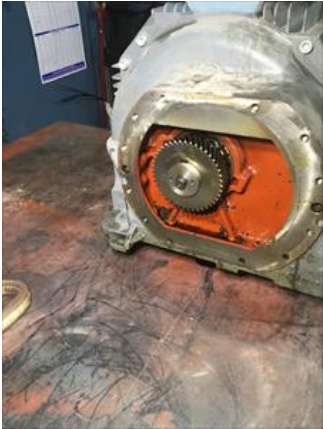
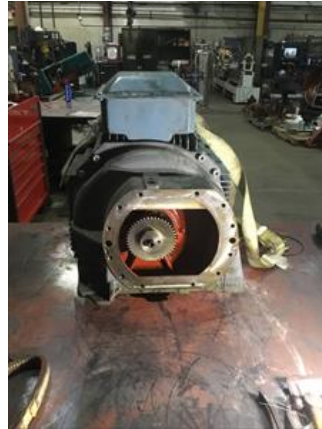
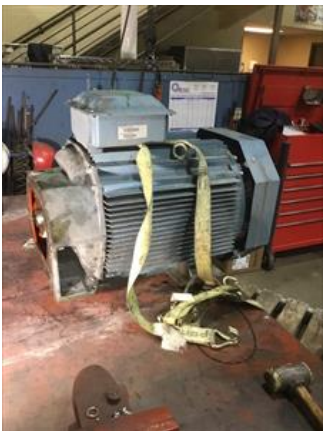
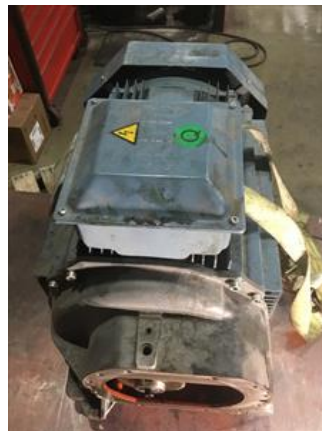
P27

3. Photos of all six sides of the machine.

4. Describe the Overall Condition of the Equipment as Received
Saturated with oil.

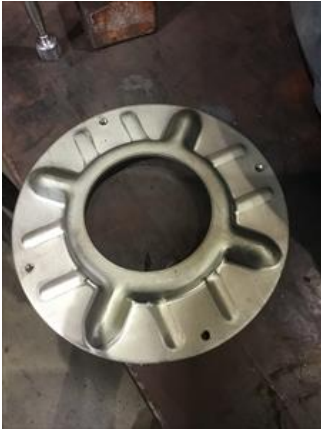
P30

55. Bearing Cap Condition

Drive End Bearing Cap

Opposite Drive End Bearing Cap

none

pass
