## AC Recondition As Found

Remington (10243)

### AC Recondition - Rev. 2

Description: 1/4HP DELCO 3600RPM

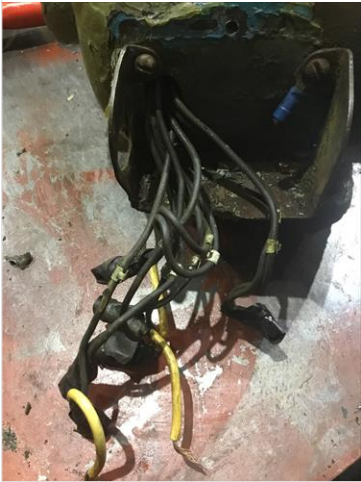
4. Describe the Overall Condition of the Equipment as Received		
Serviceable		
Initial Mechanical/Electrical		<input type="checkbox"/>
● 5. Does Shaft Turn Freely?		(Yes) Yes
6. Does Shaft Have Visible Damage?		(No) No
7. Assembled Shaft Runout		Inches
8. Assembled Shaft End Play		
9. Air Gap Variation <10%

11. Lead Length	6 Inches
12. Frame Condition	good

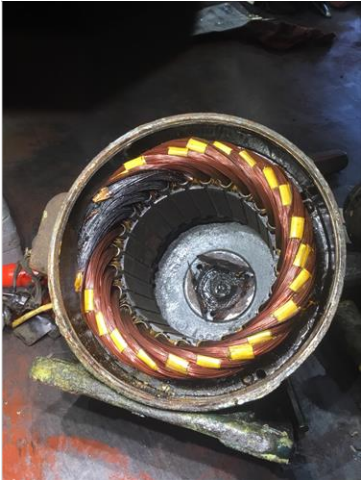
18. Stator Condition	rewind	
<b>Mechanical Inspection</b>		
19. Drive End Bearing Number-	6203	P8

*Windings single phased. D.e housing fit needs repair.*

*Rewind/machine D.E. Housing fit. Replace 2 ea. 6203 bearings.*

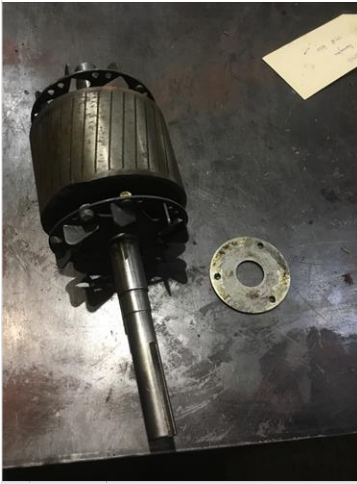
27. Opposite Drive End Bearing Qty.	1	
28. Opposite Drive End Bearing Type	(Ball) Ball Bearing	
29. Opposite Drive End Lubrication Type	(Grease) Grease Lubricated	
30. Opposite Drive End Bearing Insulation or Grounding Device?	none	
31. Opposite Drive End Wavy Washer/Snap-Ring Other Retention Device?	none	
32. Opposite Drive End Bearing Condition	replace	
33. Drive End Seal		
34. Opposite Drive End Seal		
<b>Rotor Inspection</b>
