## AC Recondition As Found

Arkansas Electric Coop. (11681)

### AC Recondition - Rev. 2

Description: 7.5HP AMETEK BLOWER 3600RPM  
215TCZ  
AMETEK PART 511570

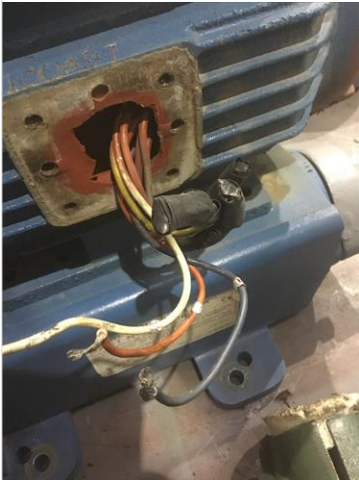
6.	Does Shaft Turn Freely?	(Yes) Yes	
7.	Does Shaft Have Visible Damage?	(No) No	
8.	Assembled Shaft Runout		
9.	Assembled Shaft End Play		
10.	Air Gap Variation <10%		
11.	Lead Condition	(P) Pass	P32

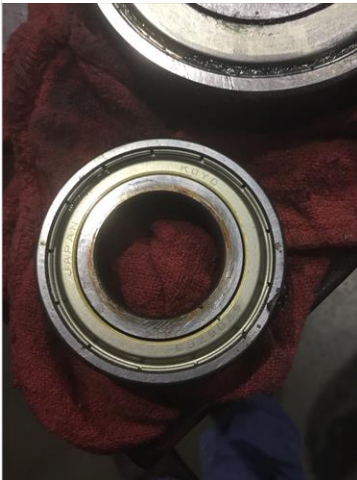
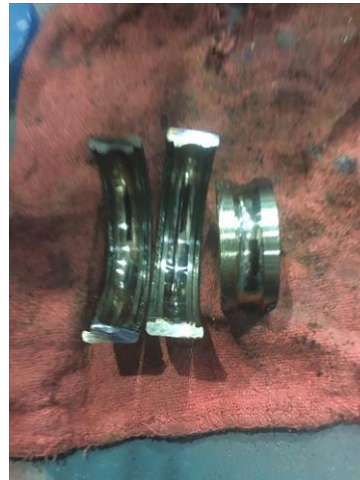
P47

Fatigue

22. Drive End Bearing Qty.	1
23. Drive End Bearing Type	(Ball) Ball Bearing
24. Drive End Lubrication Type	(Grease) Grease Lubricated
25. Drive End Bearing Insulation or Grounding Device?	na
26. Drive End Wavy Washer/Snap-Ring Other Retention Device?	no
27. Drive End Bearing Condition	surface initiated fatigue
28. Opposite Drive End Bearing Number-	6206ZZ

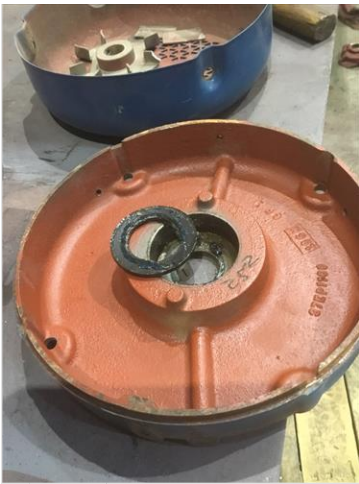
P56

34.	Opposite Drive End Bearing Condition	pass
35.	Drive End Seal	na
36.	Opposite Drive End Seal	na
<b>Rotor Inspection</b>		
37.	Rotor Type/Material	(Squirrel Aluminum) Squirrel Cage Aluminum Die Cast

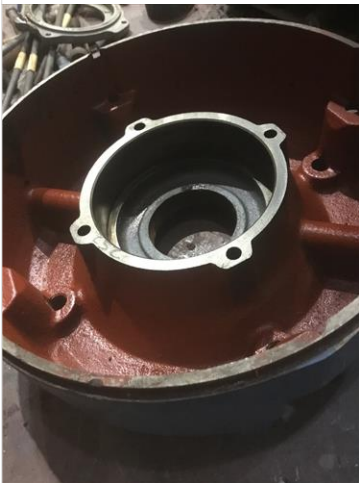
P7

53. Drive End - Endbell Bearing Fit Condition

(P) Pass

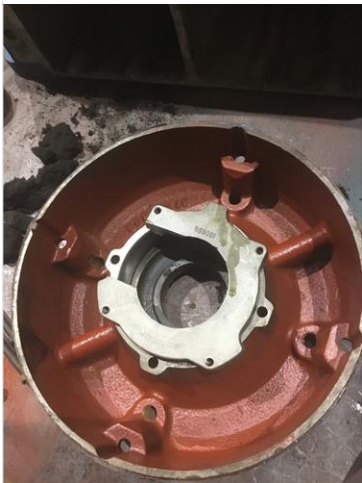
55. Opposite Drive End - Endbell Bearing Fit Condition			(F) Fail
<div> <div></div> <div>.0005 undersized</div> </div>			
56. Bearing Cap Condition			P30
Drive End Bearing Cap	Opposite Drive End Bearing Cap		
pass	na

57. End Bell Air Seal Fits			
Drive End Air Seal	Opposite Drive End Air Seal		
58. List Machine Work Needed Below			
Ode end bell housing fit undersized			
59. Technician			RW
