AC Recondition As Found
US MOTORS WARRANTY REPAIR
8100 W. FLORISSENT
ST. LOUIS, MO 63136

AC Recondition - Rev. 2

Location: LR MOTOR SHOP
Serial Number: D 04 7796198-0009 R 0001
Description: 250HP US MOTORS VERTICAL
1800RPM H445TPA

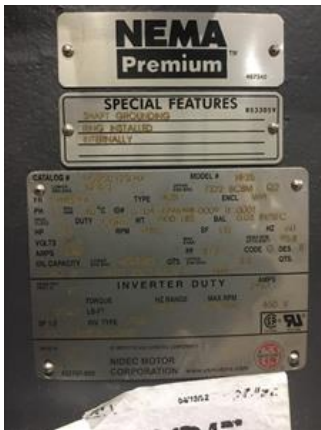
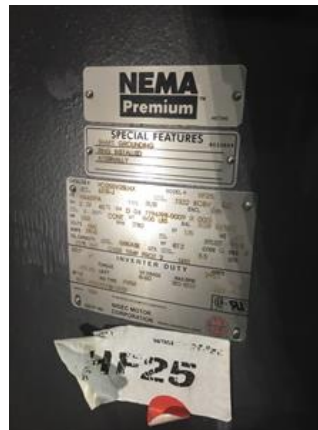
P20

- Report Date
- Nameplate Picture

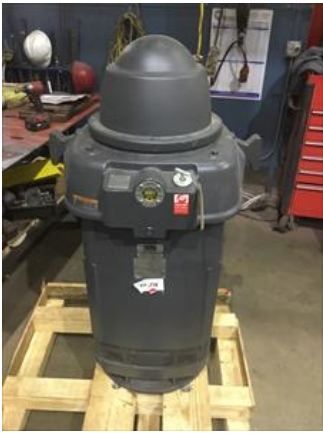
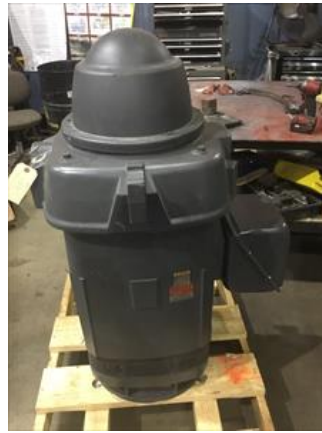
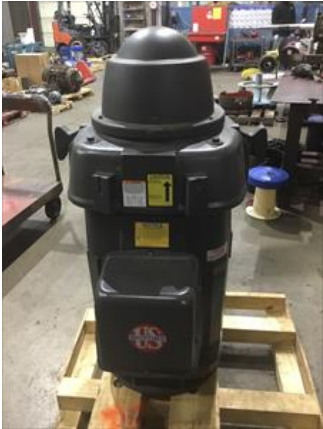
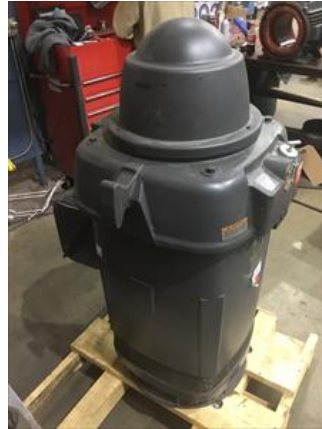
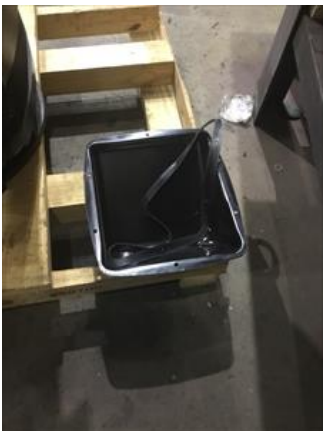
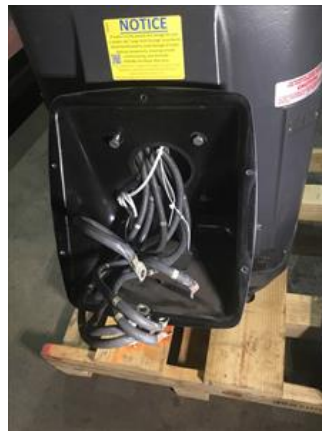
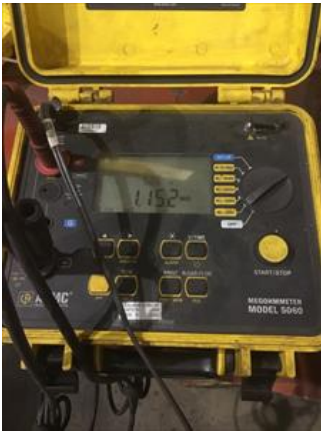
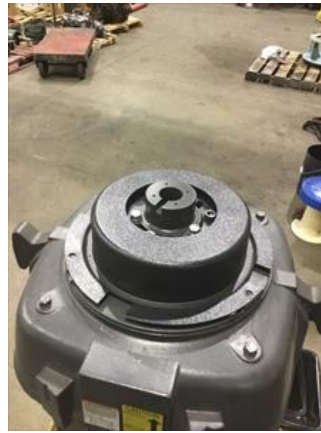
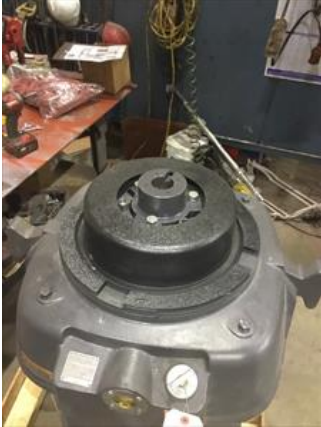
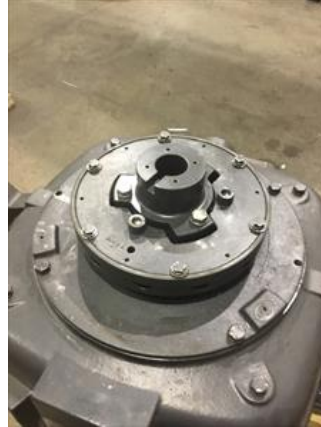
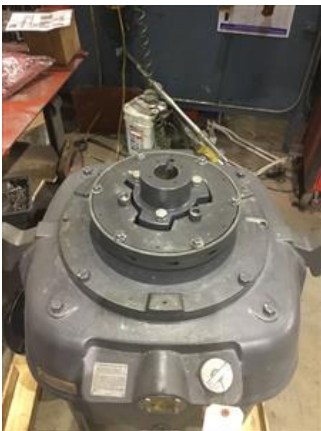
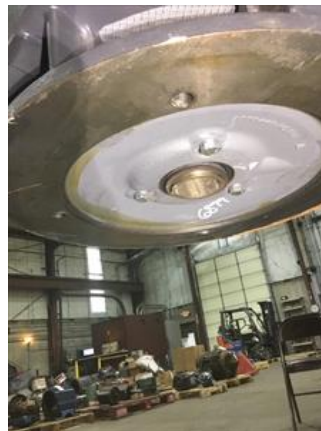
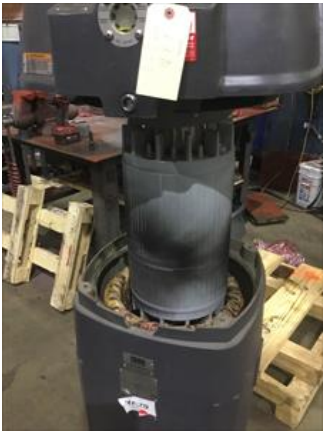
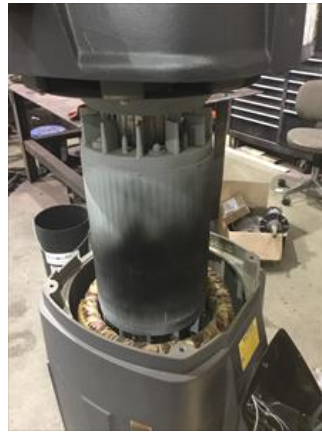
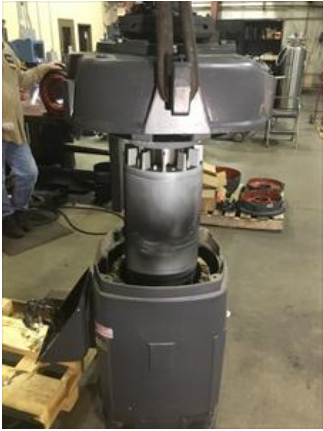
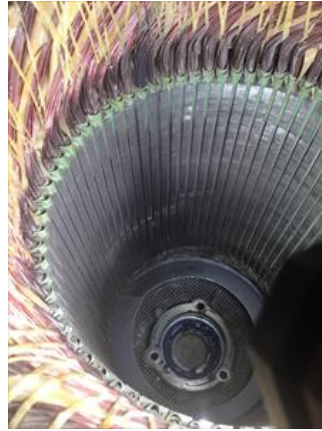
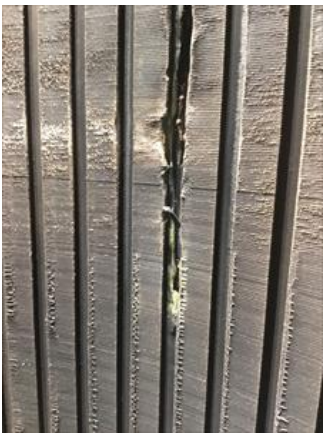
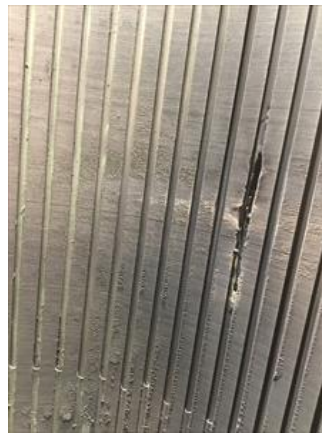
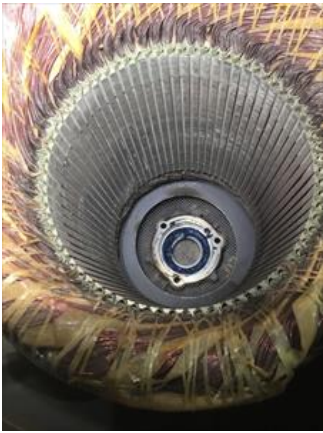
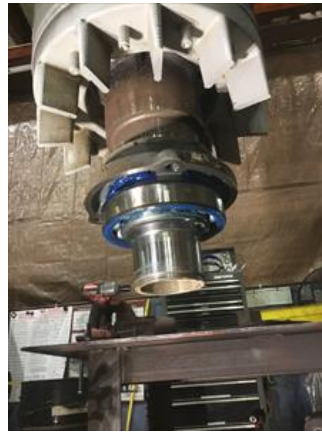
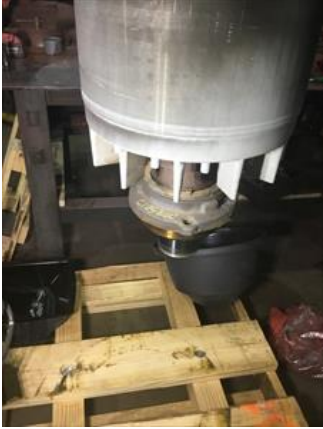
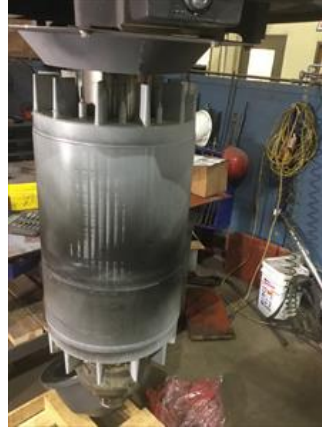
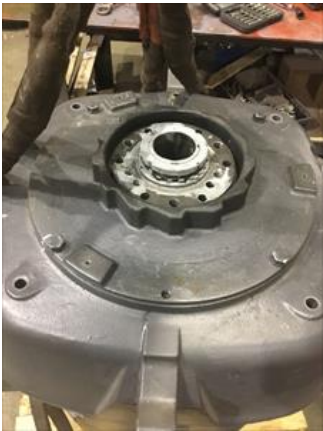
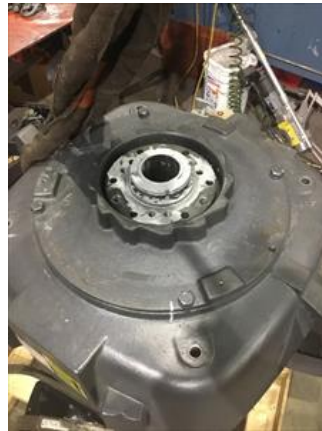
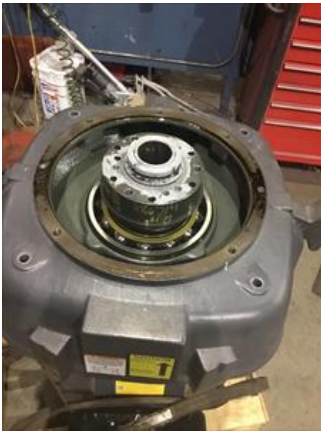
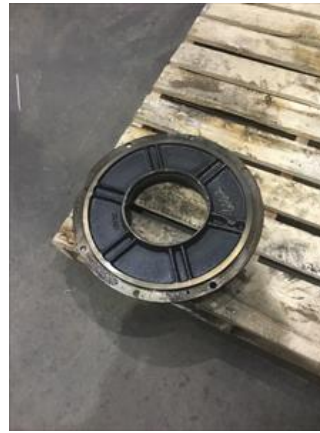
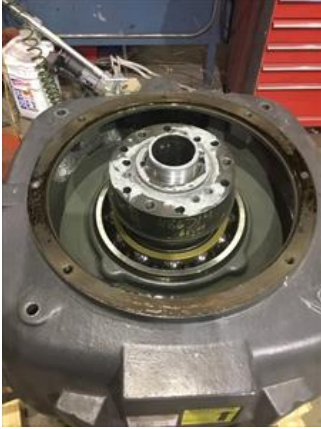
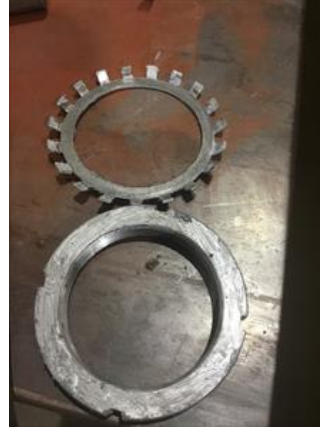
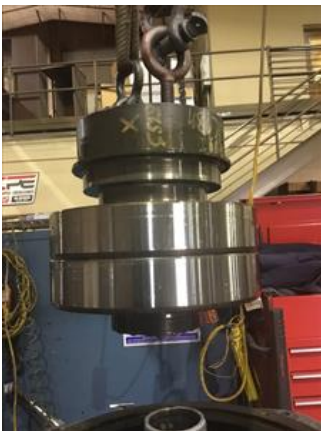
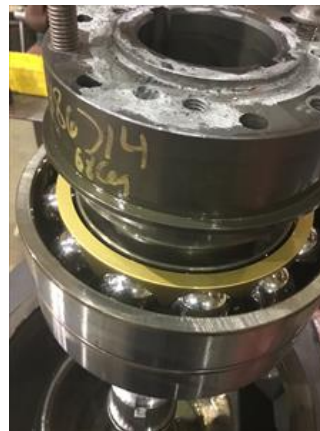
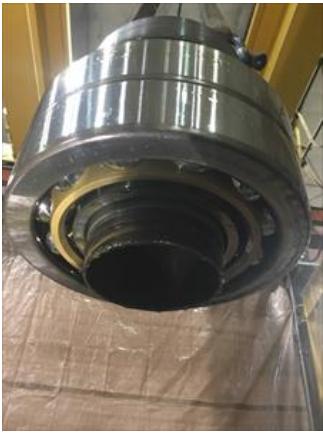
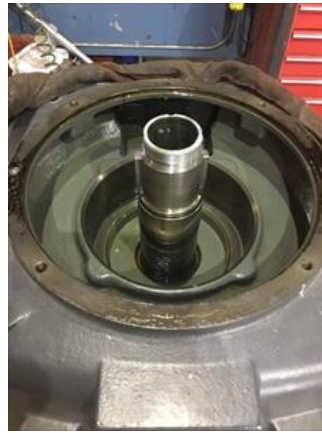
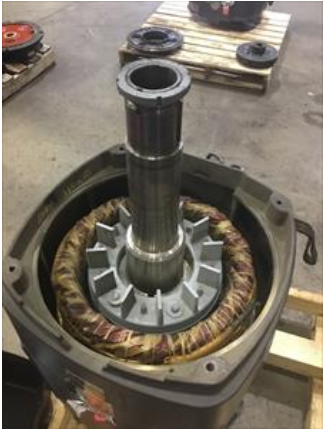
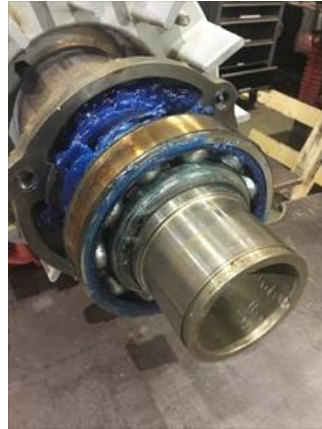
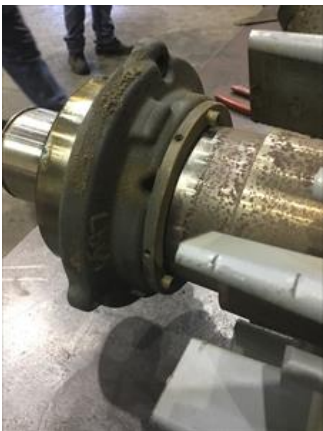
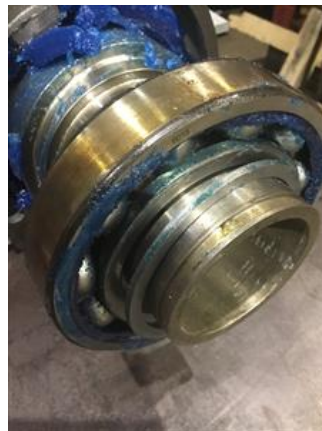
P27

- Photos of all six sides of the machine.

4. Describe the Overall Condition of the Equipment as Received
Serviceable
