AC Recondition As Found

Weaver-Bailey Contractors

Location: MOTOR SHOP LR

Description: 75HP TECO 1800RPM 365T

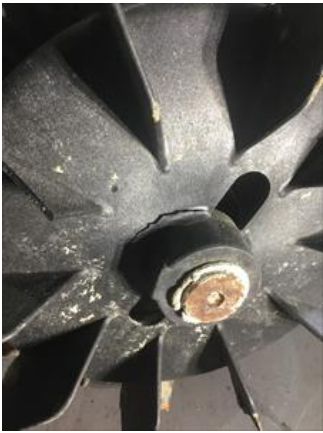
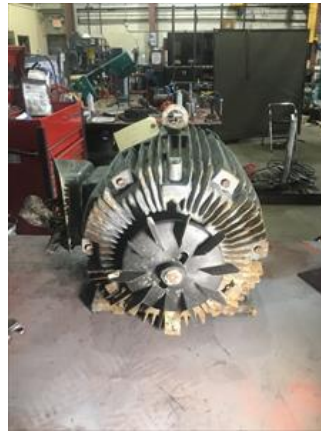
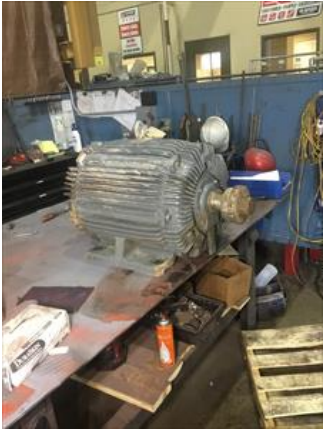
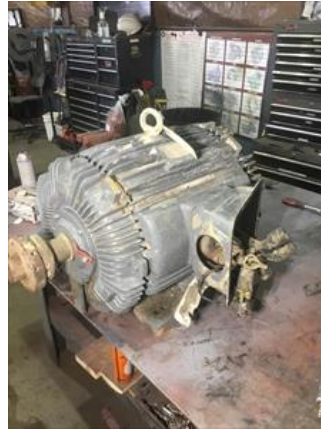
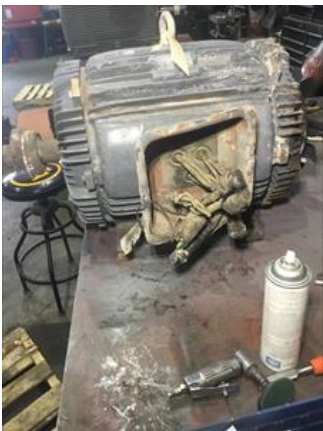
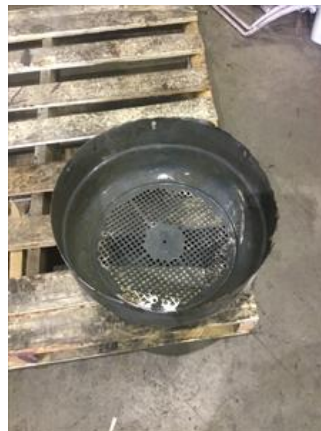
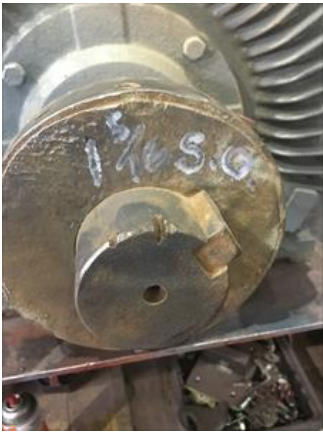
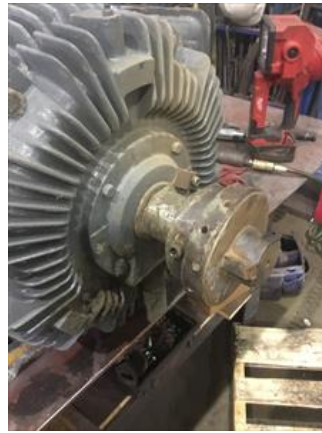
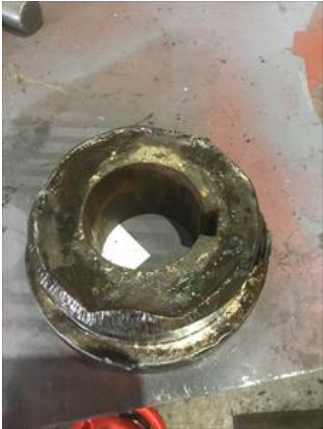
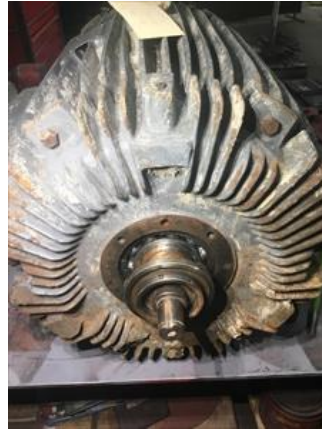
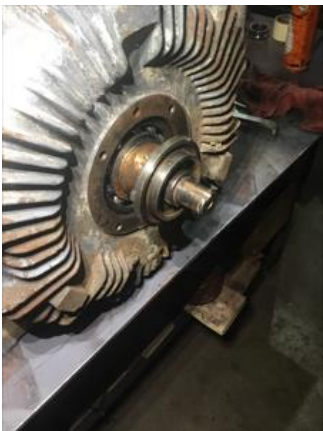
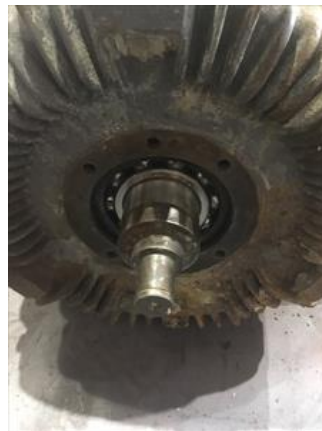
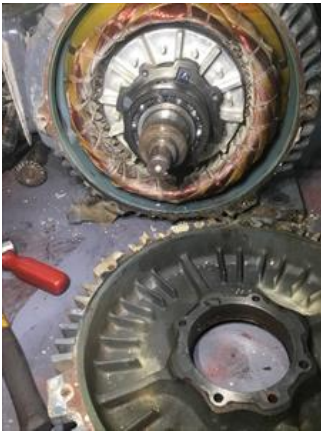
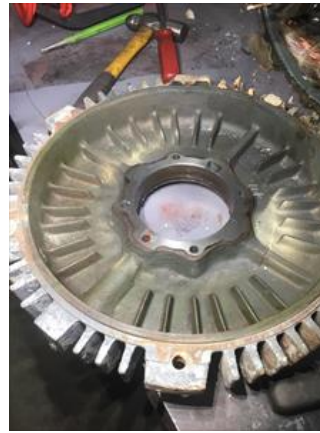
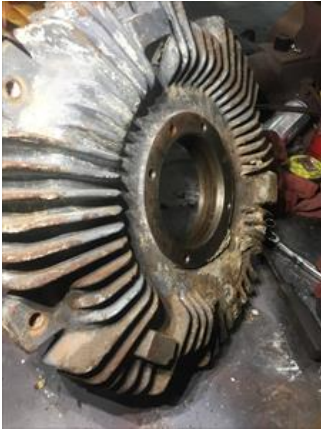
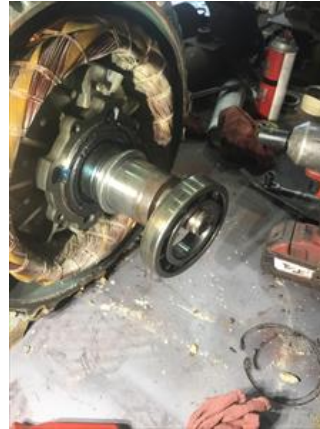
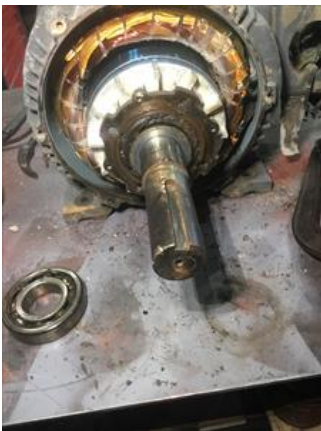
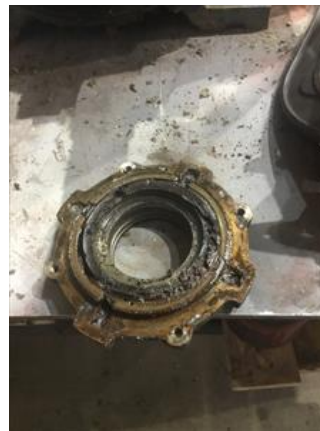
4. Describe the Overall Condition of the Equipment as Received
Fan broken, four ea. fan cover mount bolts broken off. Coupling has wear on aft end.

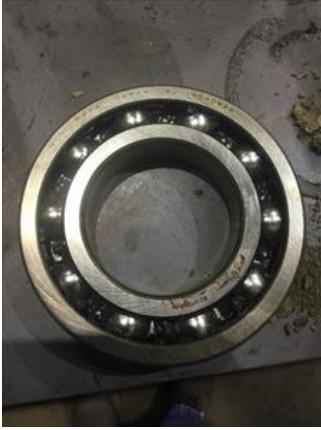
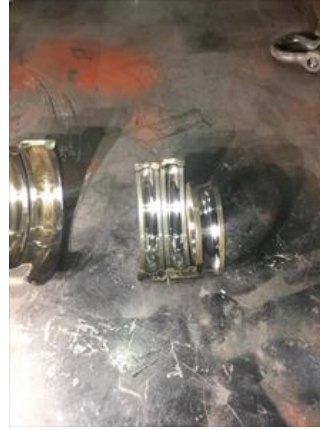
52.	Drive End - Endbell Bearing Fit Condition		(F) Fail
	Lip worn in.		
53.	Opposite Drive End - Endbell Bearing Fit		
	0 Degrees	60 Degrees	120 Degrees
	Lip worn in.

54.	Opposite Drive End - Endbell Bearing Fit Condition		(F) Fail
	Lip worn in		
55.	Bearing Cap Condition		
	Drive End Bearing Cap	Opposite Drive End Bearing Cap	
	pass	pass

Both housing fits bad. D.E. bearing has fatigue damage.
