### AC Recondition As Found

Remington (10243)

#### AC Recondition - Rev. 2

Location: MOTOR SHOP LR  
Serial Number: Z1507300199X  
Description: 15HP BALDOR 3600RPM 254TCZ

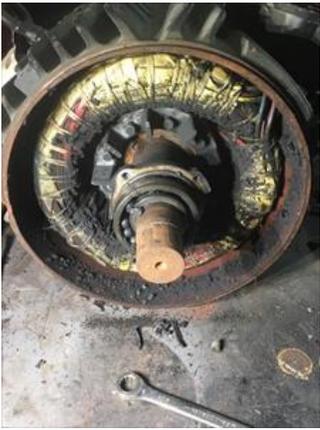
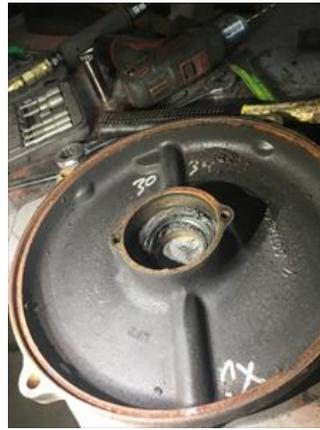
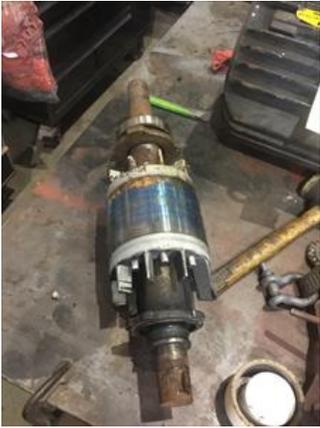
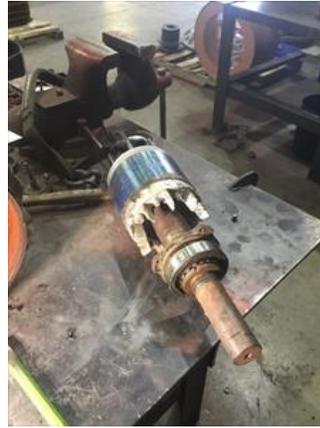
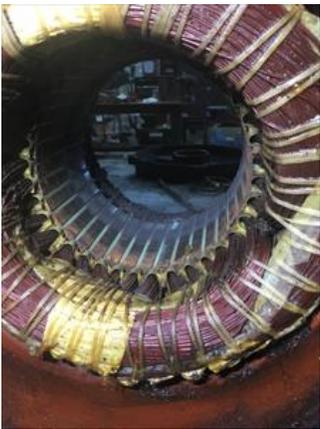
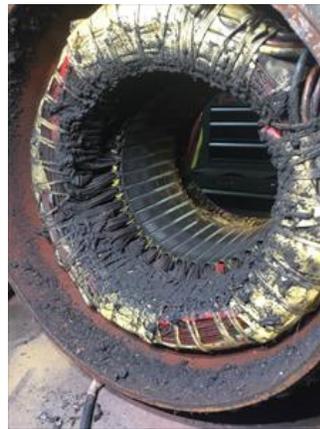
3. Photos of all six sides of the machine.

4. Describe the Overall Condition of the Equipment as Received  
*Serviceable*
