AC Recondition As Found

Peco Foods

AC Recondition - Rev. 2

Description: 5HP BALDOR 1800RPM 184JM
MEMPHIS PUMP MPAL-300-500TEBF
184647

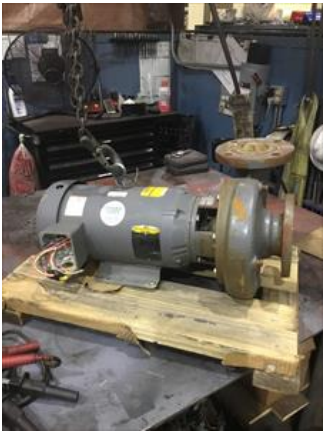
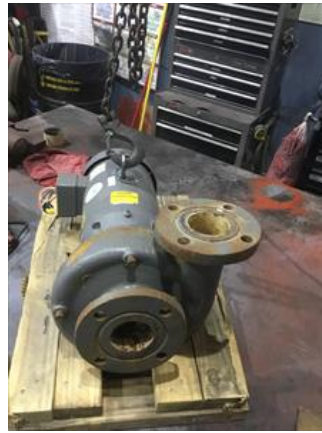
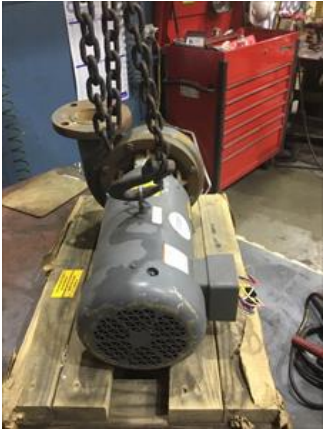
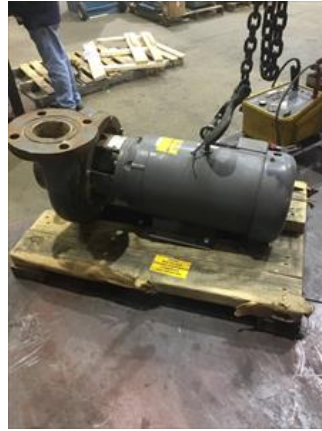
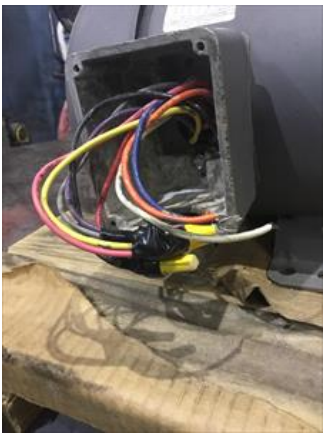
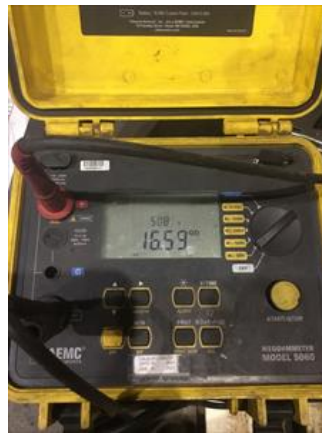
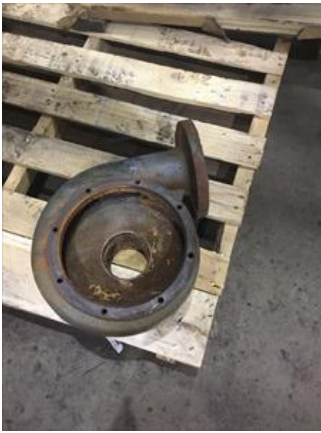
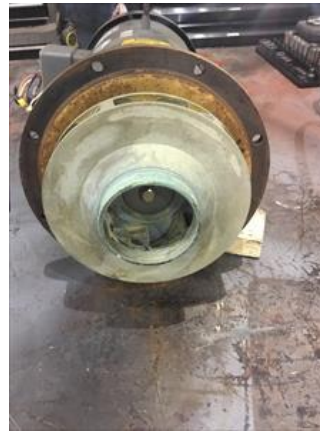
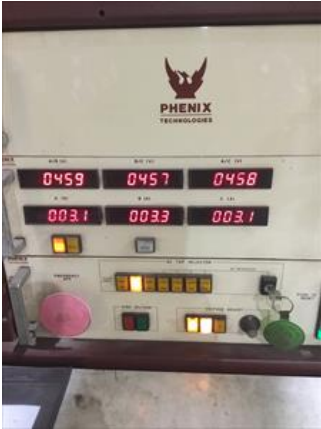
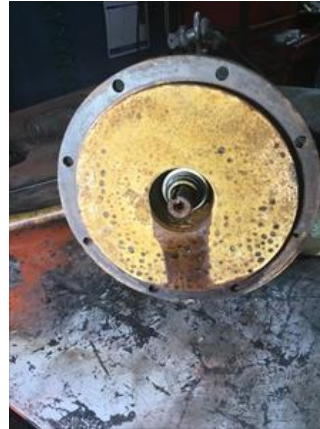
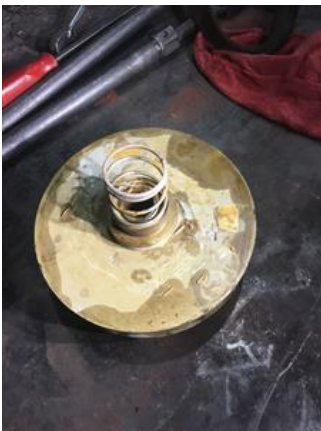
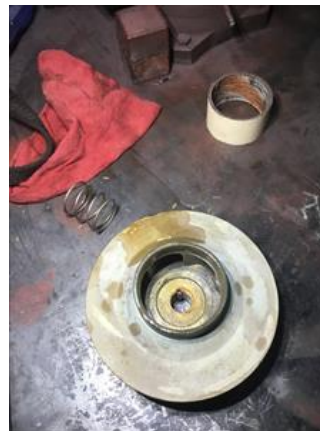
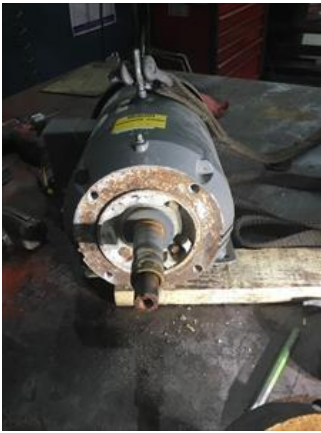
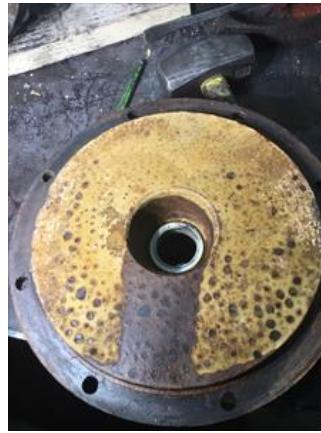
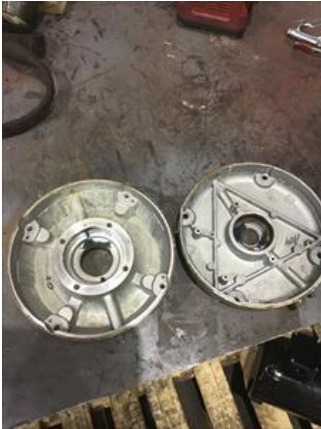
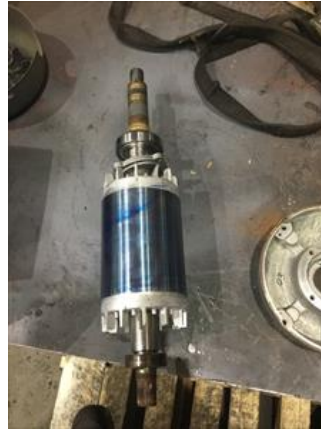
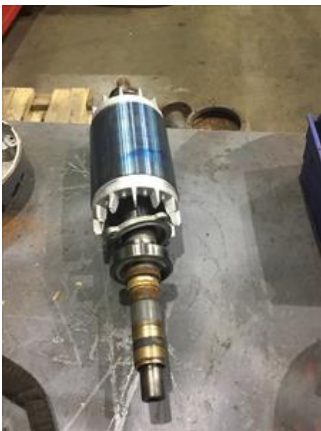
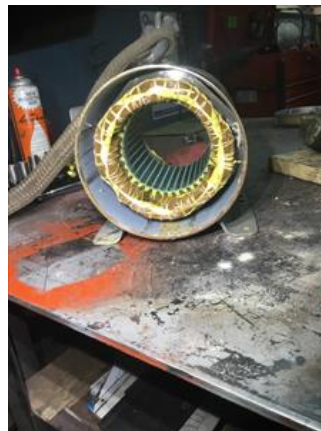
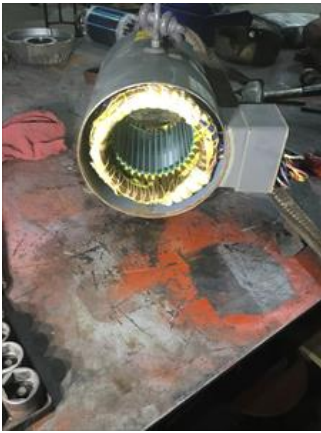
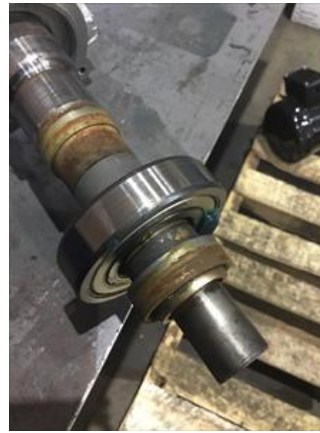
3. Photos of all six sides of the machine.

Serviceable but rusted

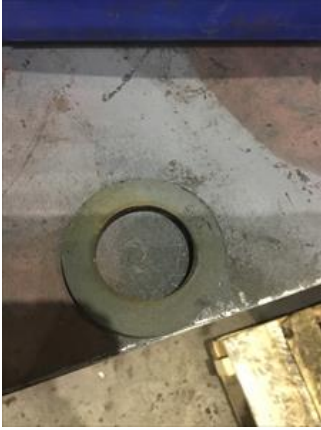
36. Opposite Drive End Seal

D.E. Seal sleeve worn. Shaft key way wallowed.

Pump seal failure due to worn seal sleeve.

Replace Seal, 6207 & 6205 bearings. Need new seal sleeve machined.
