AC Recondition As Found

Sage V Foods

AC Recondition - Rev. 2

Location: MOTOR SHOP LR
Serial Number: C0906200018
Description: 50HP Baldor 1800RPM 326TDZ

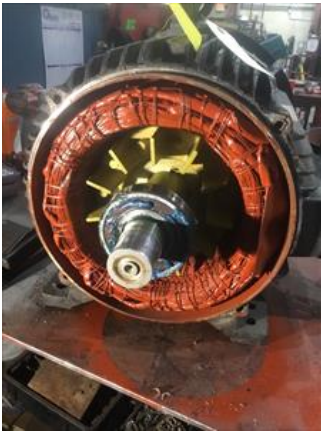
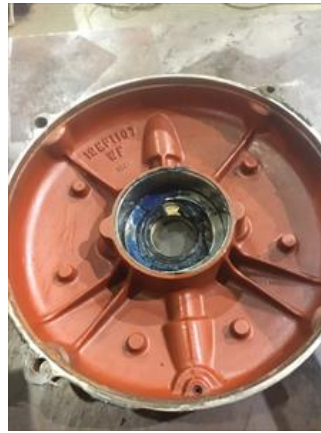
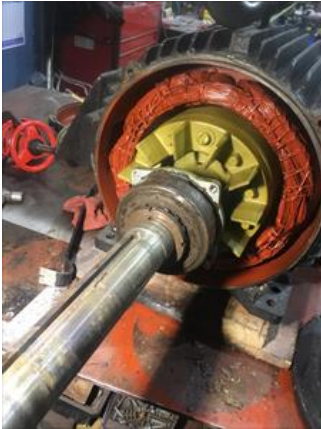
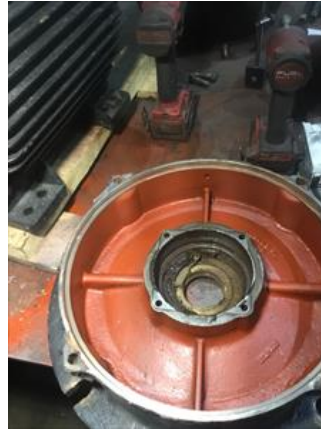
3. Photos of all six sides of the machine.

4. Describe the Overall Condition of the Equipment as Received
Serviceable

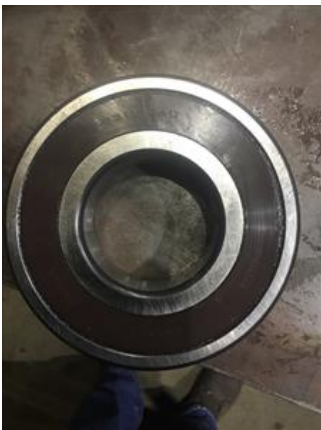
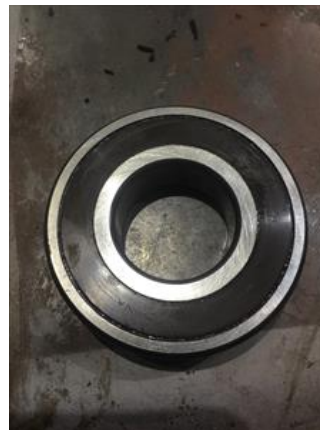
21. Drive End Bearing Qty.	1
22. Drive End Bearing Type	(Ball) Ball Bearing
23. Drive End Lubrication Type	(Grease) Grease Lubricated
24. Drive End Bearing Insulation or Grounding Device?	none
25. Drive End Wavy Washer/Snap-Ring Other Retention Device?	none
26. Drive End Bearing Condition	worn
27. Opposite Drive End Bearing Number-	6311

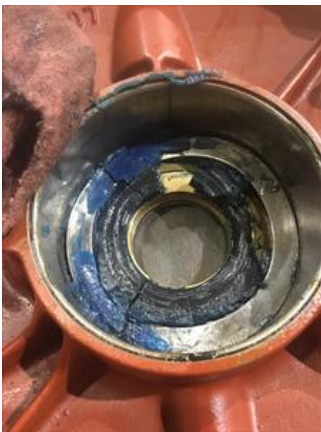
28. Opposite Drive End Bearing Qty.	1	
29. Opposite Drive End Bearing Type	(Ball) Ball Bearing	
30. Opposite Drive End Lubrication Type	(Grease) Grease Lubricated	P87

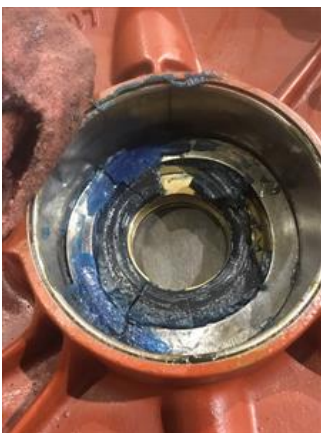
31. Opposite Drive End Bearing Insulation or Grounding Device?	none	
32. Opposite Drive End Wavy Washer/Snap-Ring Other Retention Device?	yes	P92

33. Opposite Drive End Bearing Condition	replace	
34. Drive End Seal	in pro seal	
35. Opposite Drive End Seal	In pro seal
