AC Recondition As Found
Baptist Health Medical Center
P.O. Box 8516
Little Rock, AR 72215

AC Recondition - Rev. 2

Location: MOTOR SHOP LR
Serial Number: 0990910
Description: 50HP BALDOR 1800RPM 326T

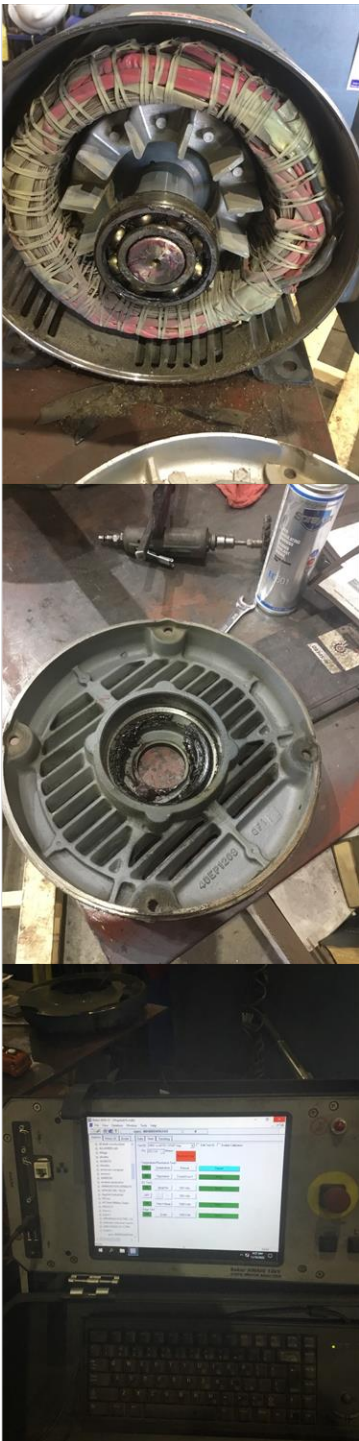
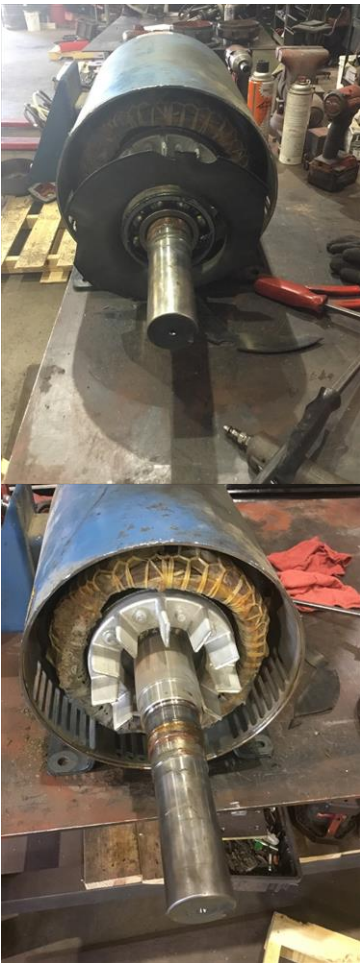
3. Photos of all six sides of the machine.

4. Describe the Overall Condition of the Equipment as Received
Serviceable but two broken baffles.

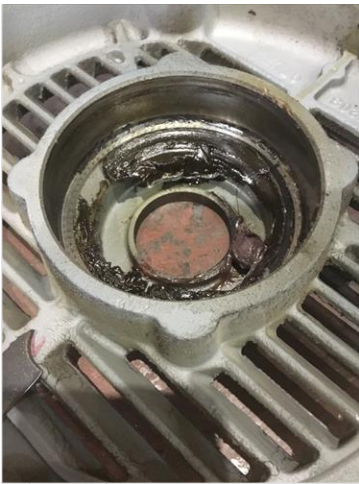
25.	Drive End Bearing Insulation or Grounding Device?	none	
26.	Drive End Wavy Washer/Snap-Ring Other Retention Device?	none	
27.	Drive End Bearing Condition	replace	
28.	Opposite Drive End Bearing Brand		
29.	Opposite Drive End Bearing Number-	6309	
30.	Opposite Drive End Bearing Qty.	1	P47

39.	Growler Test	(Pass) Pass
40.	Number of Rotor Bars	
41.	Rotor Condition	pass
42.	List the Parts needed for the Repair Below	
	<i>Replace both bearings and both end bell baffles. D.E housing fit bad.</i>	
43.	Signature of Technician that Disassembled Motor	Terrence Holland
