## AC Recondition As Found

Hiland Dairy (10126)

### AC Recondition - Rev. 2

Location: MOTOR SHOP LR  
Serial Number: W08 473295F  
Description: 30KW ATB 1800RPM 200L

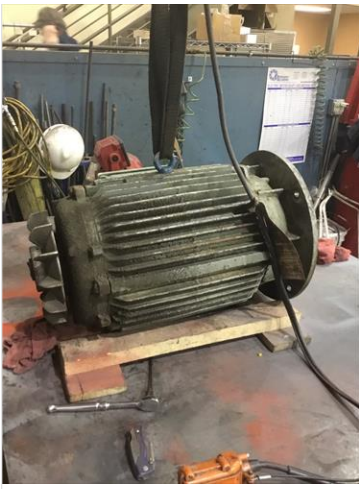
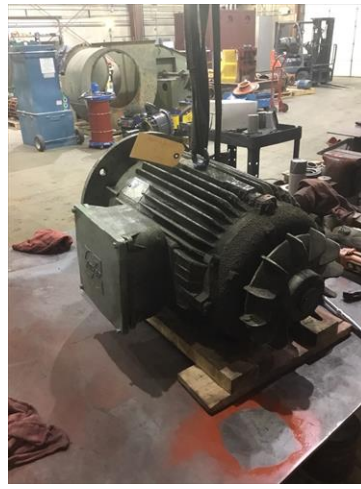
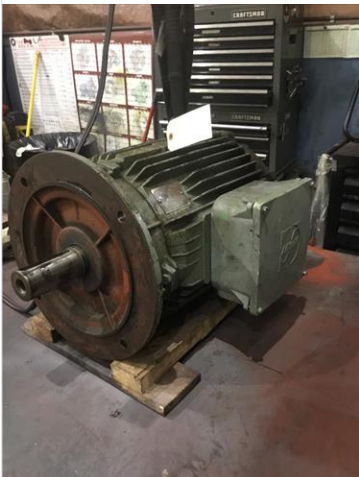
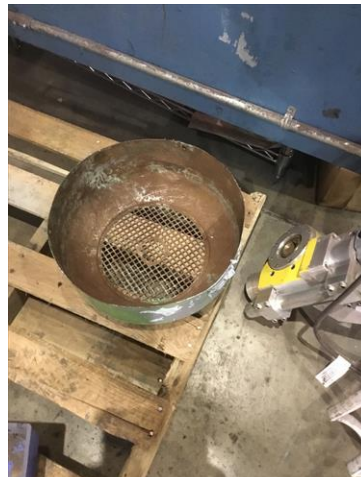
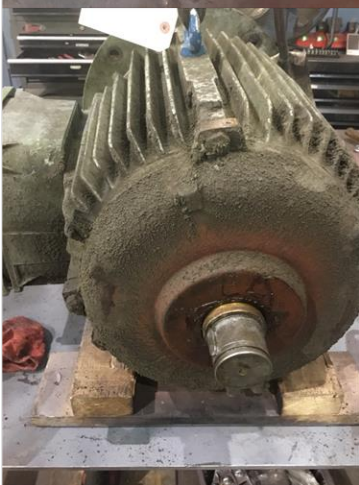
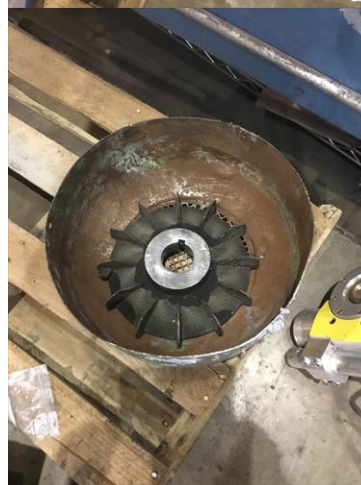
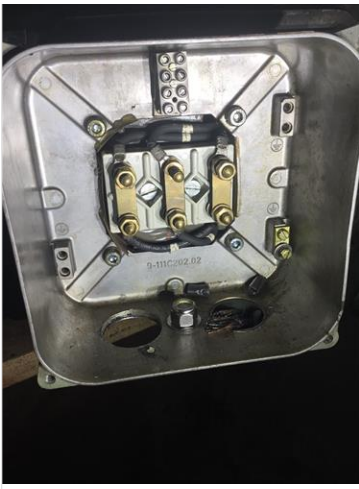
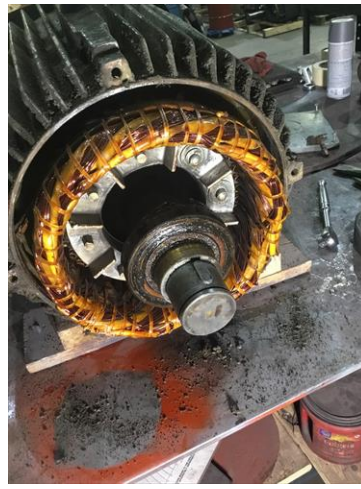
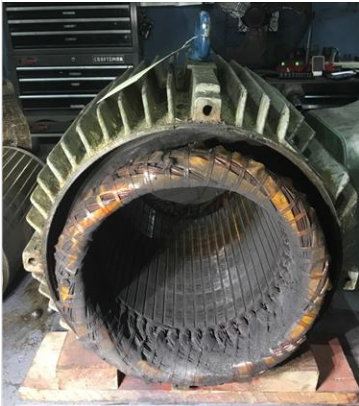
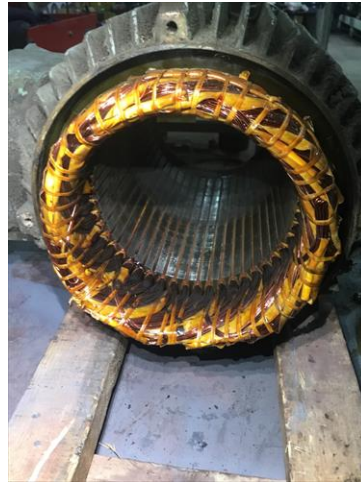
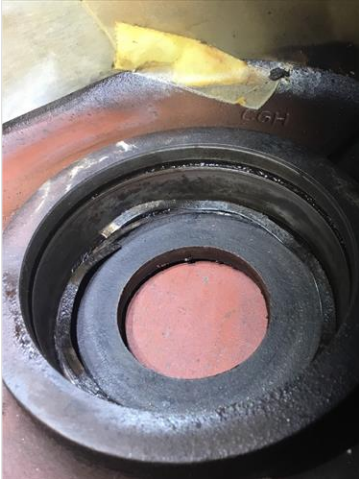
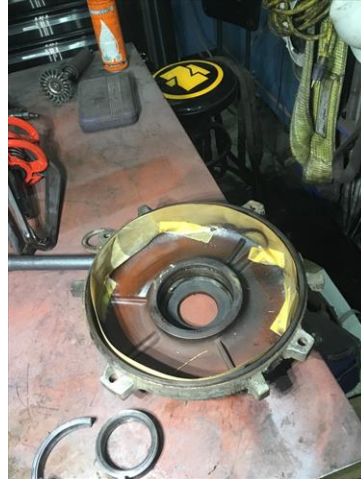
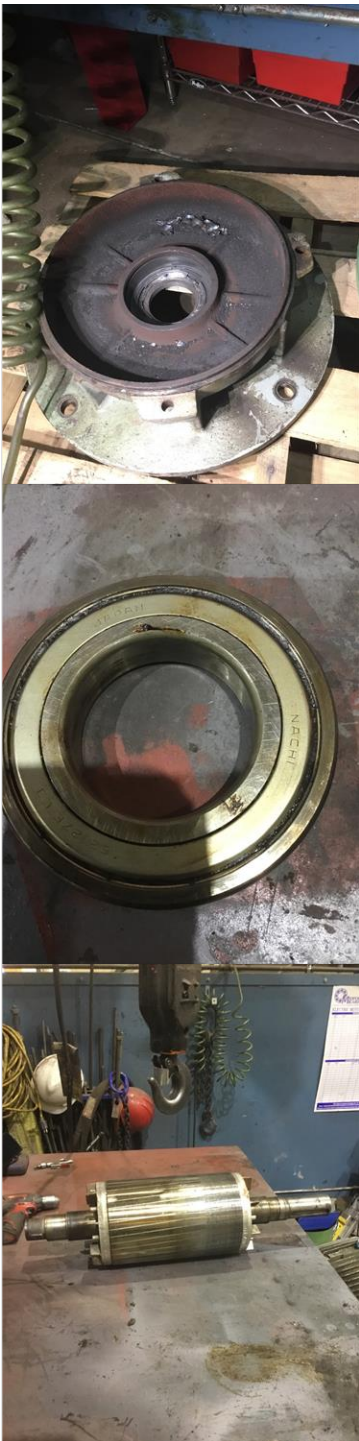
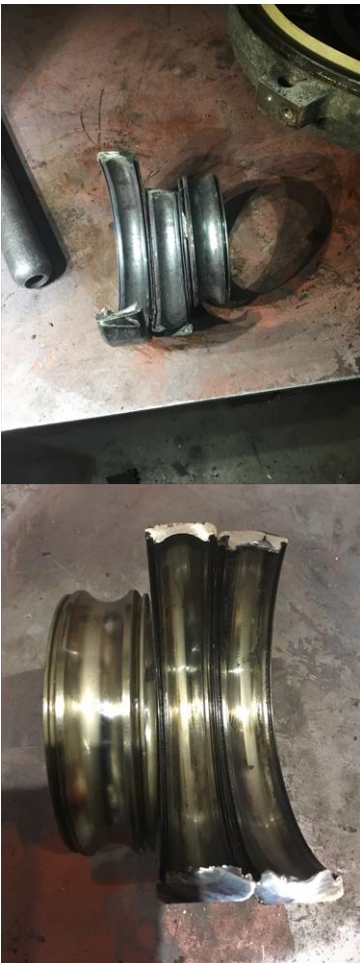
3.	Photos of all six sides of the machine.	
4.	Describe the Overall Condition of the Equipment as Received	
	<i>Serviceable</i>	
<b>Initial Mechanical/Electrical</b>

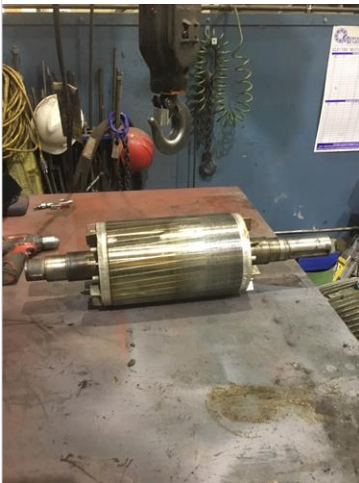
P3

| 39. Growler Test | (Pass) Pass |
| 41. Rotor Condition | pass |
