## AC Recondition As Found

### Sage V Foods

#### AC Recondition - Rev. 2

Location: MOTOR SHOP LR  
Serial Number: EF5T46663N-F4-7-8/22  
Description: 0.5HP SWECO 1200RPM 143TZX

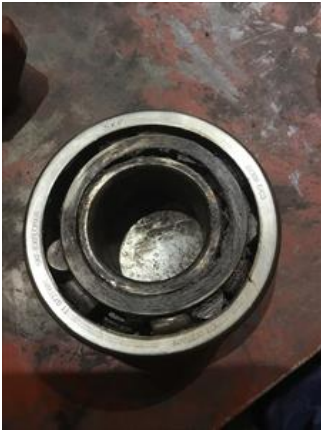
20. Drive End Bearing Brand		Skf	
21. Drive End Bearing Number-		22308/C3	P33

24. Drive End Lubrication Type	(Grease) Grease Lubricated
25. Drive End Bearing Insulation or Grounding Device?	none
26. Drive End Wavy Washer/Snap-Ring Other Retention Device?	snap ring
27. Drive End Bearing Condition	destroyed
28. Opposite Drive End Bearing Brand	SKF
29. Opposite Drive End Bearing Number-	NU 307 ECP/c3

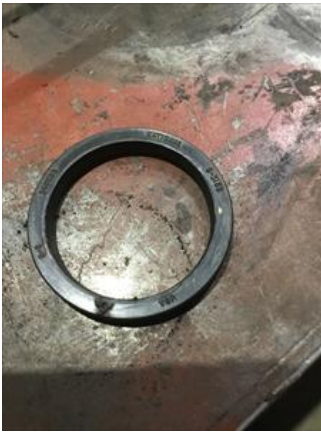
30. Opposite Drive End Bearing Qty.	1
31. Opposite Drive End Bearing Type	(Roller) Roller Bearing
32. Opposite Drive End Lubrication Type	(Grease) Grease Lubricated
33. Opposite Drive End Bearing Insulation or Grounding Device?	none
34. Opposite Drive End Wavy Washer/Snap-Ring Other Retention Device?	snap ring
35. Opposite Drive End Bearing Condition	replace
36. Drive End Seal	National 340853. S-3188
