AC Inspection as Found

AC Inspection - Rev. 2

Description: 8.6KW LENZE 3600RPM 132M

Hi-Speed Job Number: 100995

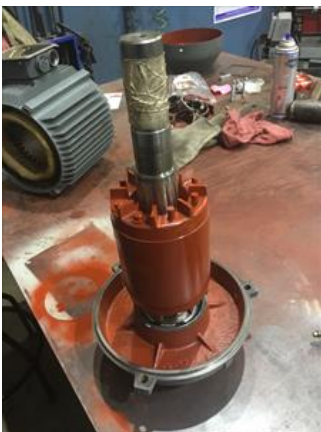
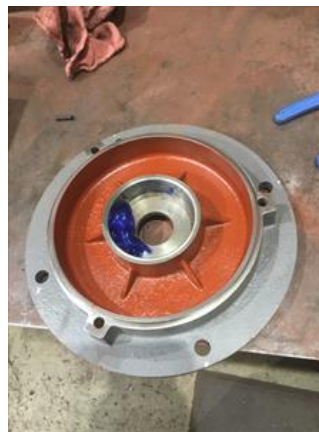
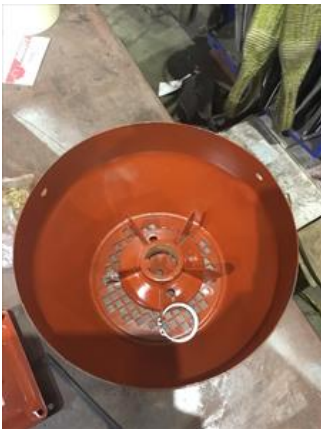
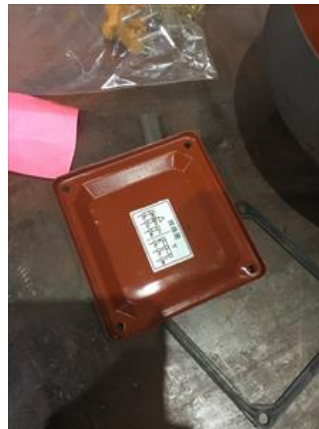
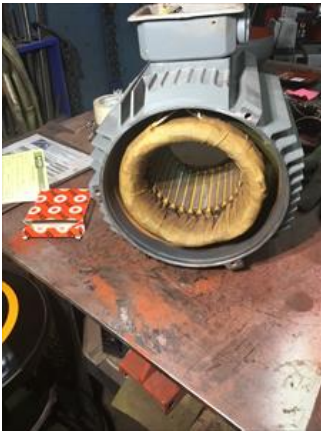
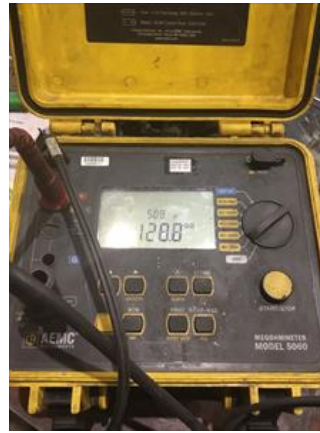
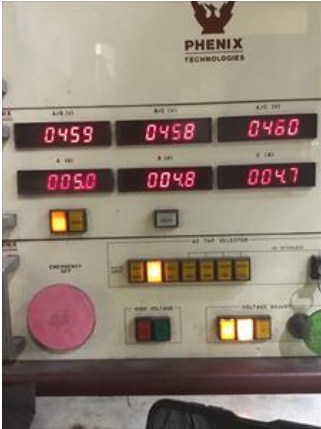
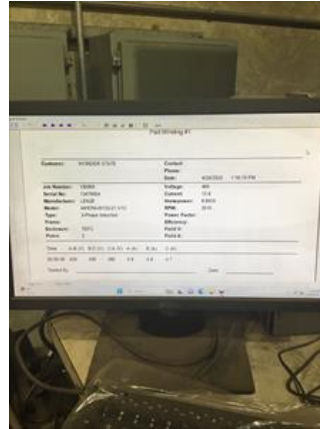
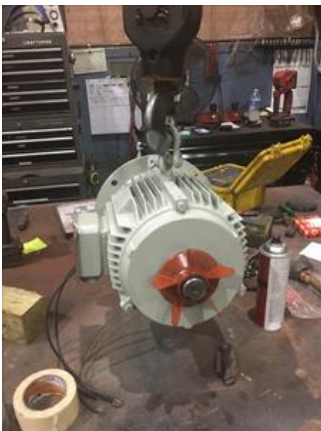
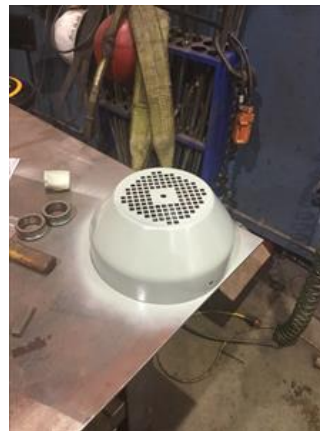
P92

92. Photograph All Major Components prior to assembly
