AC Recondition As Found

SLOAN VALVE (11763)

AC Recondition - Rev. 2

Description: 15HP BALDOR 3600RPM 254TCZ

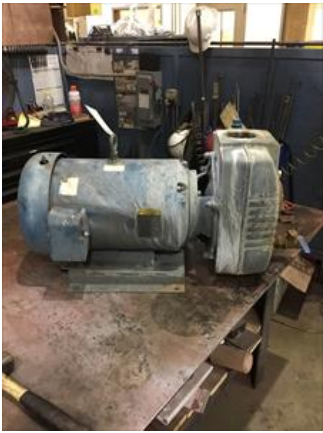
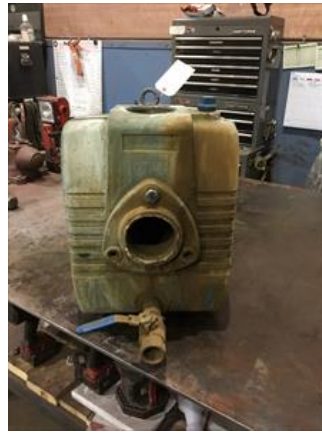
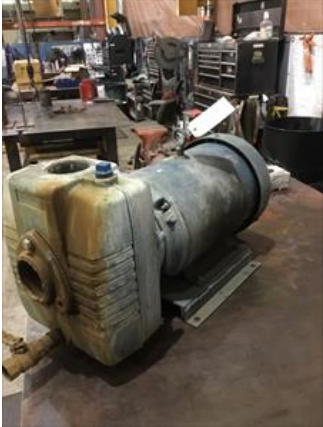
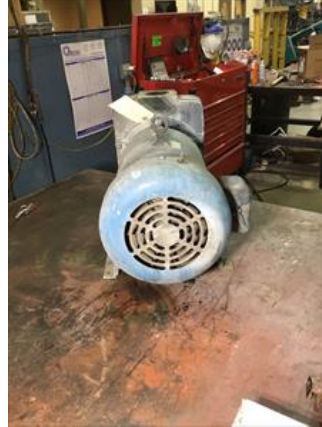
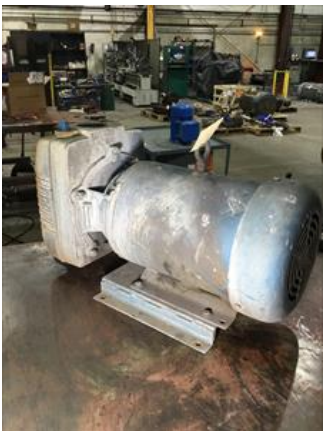
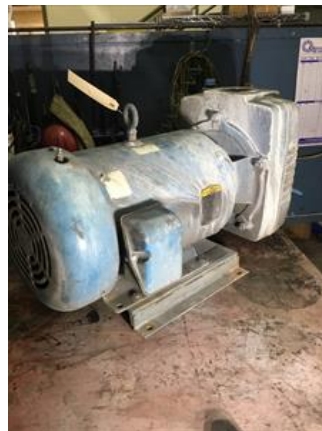
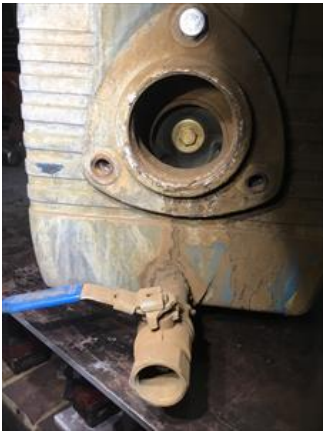
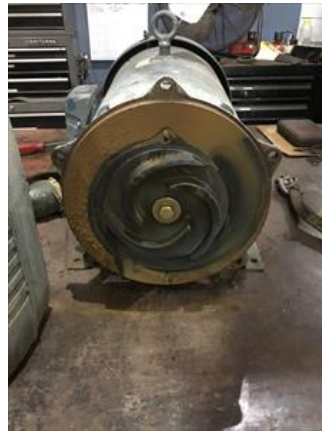
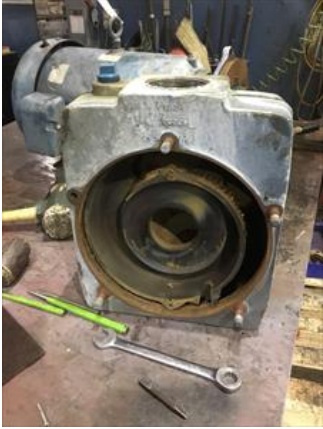
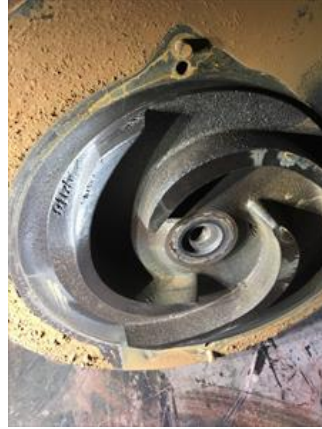
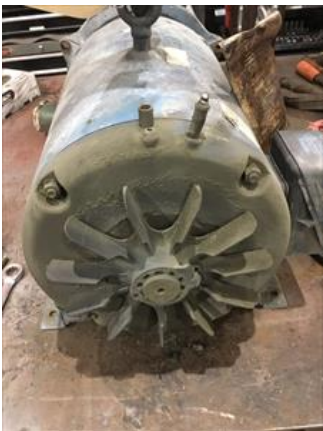
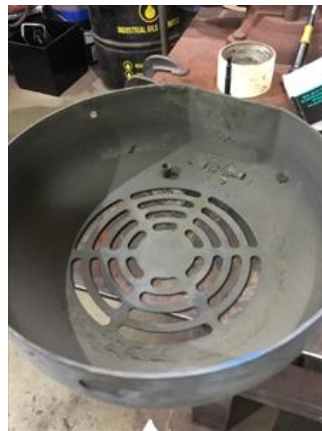
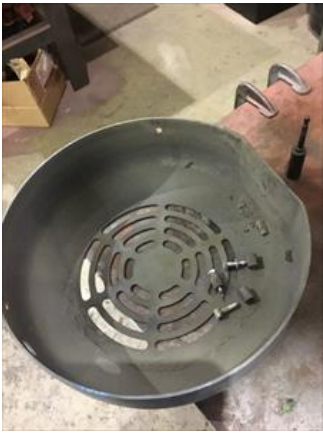
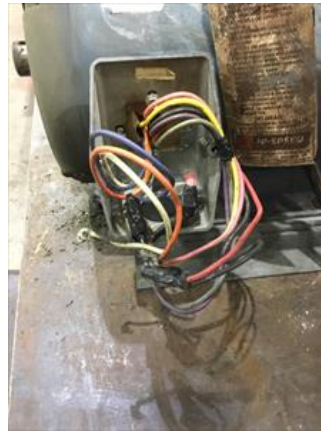
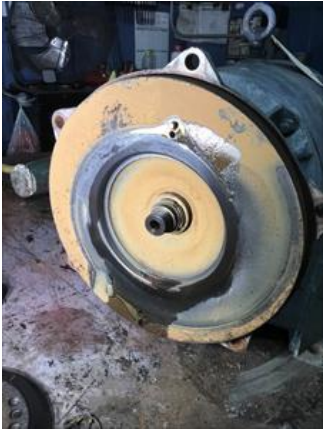
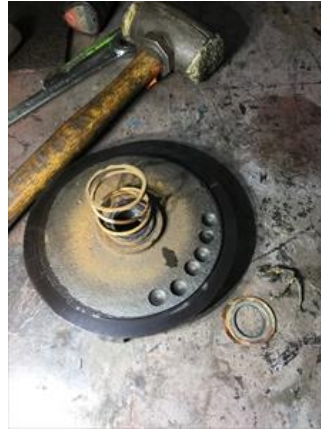
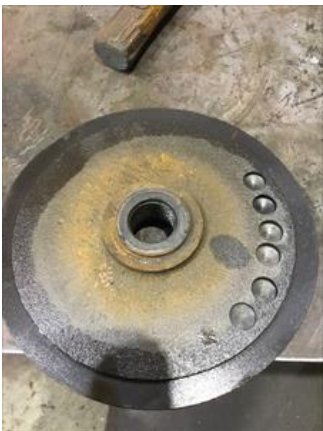
P45

4. Describe the Overall Condition of the Equipment as Received
5. Distance from the end of the shaft to the Coupling/Sheave

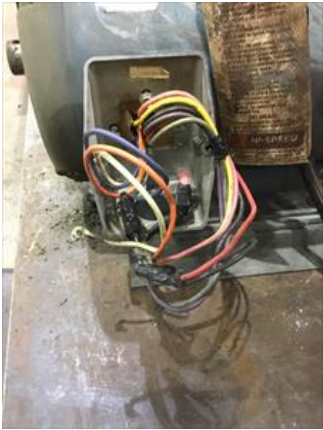
12. Lead Length	14 Inches
13. Frame Condition	pass
14. Fan Condition	(P) Pass
15. Broken or Missing Components	
Initial Electrical Inspection

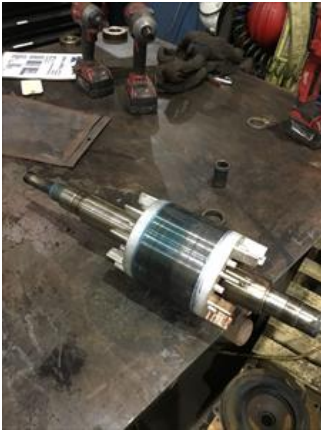
40. Growler Test (Pass) Pass
41. Number of Rotor Bars
42. Rotor Condition pass
43. List the Parts needed for the Repair Below
Re-sleeve both housing fits. Replace pump seal and make new seal sleeve. Rewind stator.
44. Signature of Technician that Disassembled Motor Terrence Holland

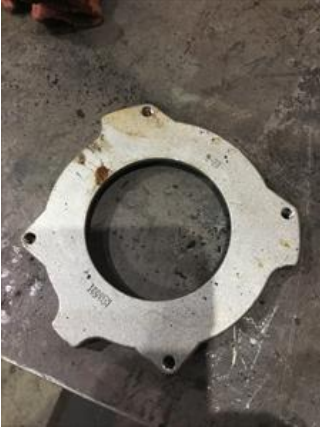
58. Bearing Cap Condition

pass
