AC Recondition As Found
ARKANSAS SERVICE ONE
14318 EAST POLK ROAD
ALEXANDER, AR 72002

AC Recondition - Rev. 2

Location: MOTOR SHOP LR
Serial Number: 6936289A-003
Description: 15HP RELIANCE 1800RPM 254T

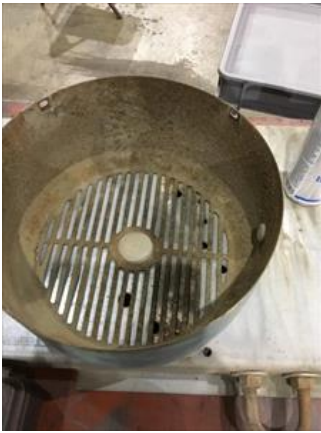
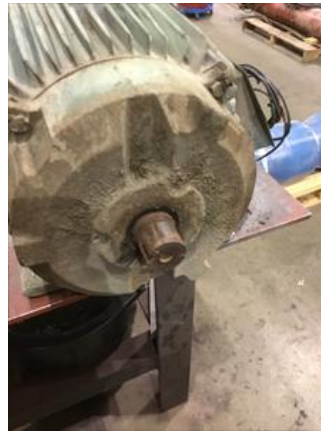
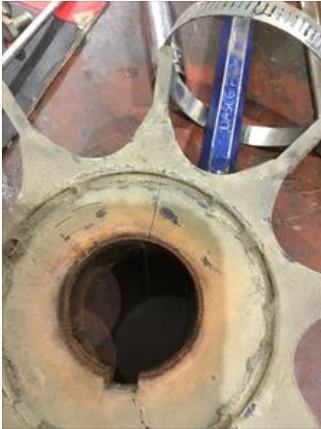
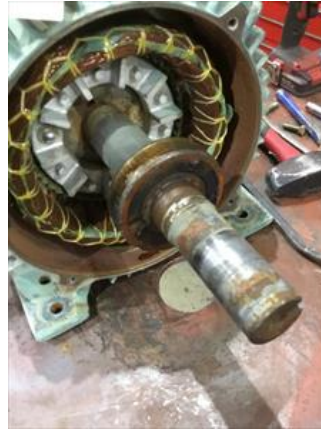
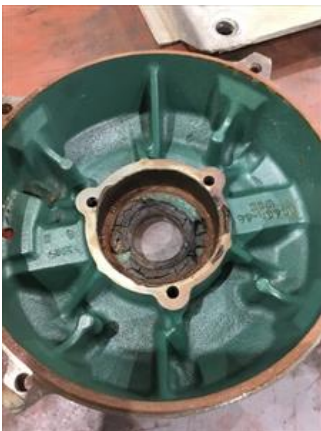
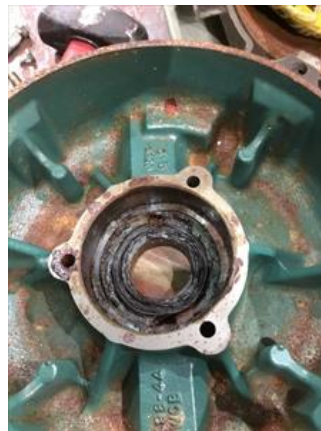
3. Photos of all six sides of the machine.
4. Describe the Overall Condition of the Equipment as Received
Ok
5. Distance from the end of the shaft to the Coupling/Sheave **0.75 inches**

6. Does Shaft Turn Freely? **(Yes) Yes**
7. Does Shaft Have Visible Damage? **(No) No**
8. Assembled Shaft Runout
9. Assembled Shaft End Play
10. Air Gap Variation <10%
11. Lead Condition **(P) Pass**
12. Lead Length **12 Inches**
13. Frame Condition **good**
14. Fan Condition **(F) Fail**
15. Broken or Missing Components **fan broken 1 5/8 shaft 7 1/2 fan diameter**

43.	List the Parts needed for the Repair Below <i>2 - 6309 2RS bearings, replacement fan 1 5/8 shaft/ 7 1/2 fan diameter</i>	
44.	Signature of Technician that Disassembled Motor	David Maclin

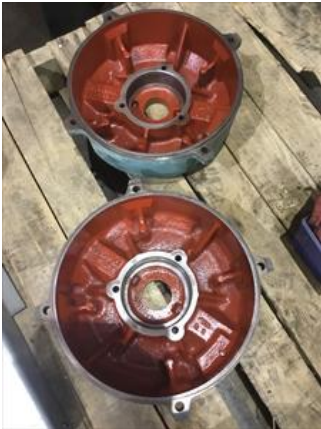
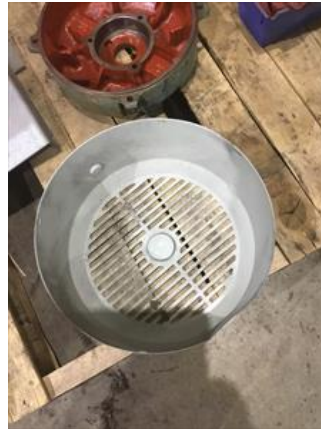
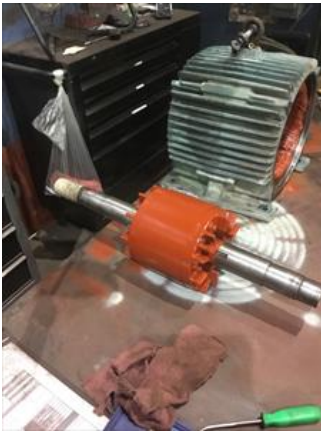
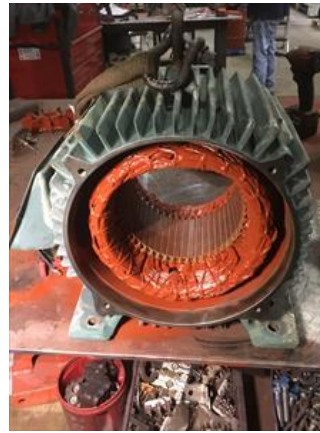
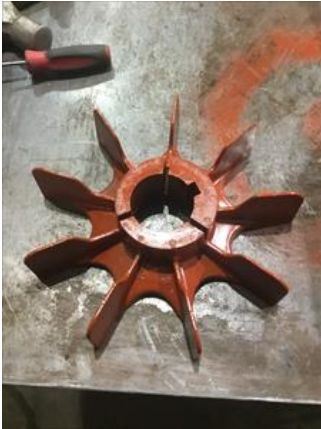
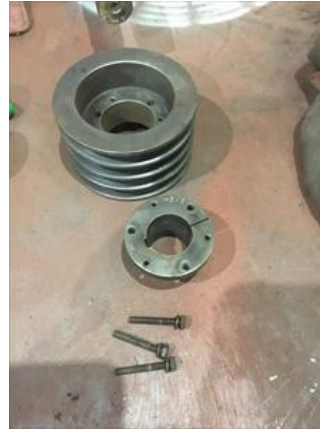
80.	Drive End Bearing Shaft Fit Post Repair		
	0 Degrees	60 Degrees	120 Degrees
81.	Opposite Drive End Bearing Shaft Fit Post Repair		
	0 Degrees	60 Degrees	120 Degrees
82.	Shaft Air Seal Fits Post Repair		
	Drive End Air Seal	Opposite Drive End Air Seal	
83.	Shaft Repair Sign-off		
Mechanical Fits- Bearing Housings - Post Repair			
84.	Drive End - Endbell Bearing Fit Post Repair		
	0 Degrees	60 Degrees	120 Degrees
85.	Opposite Drive End - Endbell Bearing Fit Post Repair		
	0 Degrees	60 Degrees	120 Degrees
86.	Bearing Cap Condition Post Repair		
	Drive End Bearing Cap	Opposite Drive End Bearing Cap	
87.	End Bell Air Seal Fits Post Repair		
	Drive End Air Seal	Opposite Drive End Air Seal	
88.	End Bell Repair Sign-off		
Assembly			 
89.	QC Check All Parts for Cleanliness Prior to Assembly		
90.	Photograph All Major Components prior to assembly
