## AC Inspection as Found

Reynolds Metals company

### AC Inspection - Rev. 2

Description: 75HP MARATHON 1800RPM 365T

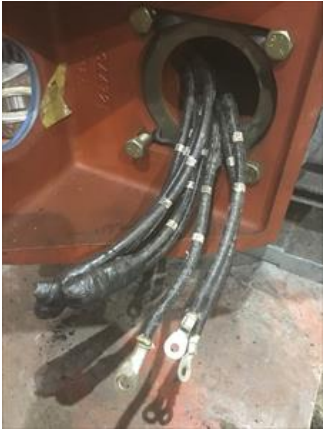
7.	Assembled Shaft Runout	0.002 Inches	
8.	Assembled Shaft End Play		
9.	Air Gap Variation <10%		
10.	Lead Condition	(P) Pass	P55

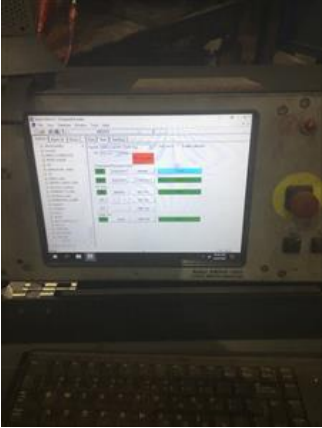
15.	Insulation Resistance/Megger		
16.	Winding Resistance		
	1-2	1-3	2-3
17.	Perform Surge Test	(P) Pass	P57

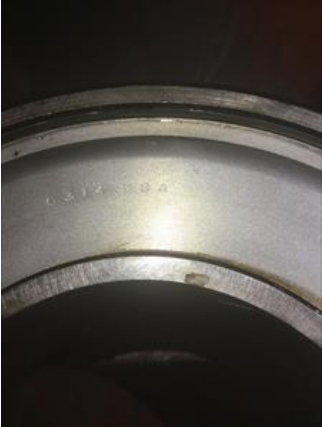
22.	Drive End Bearing Brand		
23.	Drive End Bearing Number-	6314	P32

29. Drive End Bearing Condition

replace

44. List the Parts needed for the Repair Below

*6314 & 6312 sleeves for both housing fits*

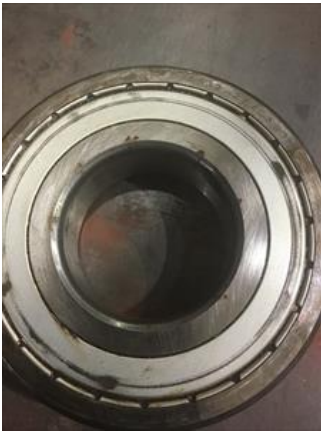
31. Opposite Drive End Bearing Number-

6312

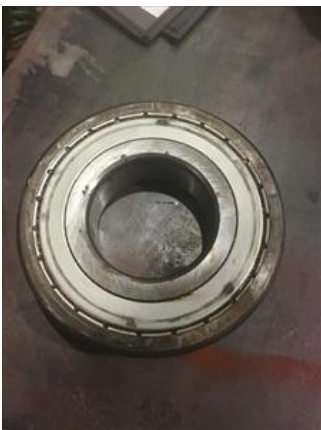
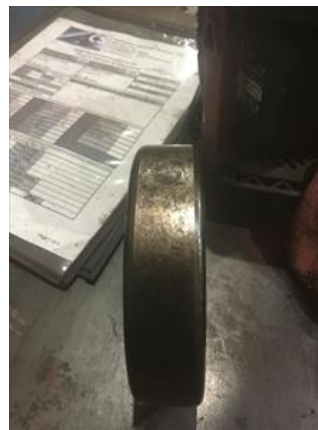
P92

33. Opposite Drive End Bearing Type

(Ball) Ball Bearing

37. Opposite Drive End Bearing Condition

replace

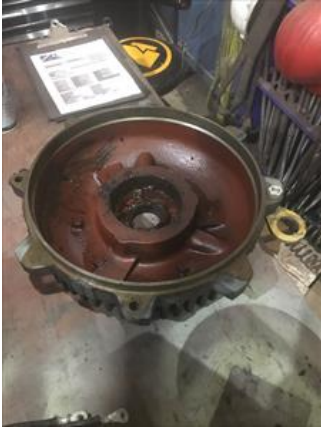
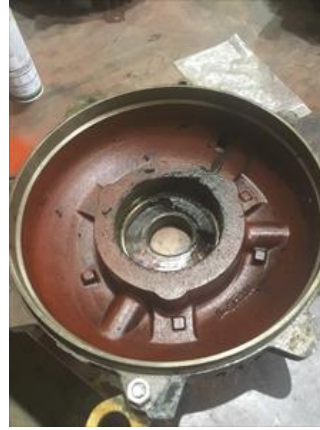
</div>		
56.	Drive End - Endbell Bearing Fit Condition		(F) Fail
57.	Opposite Drive End - Endbell Bearing Fit		
	0 Degrees	60 Degrees	120 Degrees
